Limited Condition Assessment Report

Linda Pederson Observation Tower

**Subject: Limited Condition Assessment
Observation Tower
Linda Pedersen Park
6340 Shoal Line Boulevard
Spring Hill, FL 34607**

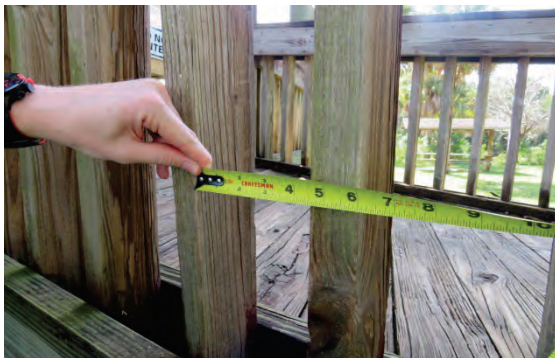
Exhibit 11 – Gap between balusters measured to be greater than 4 inches

In addition, BillerReinhart observed sections of the tower guardrails with gaps spanning greater than 4 inches between the balusters (*Refer to Exhibit 11*). If the deteriorated baluster sections are to be replaced, they will need to be respaced to comply with the maximum 4-inch spacing requirements required by building codes.

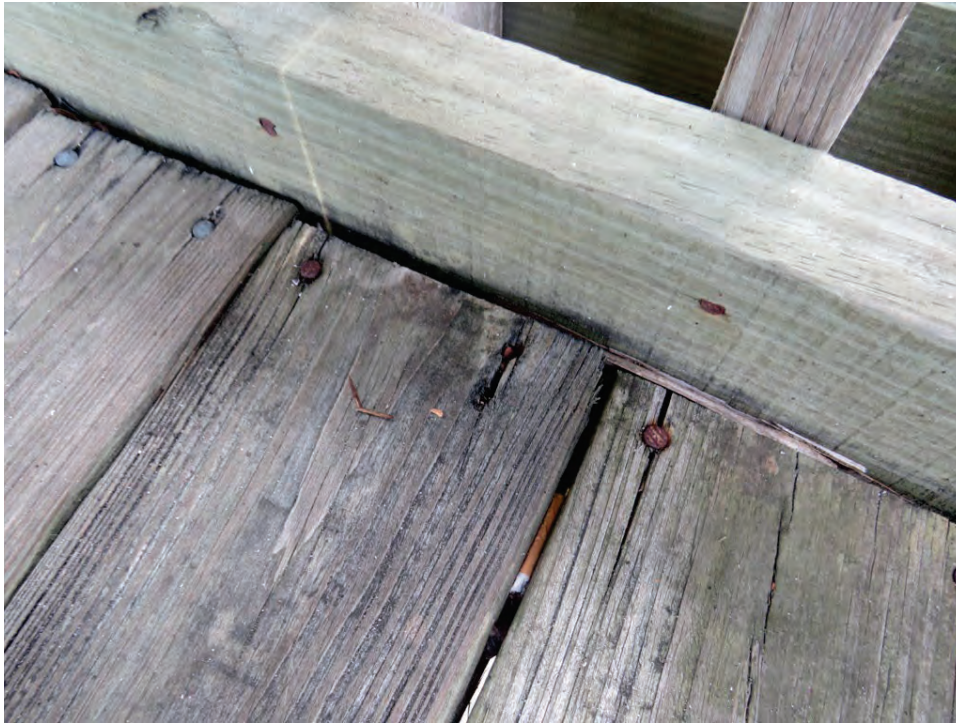
Figure A-73

Observation Deck and Landing Areas	
Overall photographs of observation deck and landing areas	<i>Figure A-56 through A-71</i>
<i>Typical Conditions</i>	
Deterioration at sporadic locations along the deck boards	<i>Figure A-72</i>
Loose and missing fasteners at sporadic locations along deck boards	<i>Figure A-73</i>
Separation/deterioration along the surface of the lumber poles	<i>Figures A-74 and A-75</i>
Staining/organic growth along the under sides of the observation decks and landings	<i>Figure A-76</i>
Deteriorated/weathered paint at sporadic locations along the poles	<i>Figure A-77</i>
Minor surface corrosion along lateral bracing components and fasteners	<i>Figures A-78 and A-79</i>
Minor displacement/separation at lateral bracing to pole connections	<i>Figures A-80 and A-81</i>
Stairways and landings above the 1 st level were enclosed by vertical balusters. Gaps between balusters were observed to be greater than 4 inches in sporadic locations	<i>Figure A-82</i>

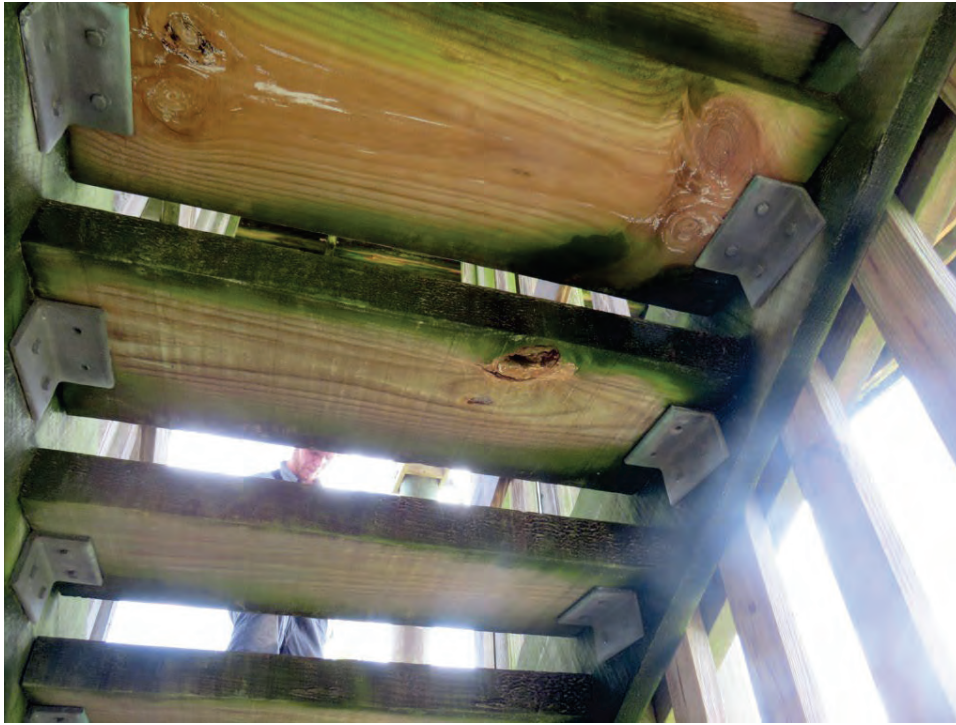
Figure A-83

Organic growth at sporadic locations along the stair treads	<i>Figure A-83</i>
Sporadic areas of deterioration along the lumber guard rail caps	<i>Figure A-84</i>

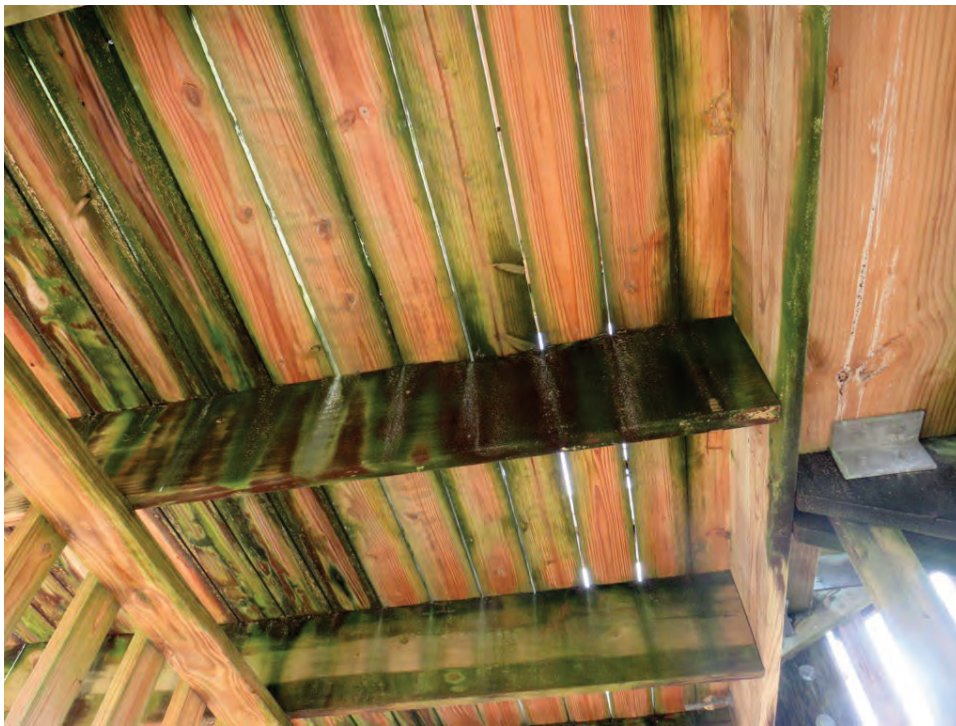
Figure A-94

Heavy staining and deterioration were observed along the joists below the landing between the 1 st and 2 nd floors	<i>Figure A-94</i>
Loose/misaligned fasteners for balusters were observed at the top stairs at the 3 rd level	<i>Figure A-95</i>
Metal joist hangers were observed along the underside of landing between the 4 th and 5 th levels. Missing fasteners were observed at sporadic locations along the hangers	<i>Figures A-96 and A-97</i>
Separations and indentations/hollows were observed along the stair treads of the 2 nd to 3 rd and 4 th to 5 th stairways	<i>Figures A-98 and A-99</i>
A metal collar was observed to be installed at an isolated area along the poles	<i>Figure A-100</i>
Heavy organic growth and section loss was observed along the stringer of the landing to 5 th floor stairway	<i>Figure A-101</i>
Missing fasteners along stringer-to-tread angles along 2 nd to 3 rd level stairs	<i>Figure A-102</i>
