# Limited Condition Assessment Report

## Linda Pederson Observation Tower

**September 2, 2025**

**Subject: Limited Condition Assessment  
Observation Tower  
Linda Pedersen Park  
6340 Shoal Line Boulevard  
Spring Hill, FL 34607**

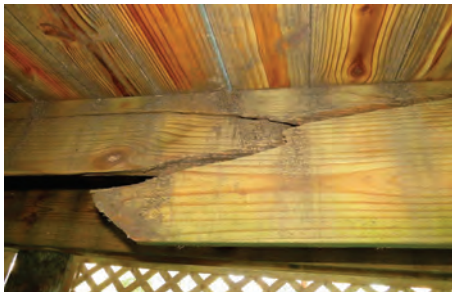
Exhibit 2 – section loss/separation along deck joist

During our assessment of the tower's current condition, BillerReinhart observed that the tower's structural components were exhibiting deterioration and damage in multiple locations. This includes section loss along lumber components (*Refer to Exhibit 2*), aged/deteriorated lumber components within the structure's deck, railings, stairways, and cladding (*Refer to Exhibits 3 and 4*), and heavy organic growth along decking and floor joists (*Refer to Exhibit 5*).

For the structure to be restored to safe operation, all the components exhibiting deterioration will need to be removed and replaced for public safety. This will expectedly include removal and replacement of the poles which support the stairway, deck systems, and lateral bracing of the tower.

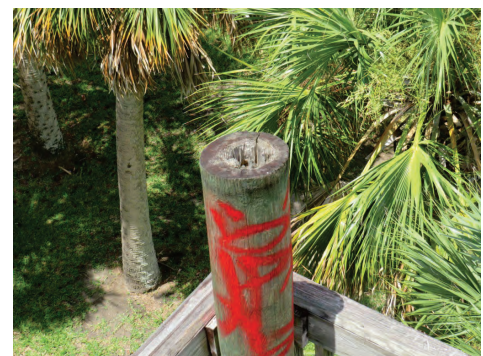
Exhibit 6 – Pole top deterioration

In addition, the lumber poles, which are critical load bearing members of the tower (gravity and lateral stability), also exhibited deterioration and signs of moisture intrusion. Conditions observed include pole top deterioration, (*Refer to Exhibit 6*), splitting/deterioration along the pole surfaces (*Refer to Exhibit 7*), and surficial moisture along the pole surfaces (*Refer to Exhibit 8*).

The structure is exposed to conditions that are favorable to decay-causing biotic agents, such as moisture, oxygen, moderate temperatures, etc. Should the lumber poles be considered for re-use, testing methods would need to be employed to assess their structural integrity, such as acousto-ultrasonic (AU) testing, a non-destructive method used to evaluate the internal condition of timber poles. This testing detects and evaluates defects, damage, and variations in mechanical properties and is particularly useful for identifying early decay in wood poles. However, advanced deterioration, such as pole top deterioration, was observed.

Service life expectancy for lumber utility poles ranges from 25 to 37 years <sup>(2)</sup> and 30 to 50 years <sup>(3)</sup>. Fifteen (15) of the poles are approximate 31 years of age and one pole is 19 years of age. Most of the lumber poles have reached the range of service life expectancy. Therefore, testing should determine which poles are candidates for re-use and which need replacement. Also, testing will need to continue to monitor the structural integrity of the re-used poles and a plan, timeframe, and budget developed for a pole replacement program.

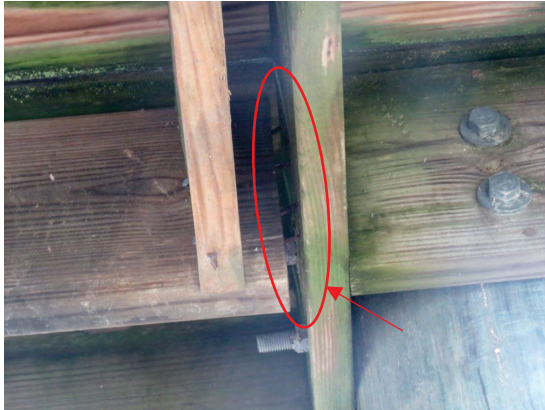
Exhibit 9 – Separation of end-nailed joist connection

building codes and safety standards. One example has been presented in the provided document *Linda Pedersen Observation Tower: Timeline*, prepared by Hernando County Department of Recreation. The document mentions an assessment of the tower conducted by a building official which reported that “end-nailed joists supporting the decking were observed to be dropping due to deteriorating fasteners (today’s codes require joist hangers).” During our condition assessment, BillerReinhart observed that most of the deck joists appeared to be end-nailed with some of the connections separating at isolated

locations (*Refer to Exhibit 9, circled in red*). The scope of work for the tower renovation will require installing new joist hangers at the deck joist connections. Furthermore, BillerReinhart observed metal joist hangers along the undersides of the 5<sup>th</sup> floor and 4<sup>th</sup> to 5<sup>th</sup> floor intermediate landing, likely installed to update the replaced joists to comply with current building codes (*Refer to Exhibit 10*).

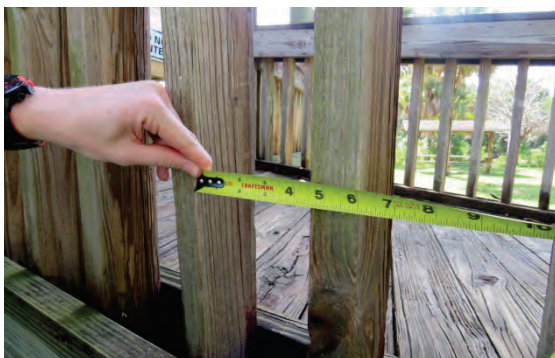
Exhibit 11 – Gap between balusters measured to be greater than 4 inches

In addition, BillerReinhart observed sections of the tower guardrails with gaps spanning greater than 4 inches between the balusters (*Refer to Exhibit 11*). If the deteriorated baluster sections are to be replaced, they will need to be respaced to comply with the maximum 4-inch spacing requirements required by building codes.

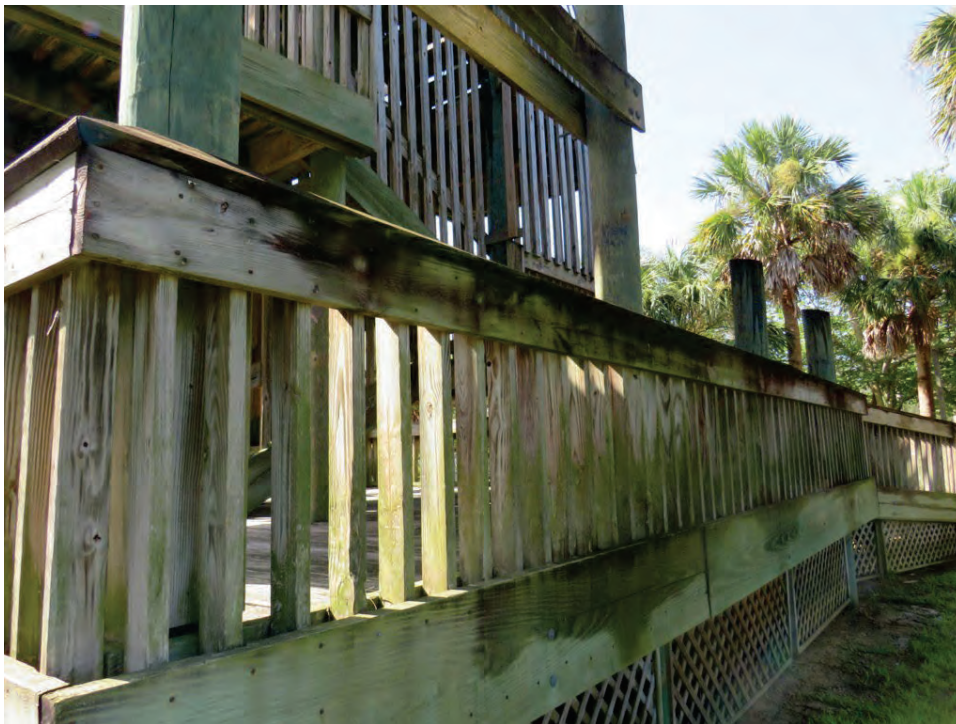
Figure A-5

| <b>Table A – Documented Observations</b> | |
|---|---|
| Organic growth and staining along the exterior rails, balusters, and fascia boards | <i>Figures A-5 and A-6</i> |

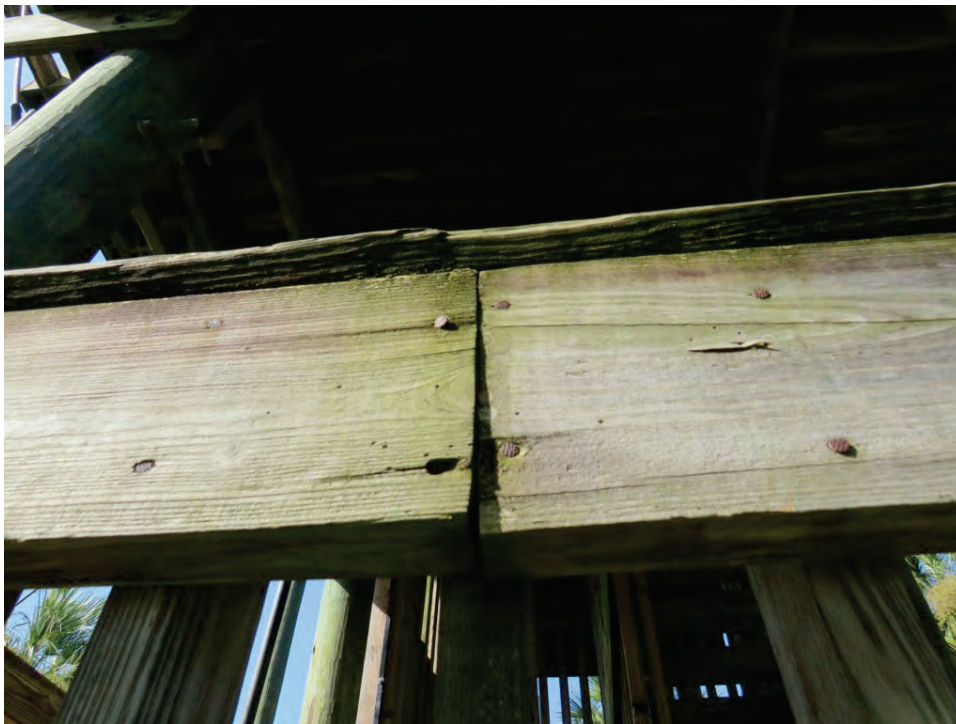
Figure A-9

| <b>Table A – Documented Observations</b> | |
|---|---|
| Horizontal separations along the perimeter rail fascia boards | <i>Figure A-9</i> |

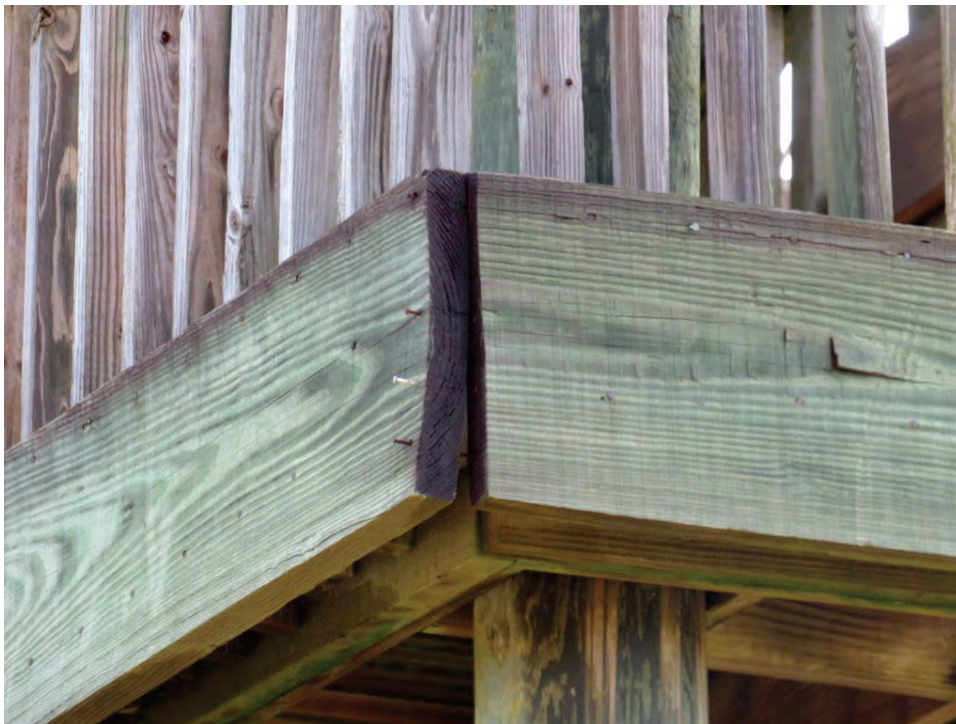
Figure A-15

| <b>Table A – Documented Observations</b> | |
|---|---|
| Separation and splitting along the lower fascia board at the west elevation of the 3 <sup>rd</sup> level railing | <i>Figure A-15</i> |

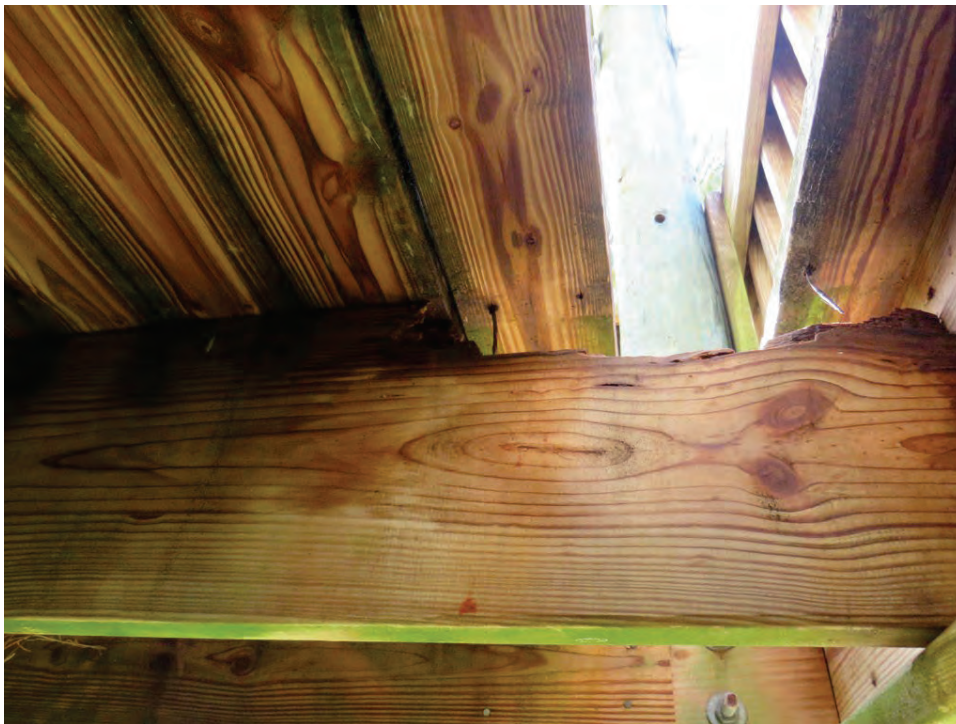
Figure A-25

| Organic growth at sporadic locations along the 1 <sup>st</sup> level joists | <i>Figure A-25</i> |

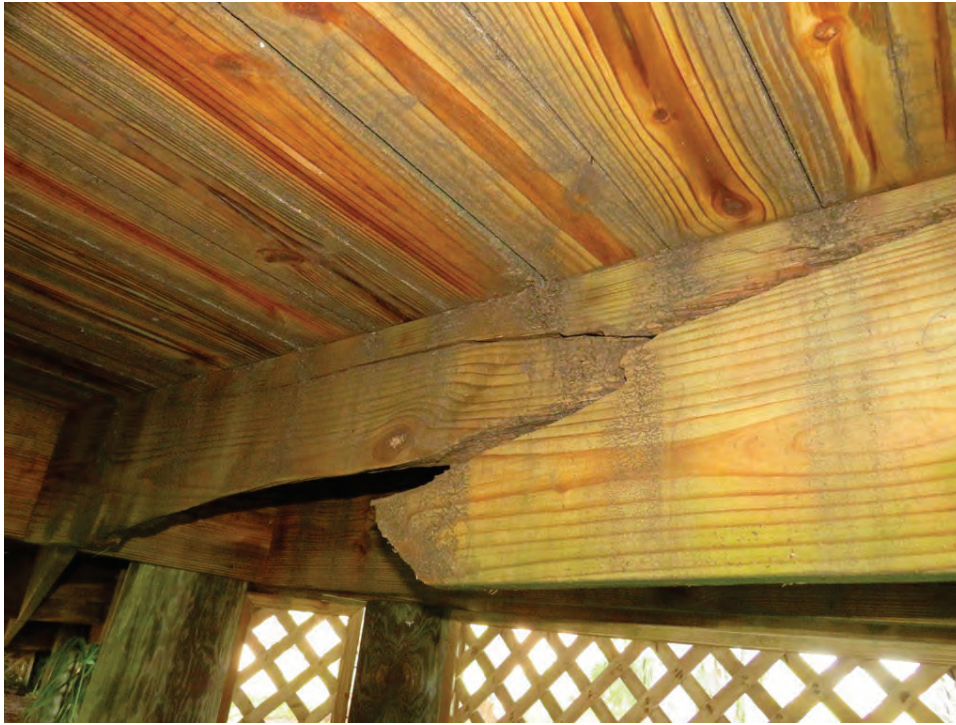
Figure A-26

| Section loss with deterioration along the top of the end section of a 1 <sup>st</sup> level floor joist at the southeast corner | <i>Figure A-26</i> |

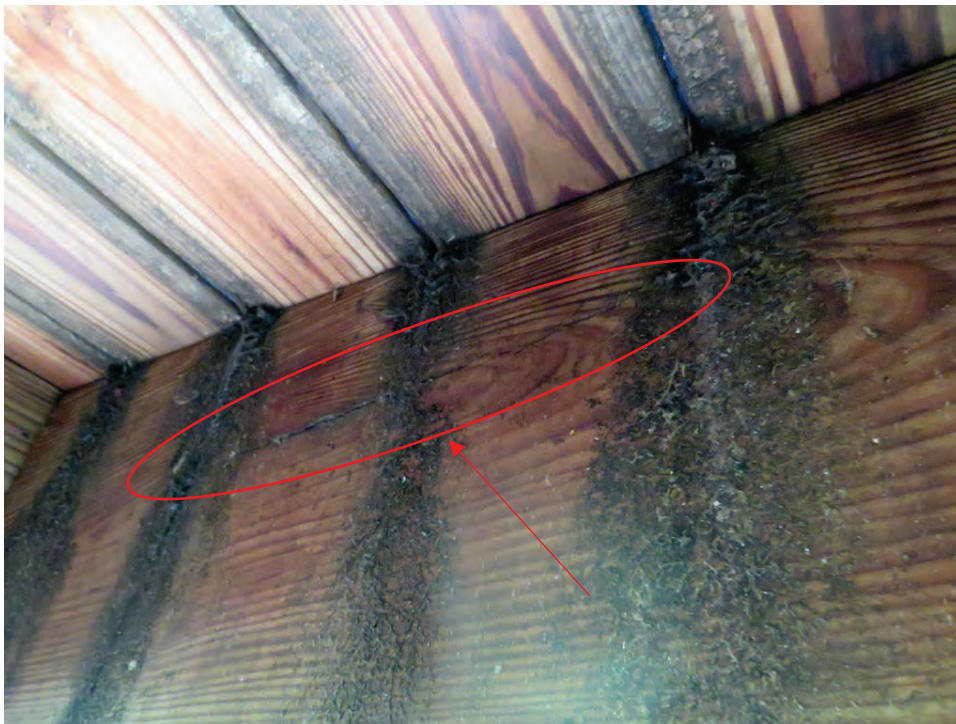
Figure A-31

| Section loss with staining along lateral brace/blocking and exposed nails between 2 <sup>nd</sup> joist girders from the south along the west elevation | <i>Figure A-31</i> |

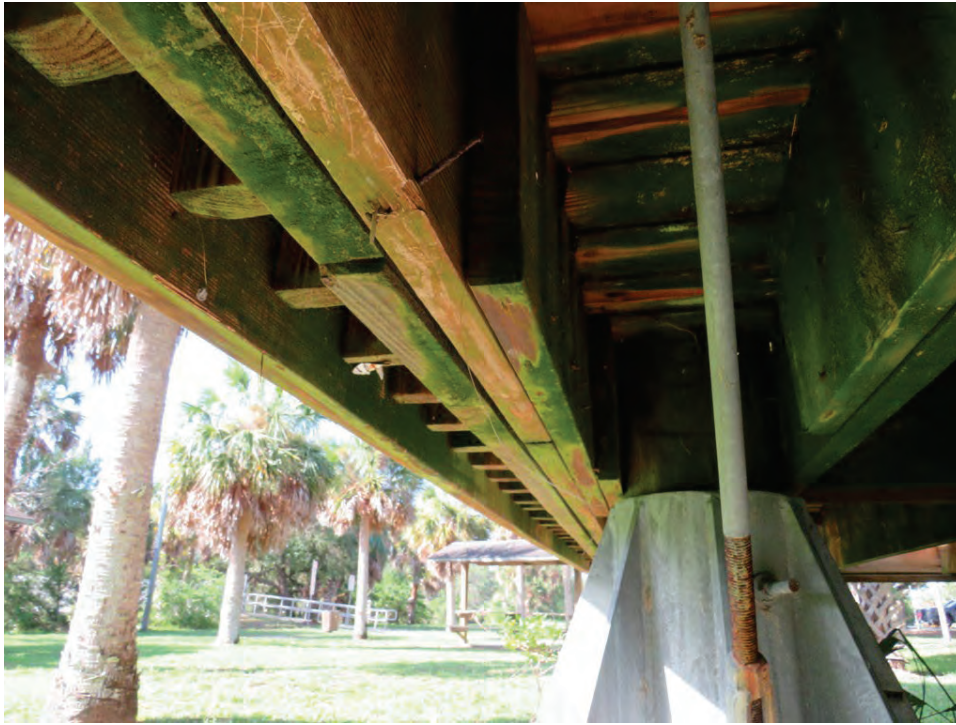
Figure A-32

| Horizontal separation along the 3 <sup>rd</sup> joist from the east within central column span (circled in red) | <i>Figure A-32</i> |

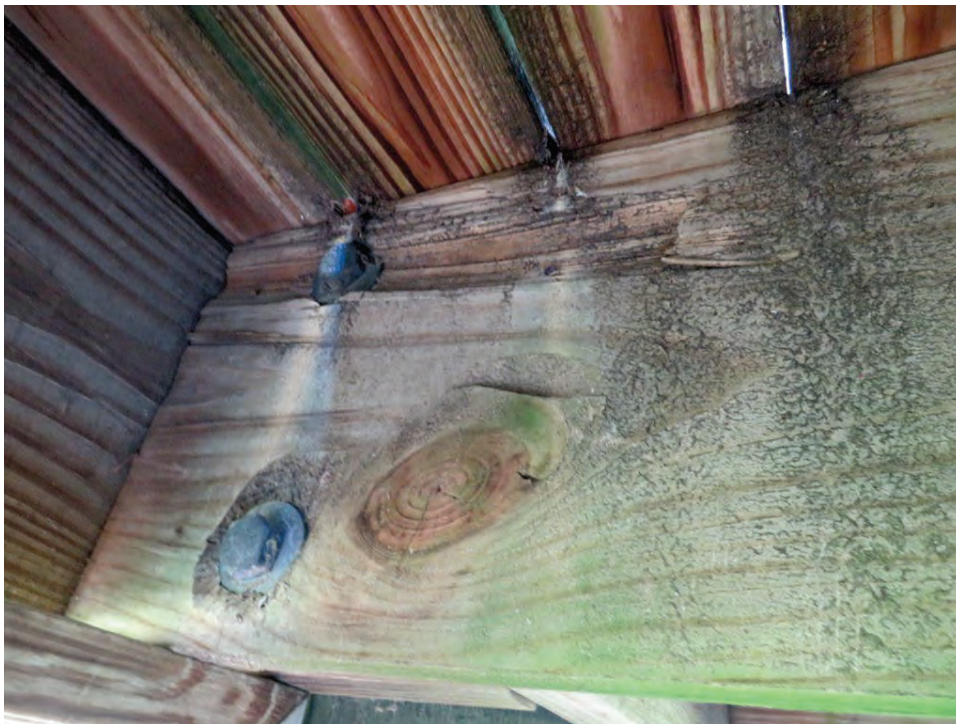
Figure A-33

| Spliced sections of 1 <sup>st</sup> level joists with abandoned, corroded nails along east elevation | <i>Figure A-33</i> |

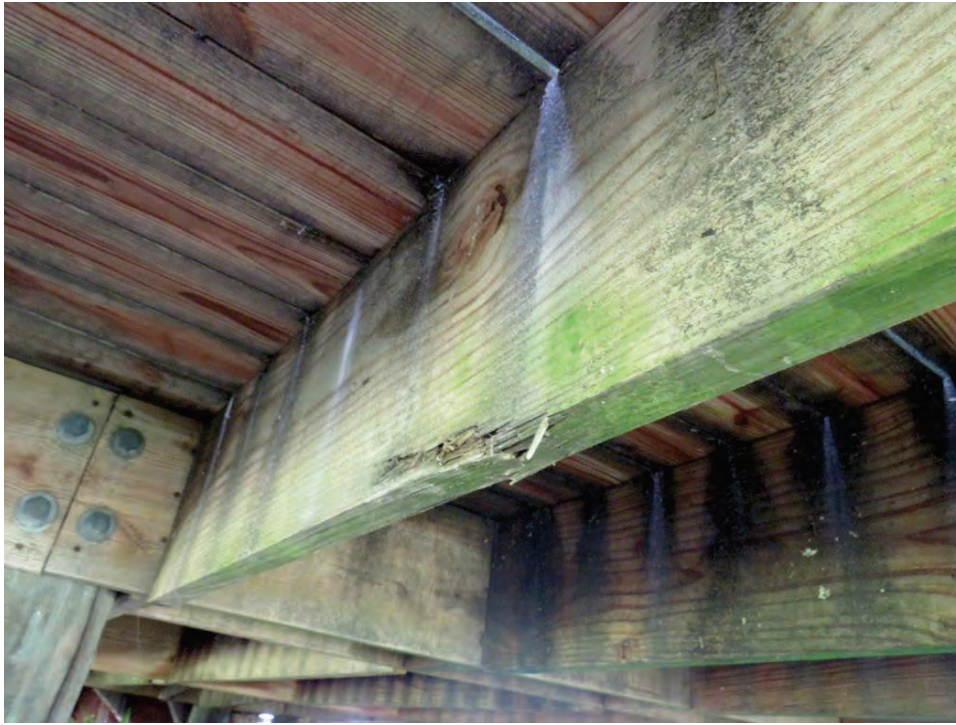
Figure A-34

| Overdriven bolts with splitting of wood at the joist-to-pole connection at the 2 <sup>nd</sup> column from the west along the north elevation | <i>Figure A-34</i> |

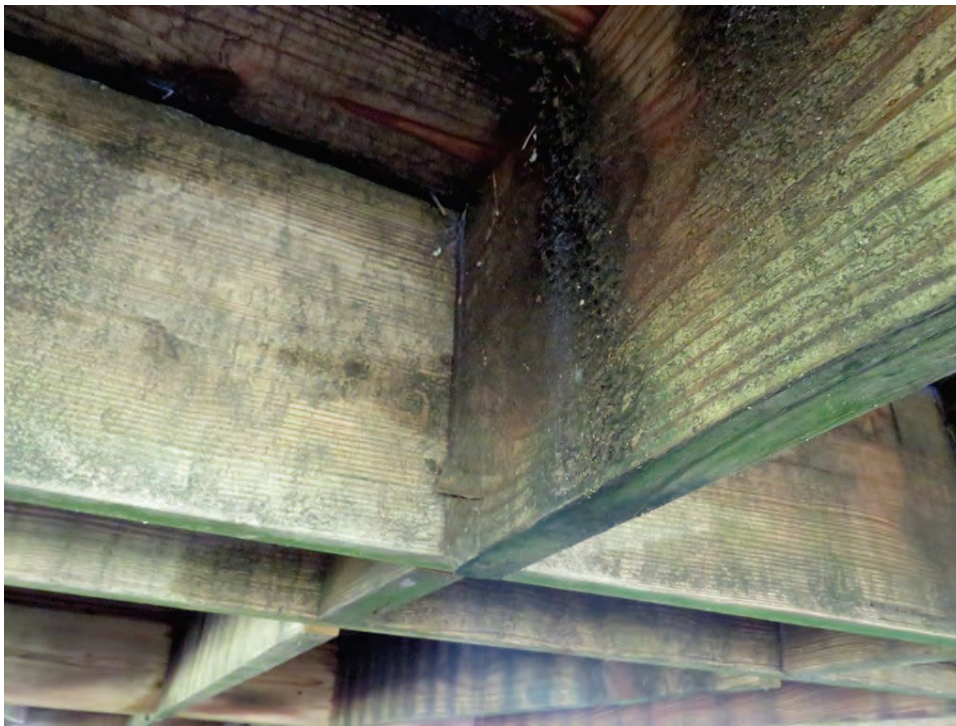
Figure A-35

| Separation at bottom of 3 <sup>rd</sup> joist from the west within the southmost column span | <i>Figure A-35</i> |

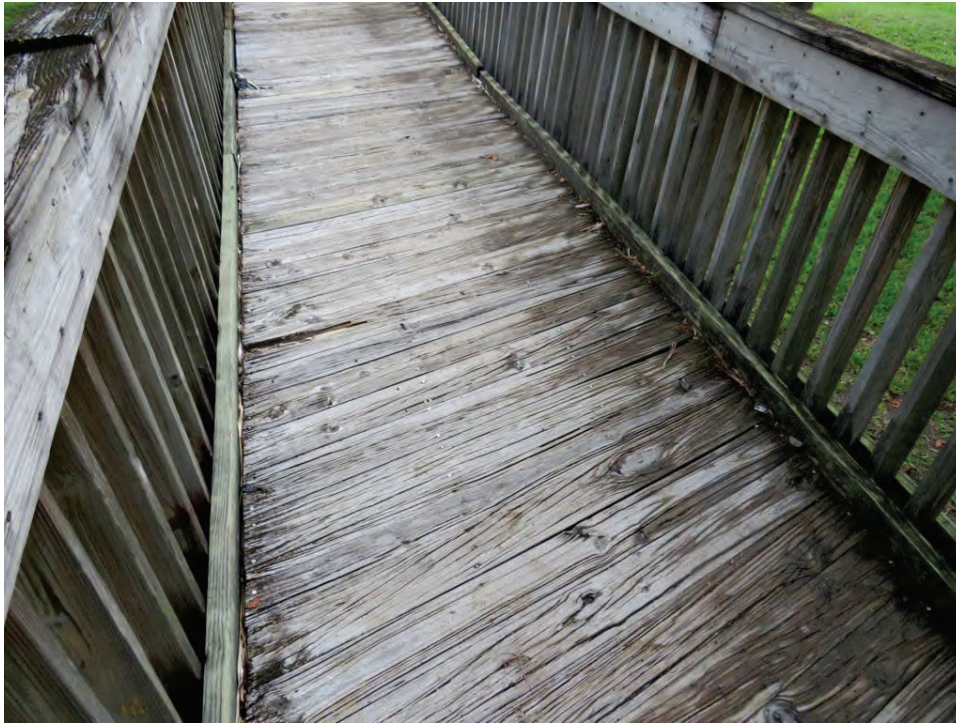
Figure A-52

| Space between rail balusters was measured to be greater than 4-inches at sporadic locations | <i>Figure A-52</i> |

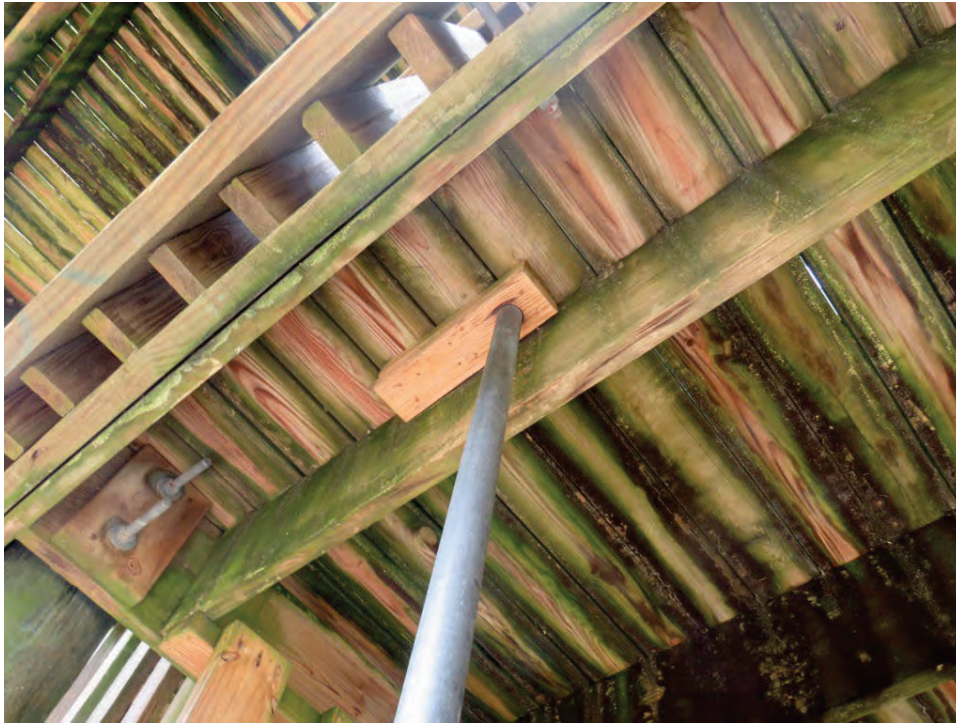
Figure A-92

| A metal post was observed to be installed along the underside of the 2 <sup>nd</sup> level. The post was observed deflecting laterally (see marked with dashed red line). | <i>Figures A-92 and A-93</i> |

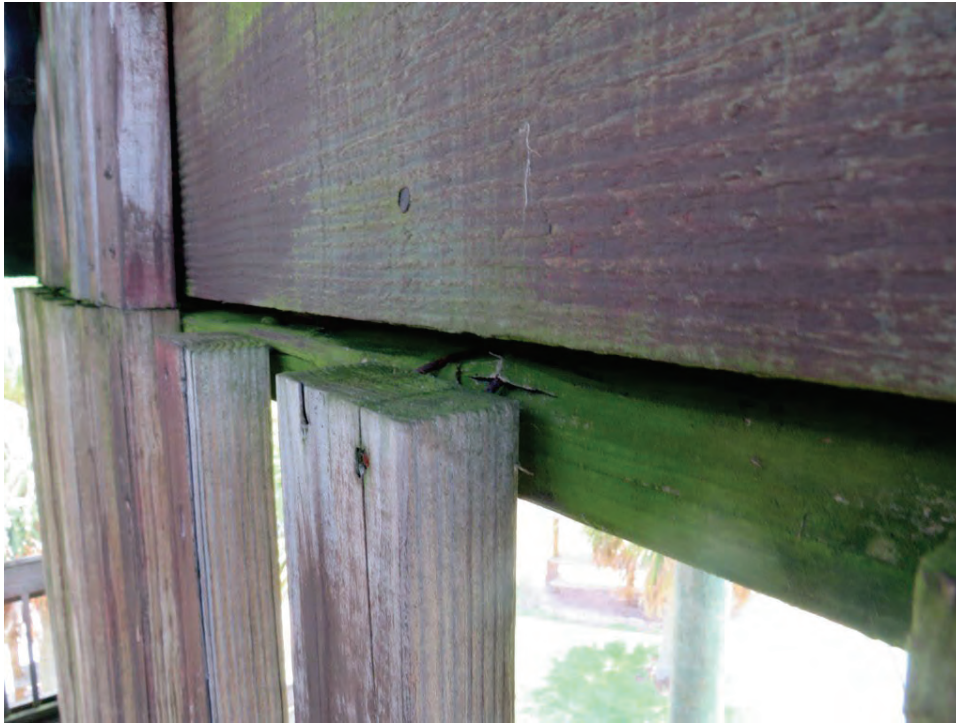
Figure A-94

| Heavy staining and deterioration were observed along the joists below the landing between the 1 <sup>st</sup> and 2 <sup>nd</sup> floors | <i>Figure A-94</i> |

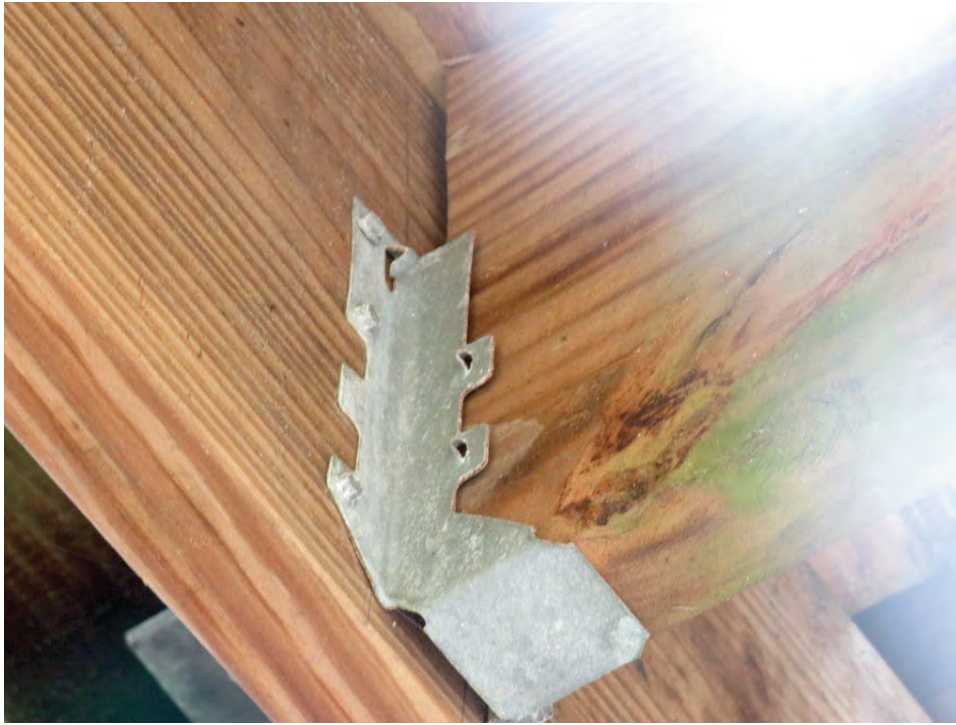
Figure A-96

| Metal joist hangers were observed along the underside of landing between the 4 <sup>th</sup> and 5 <sup>th</sup> levels. Missing fasteners were observed at sporadic locations along the hangers | <i>Figures A-96 and A-97</i> |
