Road Safety Audit Report

Spring Hill Drive from US 19 to east of Kenlake Avenue.

Hernando County, Florida

April 2025

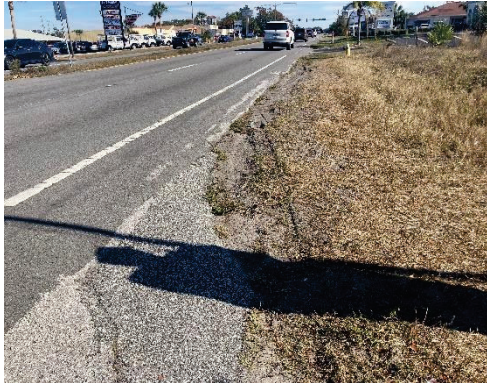
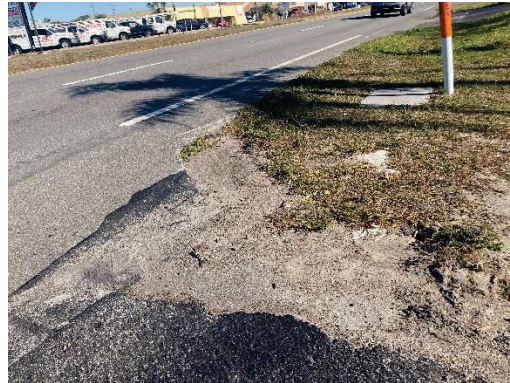
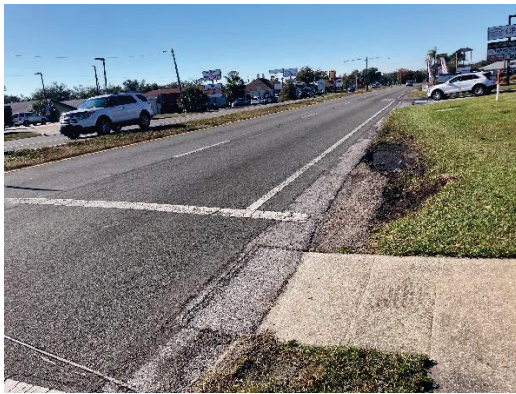
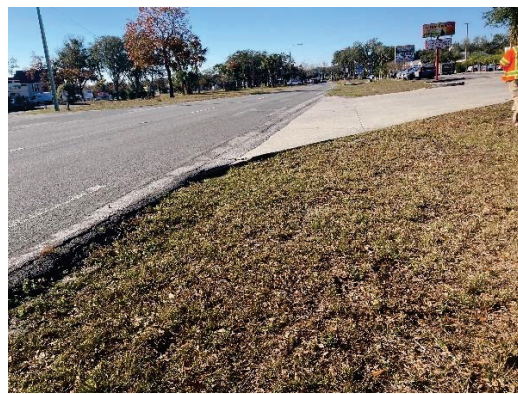
Issue Description: Pavement damage

Pavement damage was observed due to higher turning movement traffic exiting side streets and median U-turns.

Near-Term:	Resurface and provide safety edge to accommodate turning radius.
Improvement Type:	Pavement and Shoulder Drop-off Corrections

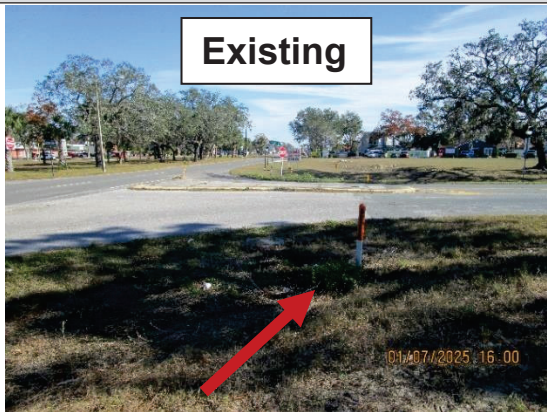
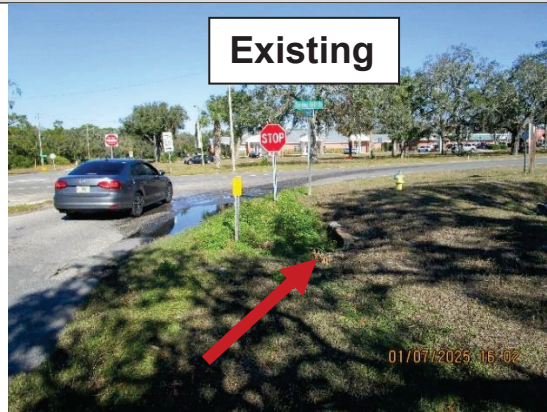
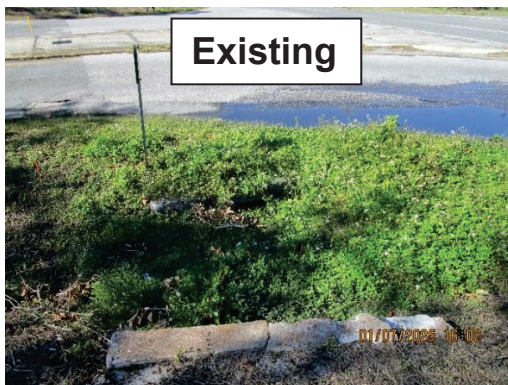
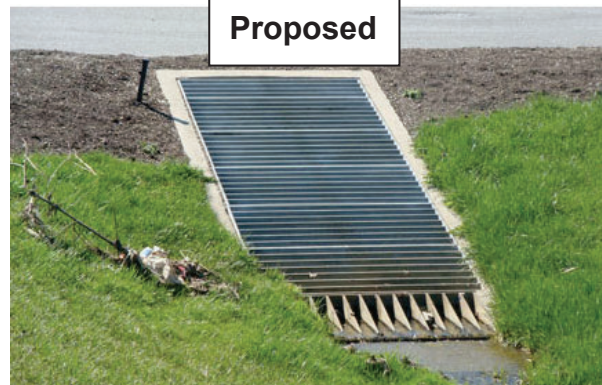
Location: SW and SE corners of Spring Hill Dr and Pinehurst Dr
Issue Description: Repair or replace drainage

The drainage is majority blocked with overgrown vegetation and dirt build up over time. The turning path gets flooded during rainfall and does not drain adequately. The side drainpipe is sumped and does not function on both ends.

Near-Term:	Regrade the drainage channels on each end of the cross drain, correct the swept path and the cross slope to drain properly and reset the cross drainpipe by replacing it. This grated inlet can be used to prevent water ponding at access points.
Improvement Type:	Drainage

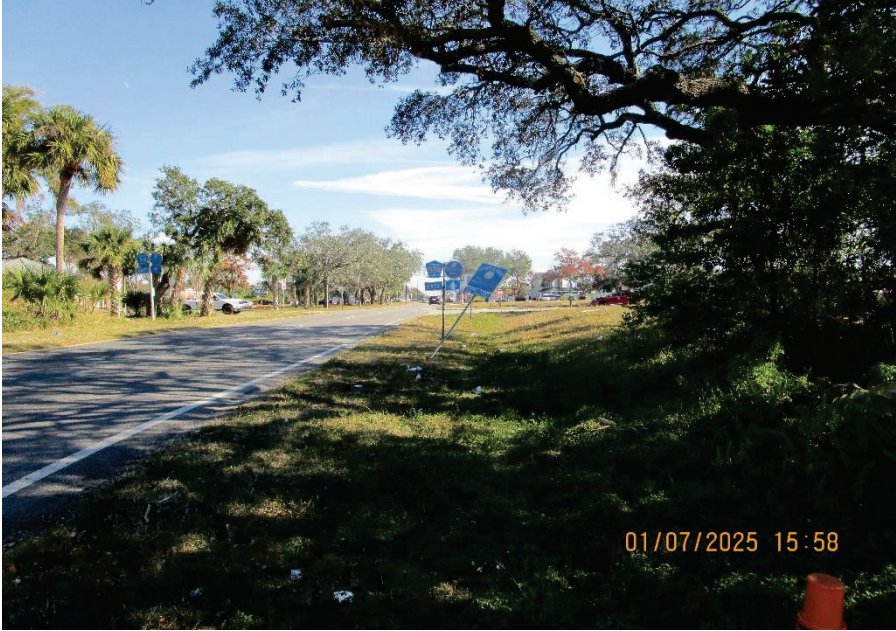
Location:	Spring Hill Drive corridor		
Issue Description:	Ground Mounted signs		
Existing

Description of Safety Issue:	Existing signs have lost reflectivity in their panel sheeting and some sign posts are damaged and do not meet the height clearances as recommended in MUTCD and FDOT Standard Plans.		
Safety Risk:			
Exposure:	<input type="checkbox"/> Low	<input type="checkbox"/> Medium	<input checked="" type="checkbox"/> High
Probability:	<input type="checkbox"/> Low	<input type="checkbox"/> Medium	<input checked="" type="checkbox"/> High
Consequence:	<input type="checkbox"/> Low	<input type="checkbox"/> Medium	<input checked="" type="checkbox"/> High
Resulting Road Safety Risk:	<input type="checkbox"/> Low	<input type="checkbox"/> Medium	<input checked="" type="checkbox"/> High
Suggestions for Consideration:			
Near-Term:	Replace all signs with new assemblies in accordance with DOT standards.

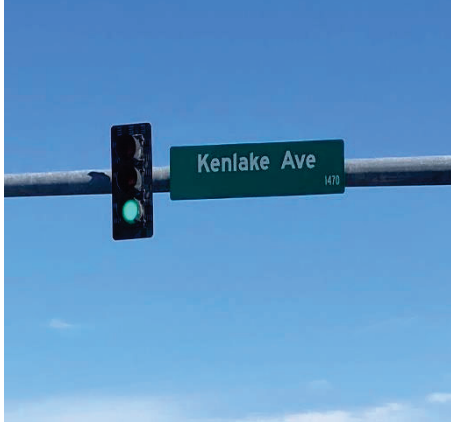
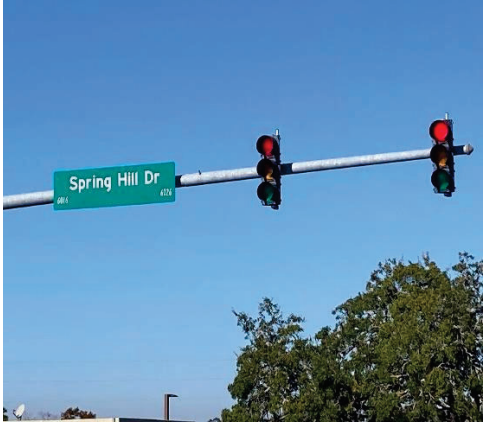
Location:		Spring Hill Dr at Kenlake Ave	
Issue Description:		Static Street Name Signs	
Existing			
<div style="display: flex; justify-content: space-around;">

</div>			
Description of Safety Issue:	Static Street Name Signs are old, faded and has lost their retroreflectivity. Recommend using Internally Illuminated Street Name Signs for better visibility and to conform with current county standards.		
Safety Risk:			
Exposure:	<input type="checkbox"/> Low	<input type="checkbox"/> Medium	<input checked="" type="checkbox"/> High
Probability:	<input type="checkbox"/> Low	<input type="checkbox"/> Medium	<input checked="" type="checkbox"/> High
Consequence:	<input type="checkbox"/> Low	<input type="checkbox"/> Medium	<input checked="" type="checkbox"/> High
Resulting Road Safety Risk:	<input type="checkbox"/> Low	<input type="checkbox"/> Medium	<input checked="" type="checkbox"/> High
Suggestions for Consideration:

Near-Term:	Install Internally Illuminated Street Name Signs on mast arms according to Traffic Engineering Manual and FDOT Standards.		
Improvement Type:	Signal

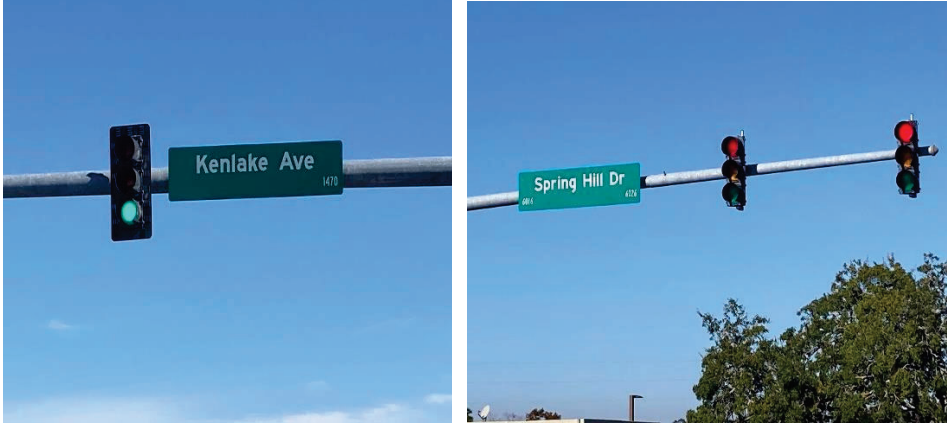
Location:		Spring Hill Dr at Kenlake Ave	
Issue Description:		Missing Retro-reflective Backplates for N-S heads	
		Existing	Proposed

Description of Safety Issue:	Signal heads at this intersection are missing retro-reflective backplates on N-S heads. Also, heads on E-W direction are missing retro-reflective border. This will increase signal visibility at night and during low-visibility conditions and comply with the current design standards.		
Safety Risk:			
Exposure:	<input type="checkbox"/> Low	<input checked="" type="checkbox"/> Medium	<input type="checkbox"/> High
Probability:	<input type="checkbox"/> Low	<input checked="" type="checkbox"/> Medium	<input type="checkbox"/> High
Consequence:	<input type="checkbox"/> Low	<input type="checkbox"/> Medium	<input checked="" type="checkbox"/> High
Resulting Road Safety Risk:	<input type="checkbox"/> Low	<input checked="" type="checkbox"/> Medium	<input type="checkbox"/> High

Suggestions for Consideration:			
Near-Term:	Install retro-reflective backplate borders on traffic signals for all approaches per FDM 232.1.5 and FDOT Standard Specification for Road and Bridge Construction Section 650. The backplates could be flexible type which does not contribute to the structural loading on the mast arm.		
Improvement Type:	Signal

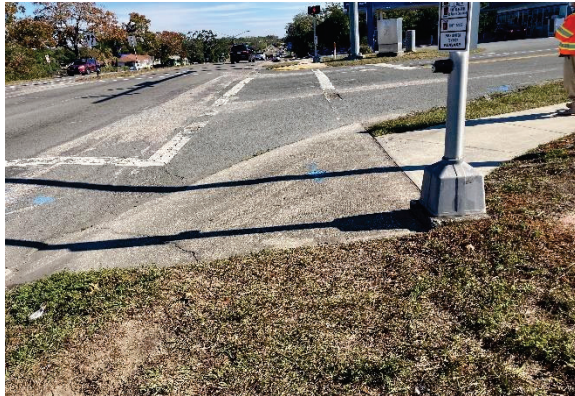
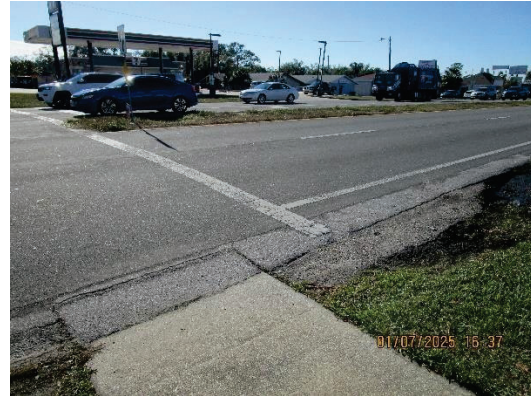
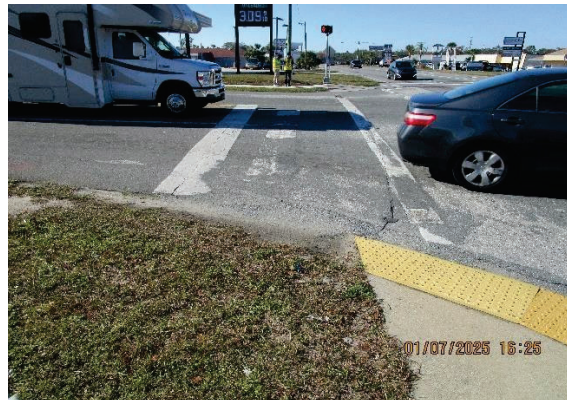
ADA Truncated Domes are in poor condition or missing

ADA detectable warning surface is deteriorating and peeling off in SW corner and rest of the 3 corners are missing the warning surface. They should be replaced to ensure that visually impaired pedestrians can safely enter the sidewalk without difficulties.

Replace all detectable warning surfaces per FDM 222.1.1 and FDOT Standard Index 522-002.

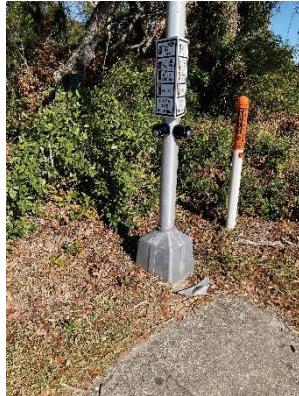
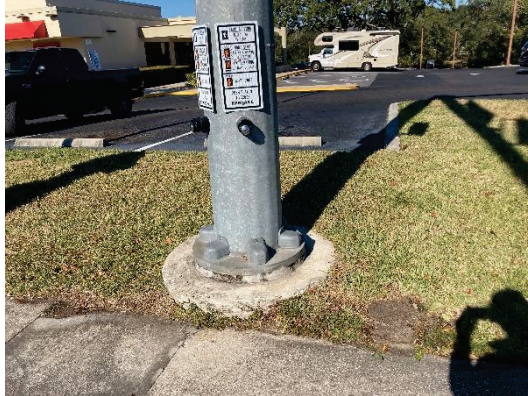
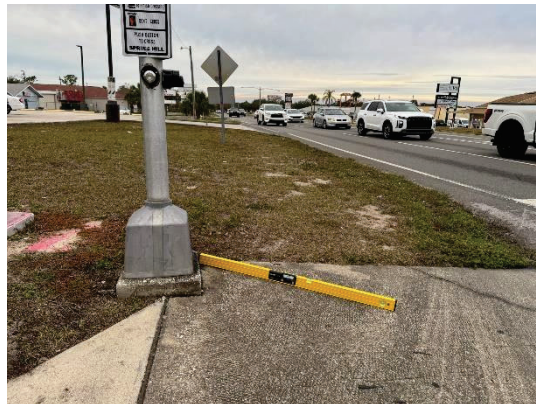
Issue Description: Pedestrian push buttons are not ADA compliant

Pedestrian push buttons are not ADA compliant. Each button is required to have 48" x 30" level area of sidewalk in front of the button within 10" for access.

Near-Term:	Replace and locate the push buttons in compliance with ADA Standards determined by the FDOT and County standards.
Improvement Type:	Pedestrian Signal

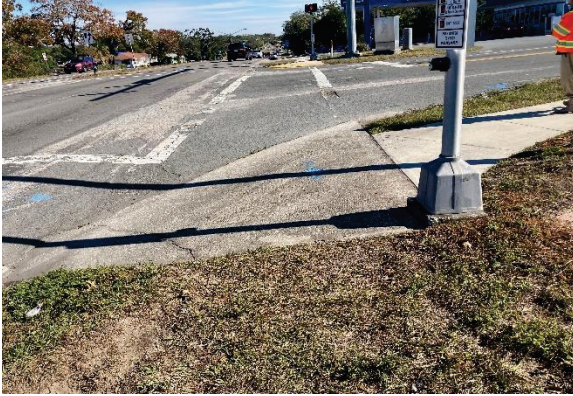
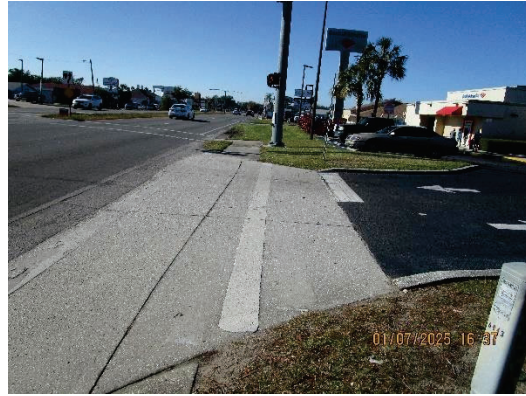
Issue Description: Missing High Emphasis Crosswalks

The existing intersection crosswalk design is missing High Emphasis marking which helps enhance the visibility and increases pedestrian safety.

Resurface the intersection and replace the crosswalk markings in accordance to FDOT Standard Plans Index 711-001.

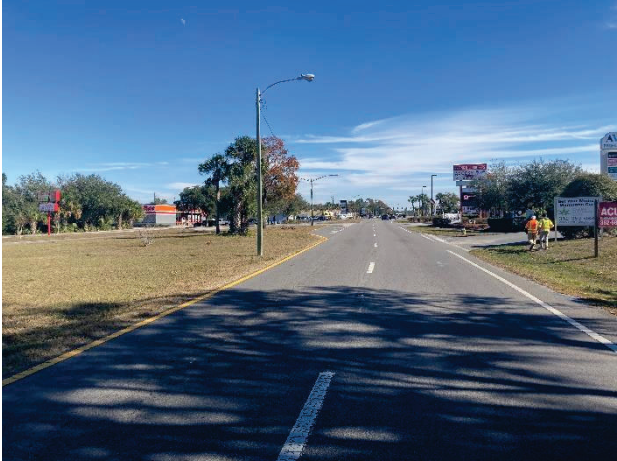
Location:		Spring Hill Drive Corridor Lighting	
Issue Description:		Upgrade and replace lighting	
<p style="text-align: center;">Existing</p>

Description of Safety Issue:	Existing luminaire heads are older 100 watt high pressure sodium (HPS) and therefore project low lighting photometric levels onto the roadway. Also, several luminaire heads are not operational and create dark spots in these areas. While none of the light poles showed any evidence of being hit, some of them were located close to the travel lanes.		
Safety Risk:			
Exposure:	<input type="checkbox"/> Low	<input type="checkbox"/> Medium	<input checked="" type="checkbox"/> High
Probability:	<input type="checkbox"/> Low	<input type="checkbox"/> Medium	<input checked="" type="checkbox"/> High
Consequence:	<input type="checkbox"/> Low	<input type="checkbox"/> Medium	<input checked="" type="checkbox"/> High
Resulting Road Safety Risk:	<input type="checkbox"/> Low	<input type="checkbox"/> Medium	<input checked="" type="checkbox"/> High

Suggestions for Consideration:			
Near-Term:	Improve Lighting levels throughout the corridor by replacing the older HPS luminaire heads with new Light Emitting Diode (LED) heads. Adhere to criteria in accordance with FDM Chapter 231 and FDOT Standard Plans Index 715-001. Consider moving poles further from the travel lanes where feasible.		
Improvement Type:	Lighting

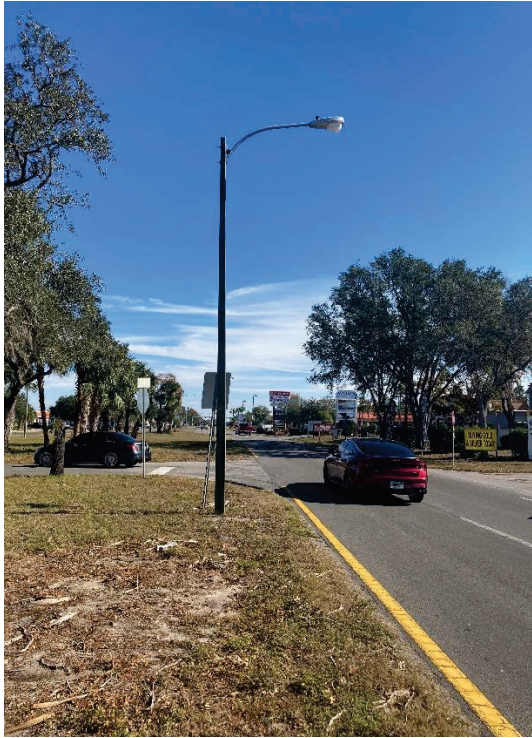
Location:		Spring Hill Drive Corridor Lighting	
Issue Description:		Upgrade and replace lighting	
<p style="text-align: center;">Existing</p>

Description of Safety Issue:	Light poles are located 5 feet from Edge of Traveled Way which is within the minimum lateral offset required by the FDOT. The speed limit is 40 MPH and roadway type is Flush Shoulder for which the lateral offset requirement is 18 feet.		
Safety Risk:			
Exposure:	<input type="checkbox"/> Low	<input type="checkbox"/> Medium	<input checked="" type="checkbox"/> High
Probability:	<input type="checkbox"/> Low	<input type="checkbox"/> Medium	<input checked="" type="checkbox"/> High
Consequence:	<input type="checkbox"/> Low	<input type="checkbox"/> Medium	<input checked="" type="checkbox"/> High
Resulting Road Safety Risk:	<input type="checkbox"/> Low	<input type="checkbox"/> Medium	<input checked="" type="checkbox"/> High
Suggestions for Consideration:

Near-Term:	Locate light poles outside minimum lateral offset criteria to improve safety for drivers. Follow FDM Chapter 215 for Roadside Safety		
Improvement Type:	Lighting

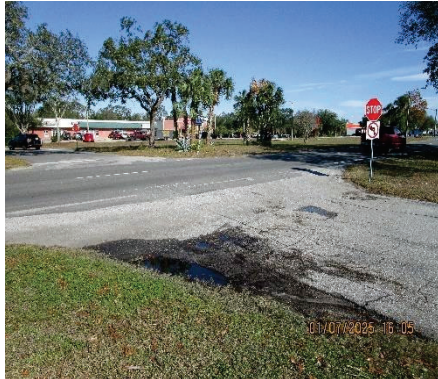
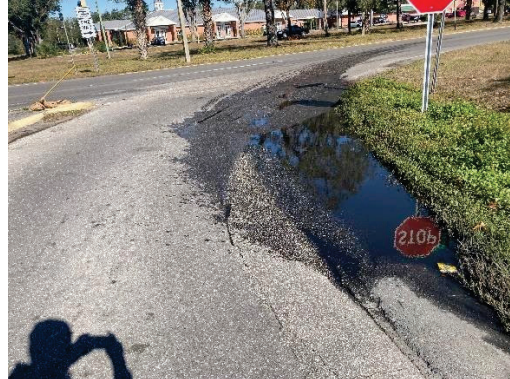
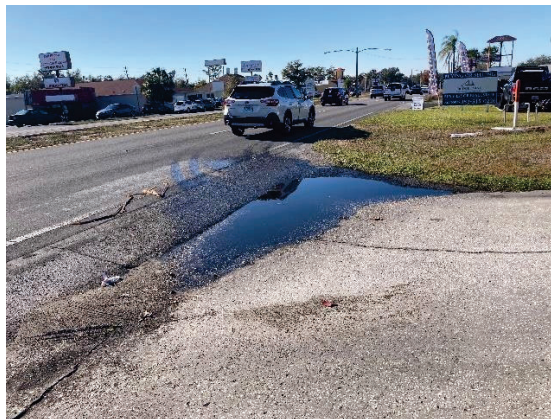
Issue Description: Drainage drop-off and water ponding

Due to pavement deformity and worn off pavement over time, there are drainage drop offs and water ponding throughout the corridor. It is a safety concern for drivers, pedestrians and bicyclists.
