RESOLUTION NO. 2025-103

Road Safety Audit Report

Spring Hill Drive from US 19 to east of Kenlake Avenue.

Hernando County, Florida

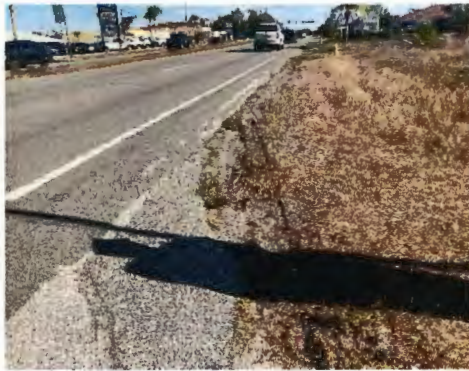
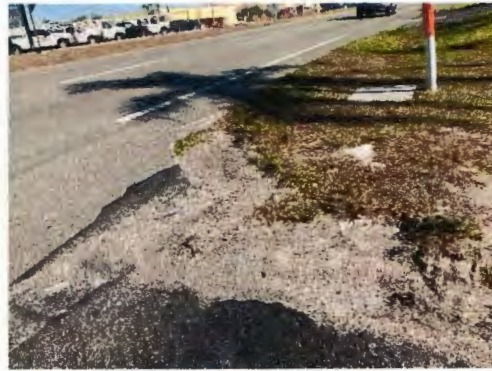
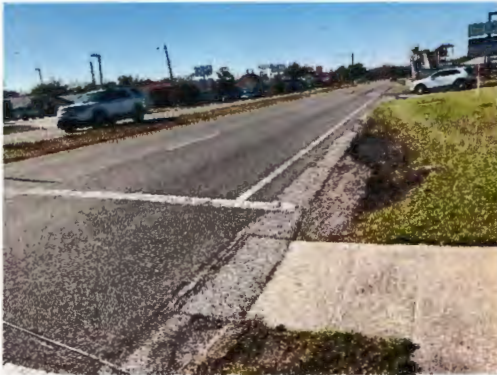
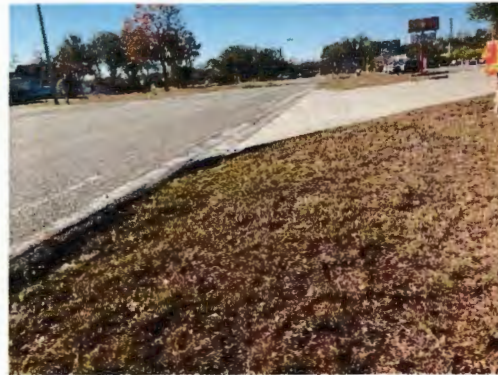
Issue Description: Pavement damage

Pavement damage was observed due to higher turning movement traffic exiting side streets and median U-turns.

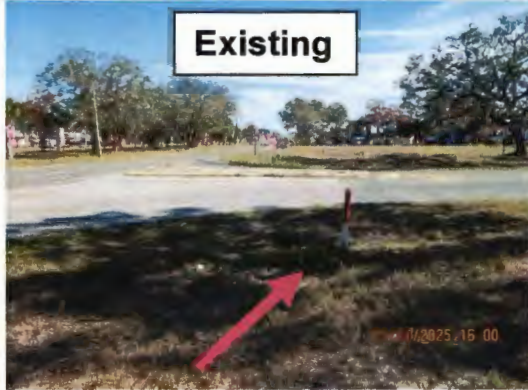
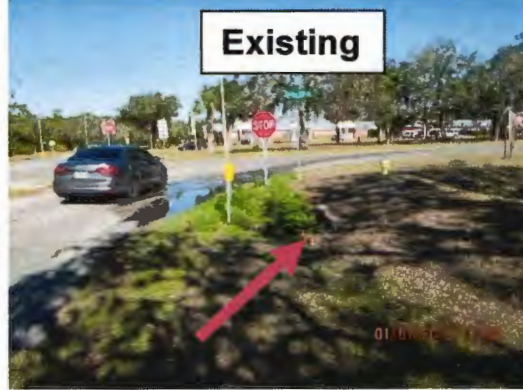
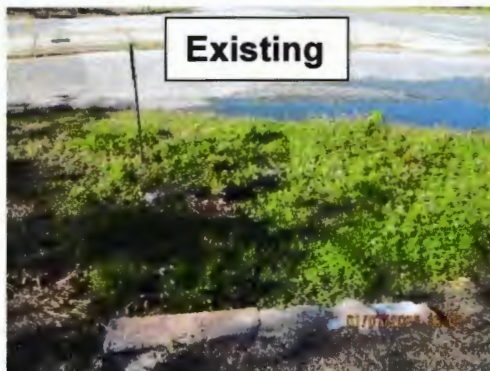
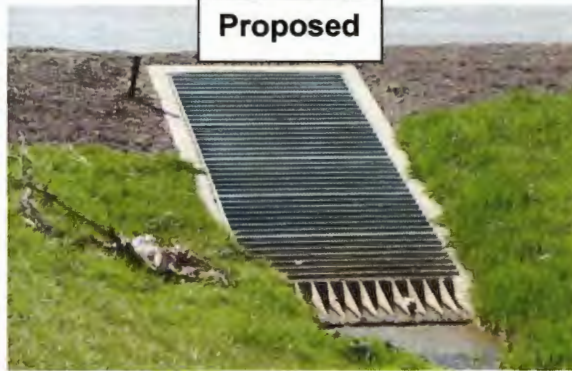
Location: SW and SE corners of Spring Hill Dr and Pinehurst Dr

Issue Description: Repair or replace drainage

The drainage is majority blocked with overgrown vegetation and dirt build up over time. The turning path gets flooded during rainfall and does not drain adequately. The side drainpipe is sumped and does not function on both ends.

Near-Term:	Regrade the drainage channels on each end of the cross drain, correct the swept path and the cross slope to drain properly and reset the cross drainpipe by replacing it. This grated inlet can be used to prevent water ponding at access points.
Improvement Type:	Drainage

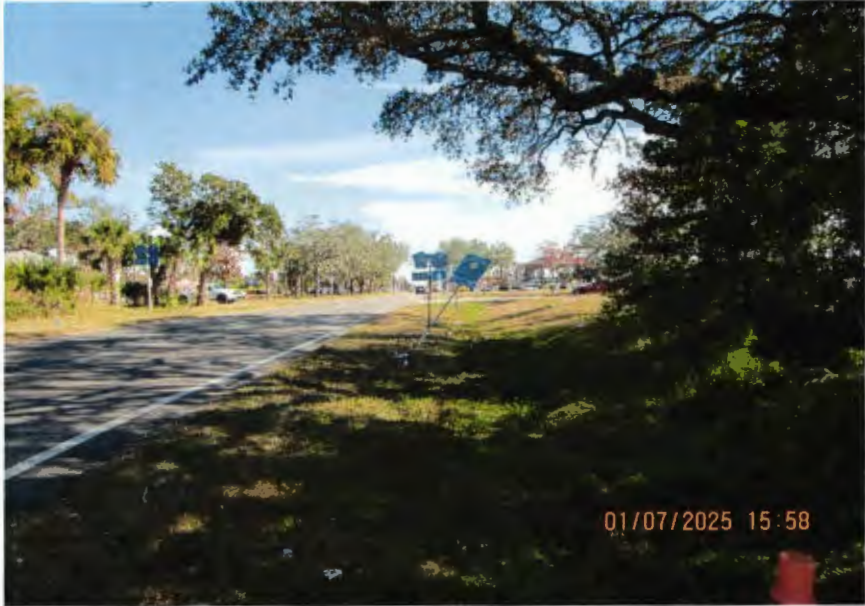
Location:	Spring Hill Drive corridor		
Issue Description:	Ground Mounted signs		
Existing

Description of Safety Issue:	Existing signs have lost reflectivity in their panel sheeting and some sign posts are damaged and do not meet the height clearances as recommended in MUTCD and FDOT Standard Plans.		
Safety Risk:			
Exposure:	<input type="checkbox"/> Low	<input type="checkbox"/> Medium	<input checked="" type="checkbox"/> High
Probability:	<input type="checkbox"/> Low	<input type="checkbox"/> Medium	<input checked="" type="checkbox"/> High
Consequence:	<input type="checkbox"/> Low	<input type="checkbox"/> Medium	<input checked="" type="checkbox"/> High
Resulting Road Safety Risk:	<input type="checkbox"/> Low	<input type="checkbox"/> Medium	<input checked="" type="checkbox"/> High
Suggestions for Consideration:			
Near-Term:	Replace all signs with new assemblies in accordance with DOT standards.

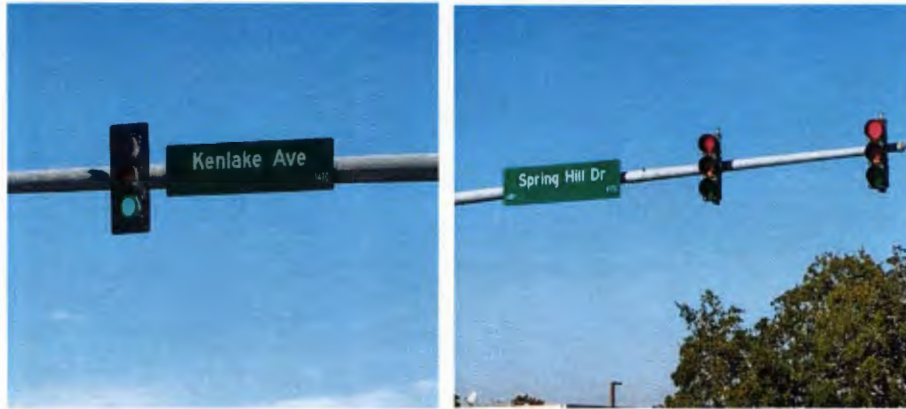
Location:	Spring Hill Dr at Kenlake Ave
Issue Description:	Static Street Name Signs

Description of Safety Issue:	Static Street Name Signs are old, faded and has lost their retroreflectivity. Recommend using Internally Illuminated Street Name Signs for better visibility and to conform with current county standards.
-------------------------------------	--

Near-Term:	Install Internally Illuminated Street Name Signs on mast arms according to Traffic Engineering Manual and FDOT Standards.
Improvement Type:	Signal

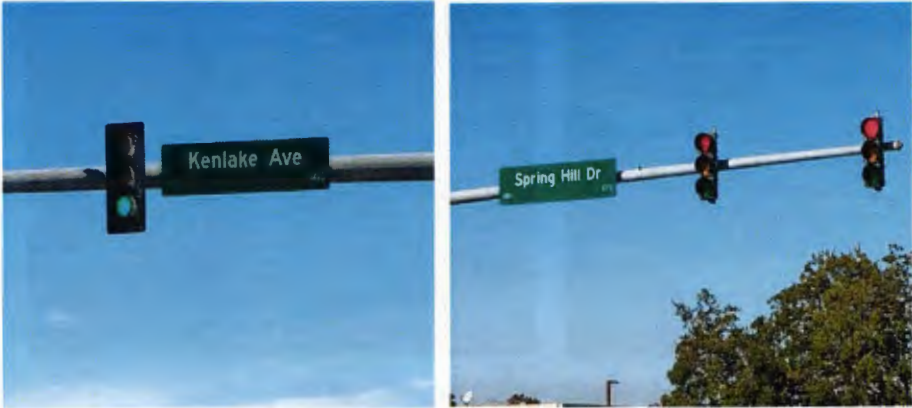
Location:		Spring Hill Dr at Kenlake Ave	
Issue Description:		Missing Retro-reflective Backplates for N-S heads	
Existing		Proposed

Description of Safety Issue:	Signal heads at this intersection are missing retro-reflective backplates on N-S heads. Also, heads on E-W direction are missing retro-reflective border. This will increase signal visibility at night and during low-visibility conditions and comply with the current design standards.		
Safety Risk:			
Exposure:	<input type="checkbox"/> Low	<input checked="" type="checkbox"/> Medium	<input type="checkbox"/> High
Probability:	<input type="checkbox"/> Low	<input checked="" type="checkbox"/> Medium	<input type="checkbox"/> High
Consequence:	<input type="checkbox"/> Low	<input type="checkbox"/> Medium	<input checked="" type="checkbox"/> High
Resulting Road Safety Risk:	<input type="checkbox"/> Low	<input checked="" type="checkbox"/> Medium	<input type="checkbox"/> High

Suggestions for Consideration:			
Near-Term:	Install retro-reflective backplate borders on traffic signals for all approaches per FDM 232.1.5 and FDOT Standard Specification for Road and Bridge Construction Section 650. The backplates could be flexible type which does not contribute to the structural loading on the mast arm.		
Improvement Type:	Signal

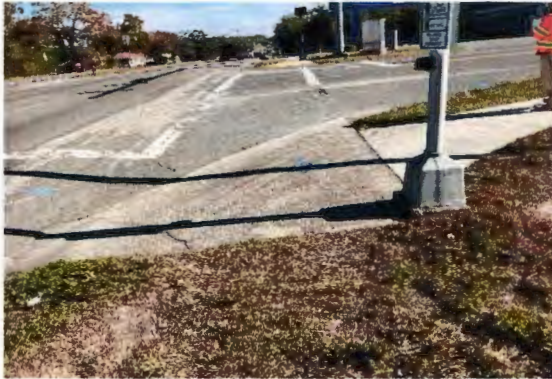
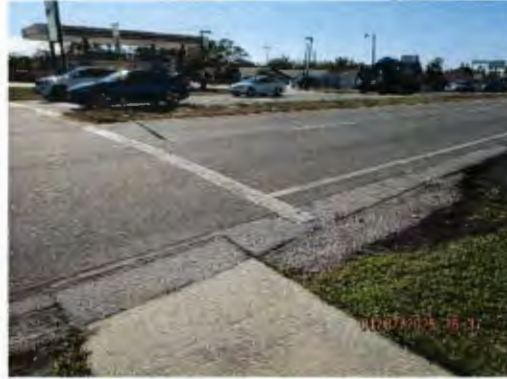
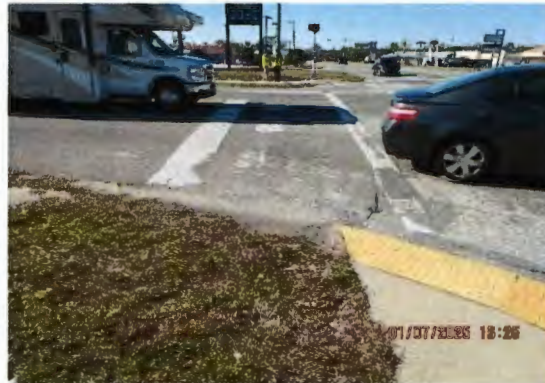
Issue Description: ADA Truncated Domes are in poor condition or missing

Description of Safety Issue: ADA detectable warning surface is deteriorating and peeling off in SW corner and rest of the 3 corners are missing the warning surface. They should be replaced to ensure that visually impaired pedestrians can safely enter the sidewalk without difficulties.

Near-Term:	Replace all detectable warning surfaces per FDM 222.1.1 and FDOT Standard Index 522-002.
Improvement Type:	Curb Ramp & ADA

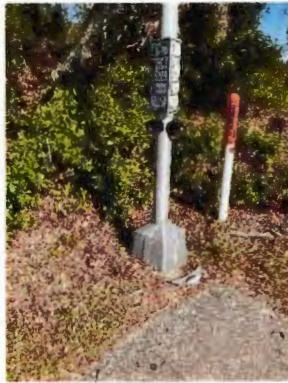
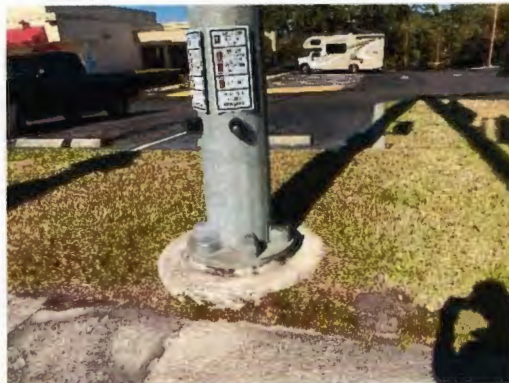
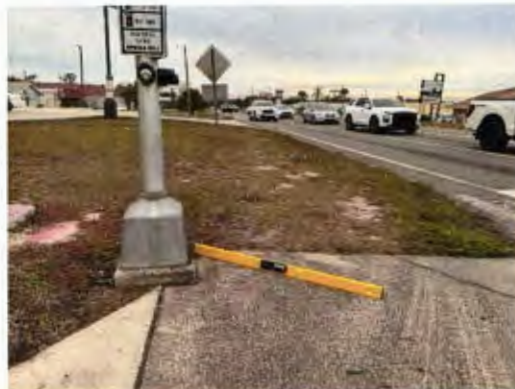
Issue Description: Pedestrian push buttons are not ADA compliant

Pedestrian push buttons are not ADA compliant. Each button is required to have 48" x 30" level area of sidewalk in front of the button within 10" for access.

Near-Term:	Replace and locate the push buttons in compliance with ADA Standards determined by the FDOT and County standards.
Improvement Type:	Pedestrian Signal

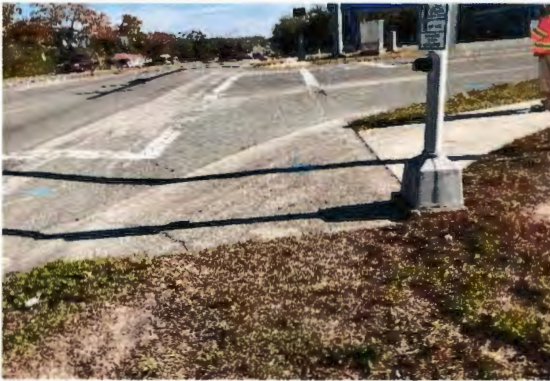
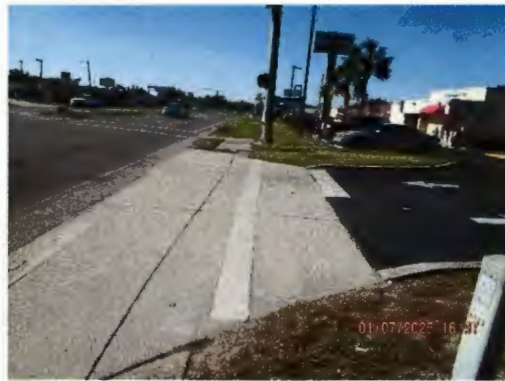
Issue Description: Missing High Emphasis Crosswalks

The existing intersection crosswalk design is missing High Emphasis marking which helps enhance the visibility and increases pedestrian safety.

Resurface the intersection and replace the crosswalk markings in accordance to FDOT Standard Plans Index 711-001.

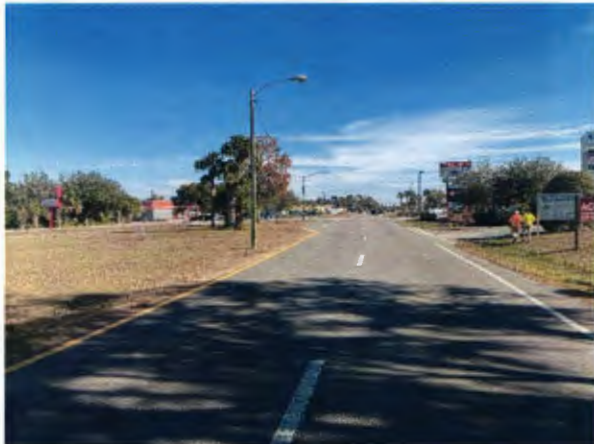
Location:	Spring Hill Drive Corridor Lighting		
Issue Description:	Upgrade and replace lighting		
Existing

Description of Safety Issue:	Existing luminaire heads are older 100 watt high pressure sodium (HPS) and therefore project low lighting photometric levels onto the roadway. Also, several luminaire heads are not operational and create dark spots in these areas. While none of the light poles showed any evidence of being hit, some of them were located close to the travel lanes.		
Safety Risk:			
Exposure:	<input type="checkbox"/> Low	<input type="checkbox"/> Medium	<input checked="" type="checkbox"/> High
Probability:	<input type="checkbox"/> Low	<input type="checkbox"/> Medium	<input checked="" type="checkbox"/> High
Consequence:	<input type="checkbox"/> Low	<input type="checkbox"/> Medium	<input checked="" type="checkbox"/> High
Resulting Road Safety Risk:	<input type="checkbox"/> Low	<input type="checkbox"/> Medium	<input checked="" type="checkbox"/> High

Suggestions for Consideration:			
Near-Term:	Improve Lighting levels throughout the corridor by replacing the older HPS luminaire heads with new Light Emitting Diode (LED) heads. Adhere to criteria in accordance with FDM Chapter 231 and FDOT Standard Plans Index 715-001. Consider moving poles further from the travel lanes where feasible.		
Improvement Type:	Lighting

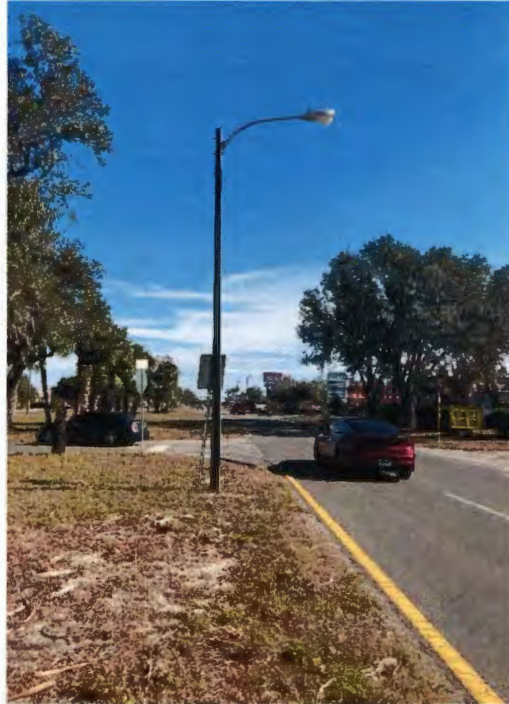
Issue Description: Upgrade and replace lighting

Light poles are located 5 feet from Edge of Traveled Way which is within the minimum lateral offset required by the FDOT. The speed limit is 40 MPH and roadway type is Flush Shoulder for which the lateral offset requirement is 18 feet.

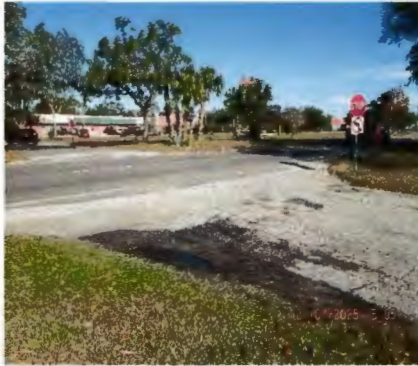
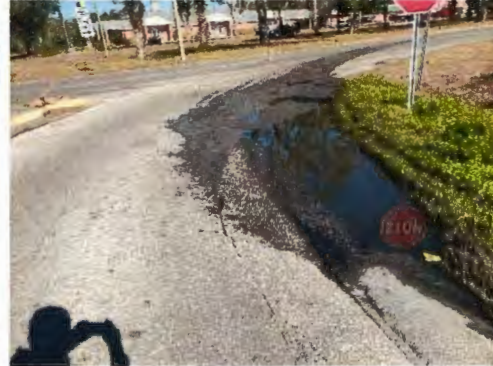
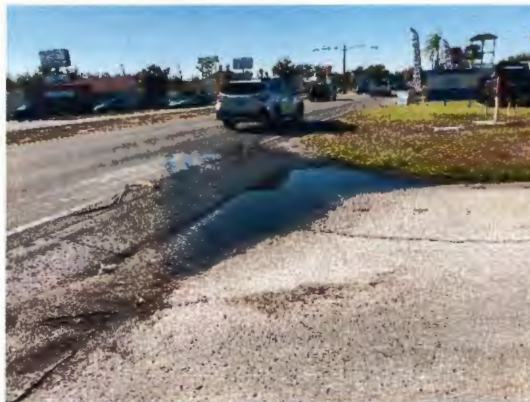
Location: Spring Hill Drive and side streets
Issue Description: Drainage drop-off and water ponding

Due to pavement deformity and worn off pavement over time, there are drainage drop offs and water ponding throughout the corridor. It is a safety concern for drivers, pedestrians and bicyclists.
