ADA Site Review and Comments

Project: **Chinsegut Hill Retreat**
22495 Chinsegut Hill Rd, Brooksville, FL 34601

Survey Date/Time: **May 25, 2021 @ 9:15 am**

Summary: **Accessible path slopes/surfaces, accessible parking space, ramps slope, emergency egress accessibility**

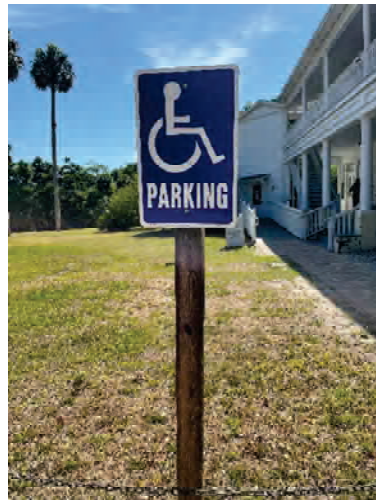
Figure 9: Signage

✘ Pole Signage: **Improper Height: 53"** (<84" & >60" Abv Grade - FAC 502.6.1)
Improper Type: Missing Penalty and Statue # (International symbol of accessibility and the caption "PARKING BY DISABLED PERMIT ONLY." Such a sign, erected after October 1, 1996, must indicate the penalty for illegal use of the space and state statute #. Face of sign to be located 24" min. from face of curb.

Possible Solution: Remount existing sign to taller pole so bottom of sign is placed between 60" and 84" above grade. Consider adding required parking striping to comply with Hernando County Standards. (Figure 11)

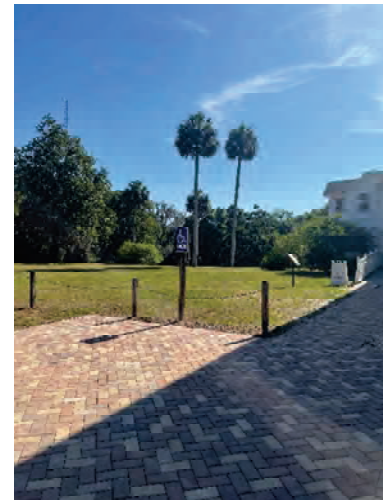
Figure 10: Parking Space

Spaces: 1
 Parking Type: 90 degree
 Stall Size: 12'-4" X 19'-11" (12' Width Req. - FAC502.2)

Striping: Hernando County Requires Accessible Parking to be striped
 Parking Slopes: Cross Slope = <2% (<2% or <1:48 allowed - FAC 406.3)
 Running Slope = 2% (<2% or <1:48 allowed - FAC 406.2)

+ Aisle Width: 5'-0" (5'-0" Req. FAC502.3.1)
 Aisle Slopes: <2% (<2% or <1:48 allowed FAC502.4)

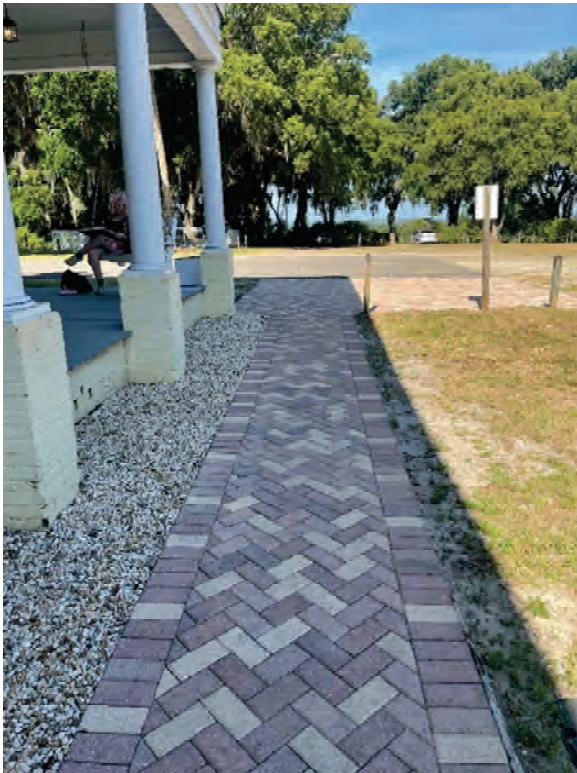
Figure 12, Accessible Path of Travel: Parking to Manor

A-B Accessible Path: An accessible path is present from the accessible parking area (A) to the Main House (B) via a paver sidewalk from the accessible parking space. *(Figure 12)*

- +** Width: 4'-0" (Min. 44" Egress Required)
- +** Slopes: <2% in all directions (Max. <2% Cross Slope and <5% Running Slope allowed)

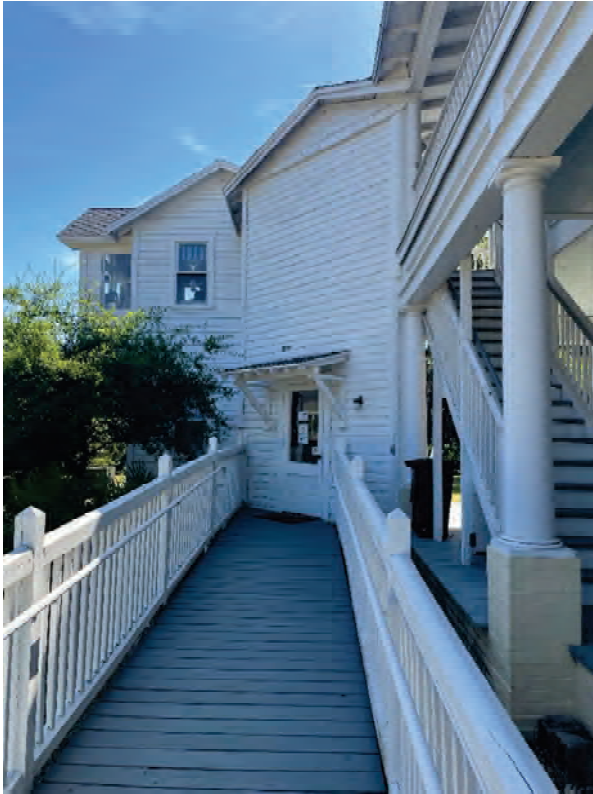
Figure 13, Accessible Ramp: Manor Public Entrance and Restrooms

B-C Accessible Ramp: An accessible ramp exists from the parking area to the guest entry point to the manor and public accessible restrooms. Ramp is constructed of painted pressure treated lumber with railings. *(Figure 13)*

- +** Width: 5'-0" (Min. 44" Egress Required)
- +** Slopes: <2% Cross Slope & 7% Running Slope (Max. <2% Cross Slope and <8% Running Slope allowed)
- +** Length: 25' (Max. 30' allowed)
- +** Landing: 60" x 60" <2% Slope (60" x 60" @ <2% Slope Allowed)

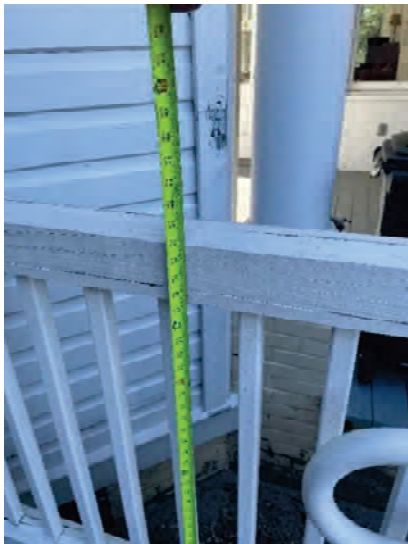
Figure 14, Guardrail Height

- Guardrail: 41"-42" (Min. 42" Required)
- Picket Spacing: 3.5" (4" Max. allowed)

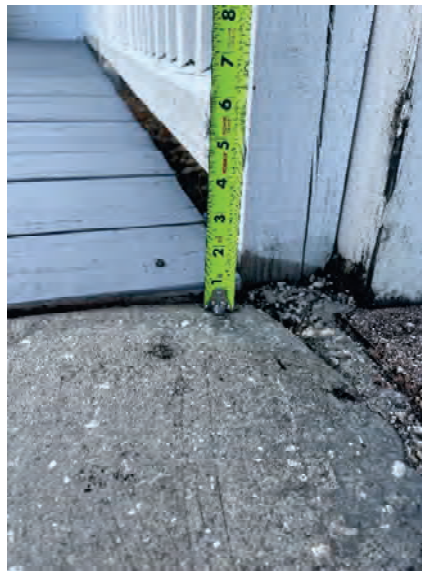
Figure 19, Elevation Change

Trip Hazard: **.75" change in elevation with no bevel** (.5" allowed with a .5" bevel otherwise .25" maximum allowed FAC 303.2)
 (Figure 20)

Possible Solution: Replace concrete are base of ramp to provide level and consistent landing of <2% Slope.

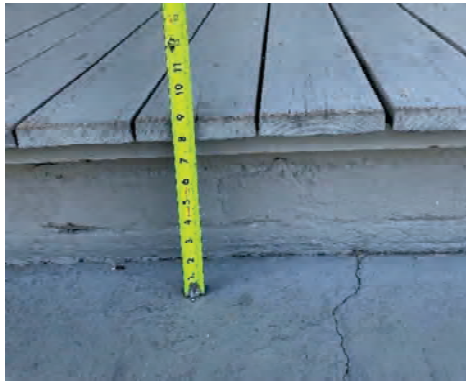
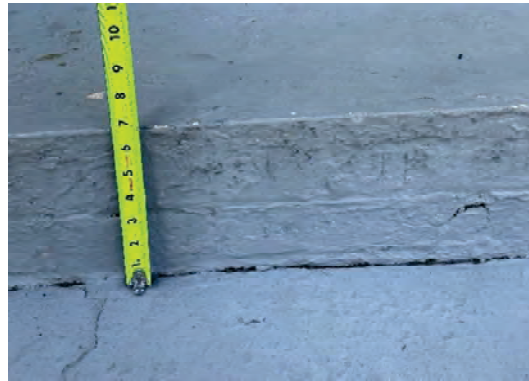
Figure 21 & 22 Step Risers

Stair Riser: 6.5" – 9" (Risers shall be a maximum of 7" in height and shall not vary between steps more than 3/8" over the course of the flight. FAC) (Figure 21-22)

Possible Solution: Replace steps with code compliant steps and railings.

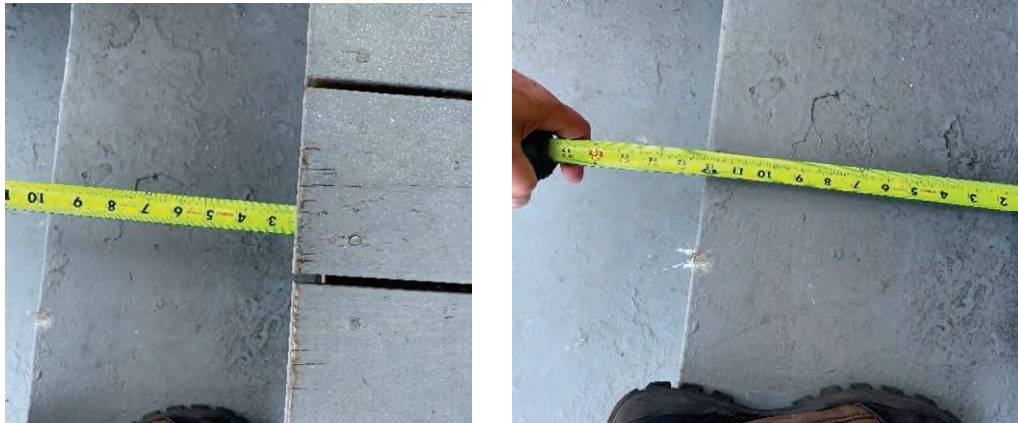
Figure 23 & 24 Step Tread Depth and Nosings

Stair Treads: 9.5 - 12" (Treads shall be a minimum of 11" in depth and shall not vary between steps more than 3/8" over the course of the flight. FAC) (Figure 23-24)

Nosing: Top Stair nosing is 2" + (Maximum Nosing shall not exceed 1.5" FAC 505.4) (Figure 23)

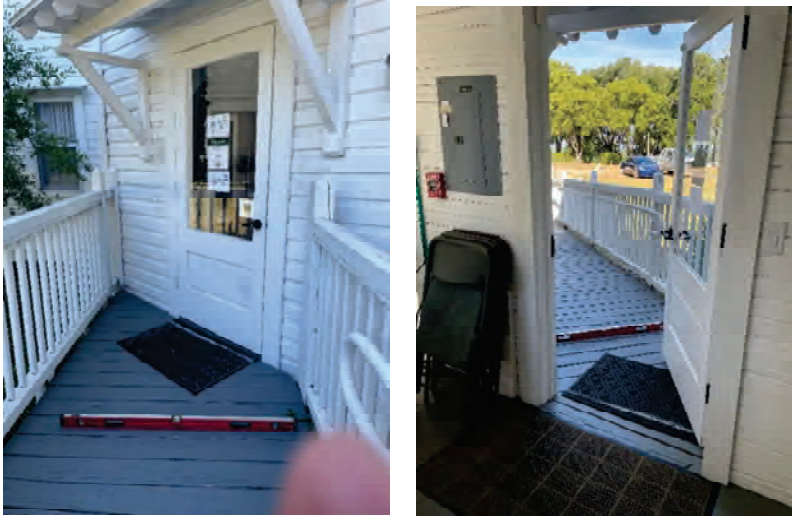
Figure 25, Clear Door Area / Landing

Clear Door Space: 52.5" x 60" (Min. 60" x 60" or 48" x 60" for forward approach) FAC 404.2.4.1 (Figure 25)

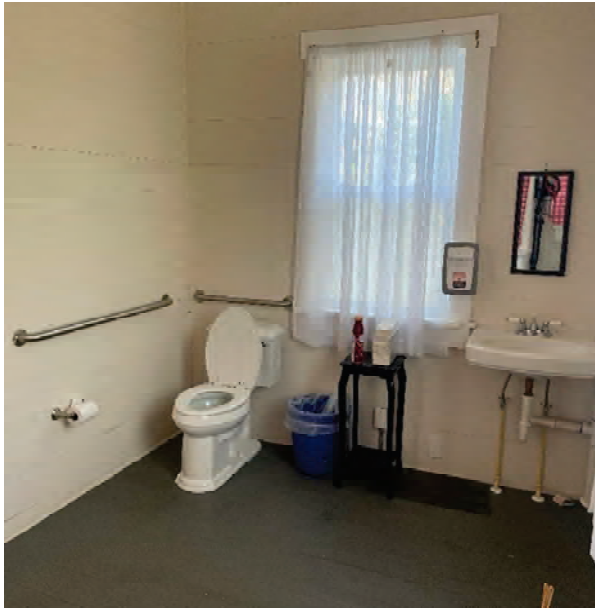
Figure 26: Accessible Restroom

C: Accessible Restroom: An accessible restroom is located in the office/foyer space at the top of the accessible ramp at the Main House (C) (Figure 26)

- ✘** Water Closet Height: 17.5" (19" Required) (Figure 27)
- +** Side Clearance: 18" (18" required) (Figure 28)
Flush Lever on Room Site: Yes
Lavatory Depth: 21" (19" required) (Figure 31)
Controls: Levers are Historic (Exempt)
Height: 33" (32" – 34" Required) (Figure 33)
- ✘** Lavatory Side Clearance: 4" (6" required) (Figure 32)
Scald Protection: Missing (Figure 34)
- +** Door Clearance: Push 23" (12" Required) Pull 18.5" (18" Required 24" Preferred)
Door Signage: Sign at 54" AFF w./ Brail (Figures 35-36)
- ✘** Grab Bars: 24" Rear 48" Side (36" Rear and 48" Side) (Figures 29, 30)
35" High (34" – 36" Allowed) (Figure 26)
(Historic Exception Allowed for Window)

exempt from the ADA where such improvements are not physically possible or will alter the historic nature of the building. In this case, the restroom has been moderately altered and some improvements are possible. Grab bar and lavatory alterations are not possible without relocating a window and thus, NO CHANGES are possible.

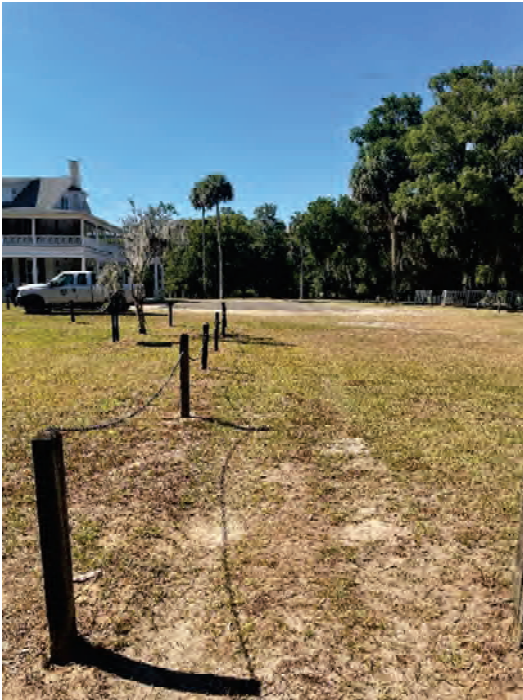
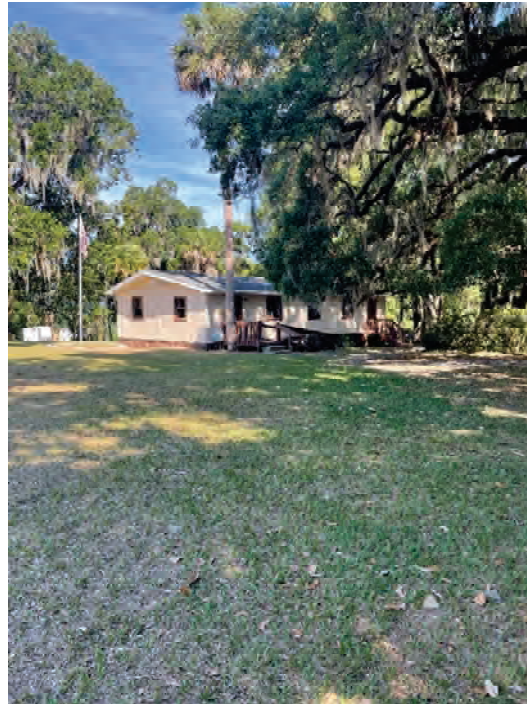
Figures 37 & 38: Accessible Path – Points D,E & G (Manor, Parking, Classroom)

An accessible path is necessary from the Manor House & Parking Area to the Classroom. A path is possible between this locations and is generally depicted in *(Figure 6)* previously shown. Said path shall be:

No Path Provided

3% - **7%** in path of travel <2% cross slope (Max. <2% Cross Slope and <5% Running Slope allowed)

Install a 5'-0" wide concrete sidewalk (min. 4" thick @ 2500 psi with control joints in 5'-0" increments) from the Manor House to classroom (connecting points D, E & G). Potential path indicated in (Figure 6 & 7). Path shall be no greater than 5% in slope in the direction of travel with a maximum 2% cross slope which is possible in the general path shown in Figure 6. The sidewalk can be curved to fit with the dynamics of the land and prevent abrupt changes in direction and allow avoidance of tree and tree roots.

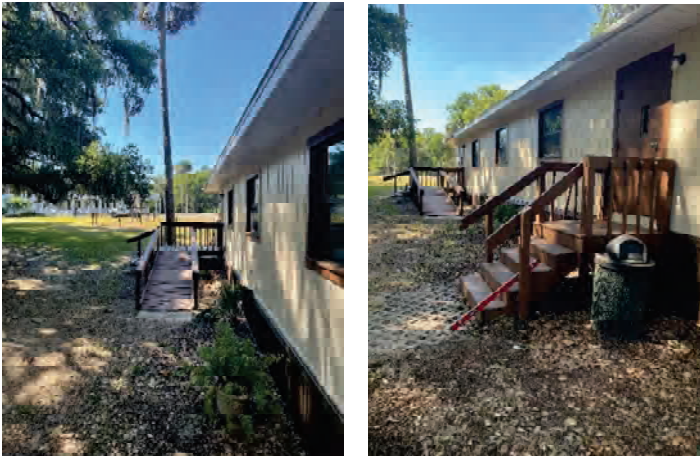
Figures 39 & 40: Path from Manor to Classroom, Egress Ramp and Stairs

Classroom has a Stair/Ramp/Deck combination structure which is approximately 18" -40" above grade. (Figures 39 & 40).

- + Width: 45.5" (Min. 44" Egress Required)
 Landing: 60" x 60" <2% Slope (60" x 60" @ <2% Slope Allowed)
- ✗ Guardrail: 34" (Min. 42" Required)
 Picket Spacing: 4" (4" Max. allowed) (Figure 41)
- ✗ Handrail Height: 34" (34"-38" allowed FAC 505.4)

Possible Solution: The deck height and position requires modification along with railings, guardrails, steps and as analyzed below, the ramps is also non-compliant. Thus, reconstruction of the entire deck and adjacent stairs is required. Since the classroom is built on an incline, a sketch is provided later in this report which changes the direction of the ramp to minimize slope and construction materials.

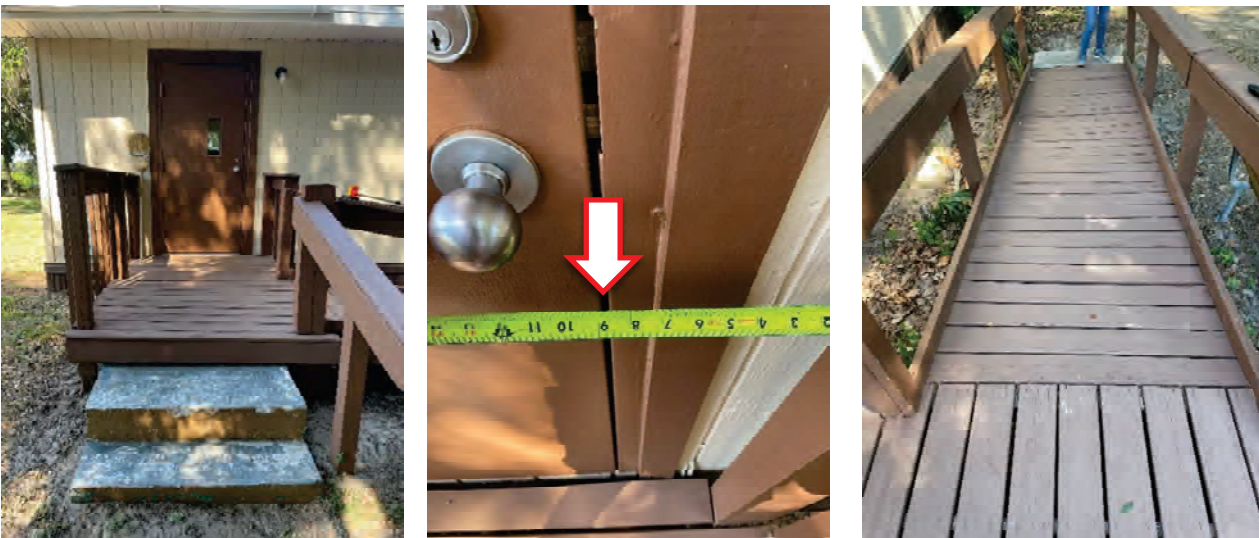
Figures 41, 42, & 43: Classroom Stair, Landing, Clearance and Ramp

Handrail Dia: Non-Compliant Design (1.5" Dia. required FAC 505.6)
 Handrail Extension: 4" (12" min. Required FAC 505.10)
 Handrail Clear: Non-Compliant Design (1.5" min. clearance required FAC 505.5) (Figure 41)

Threshold: 1" change in elevation with no bevel (.5" allowed with a .5" bevel otherwise .25" maximum allowed FAC 303.2) (Figure 41)

Stair Riser: 4" – 8" (Risers shall be a maximum of 7" in height and shall not vary between steps more than 3/8" over the course of the flight. FAC) (Figure 41)

Stair Treads: 9.5 - 12" (Treads shall be a minimum of 11" in depth and shall not vary between steps more than 3/8" over the course of the flight. FAC) (Figure 41)

Door Clearance: 9" (Clear space at Door Handle on pull side of door shall be a min. of 18", 24" preferred) (Figure 42)

Slopes: <2% Cross Slope & 14.5% Running Slope (Max. <2% Cross Slope and <8% Running Slope allowed)

Guardrail: 34" (Min. 42" Required)
 Picket Spacing: 48" (4" Max. allowed)
 Handrail Dia: Non-Compliant Design (1.5" Dia. required FAC 505.6)
 Handrail Extension: 4" (12" min. Required FAC 505.10)
 Handrail Clear: Non-Compliant Design (1.5" min. clearance required FAC 505.5) (Figure 41)

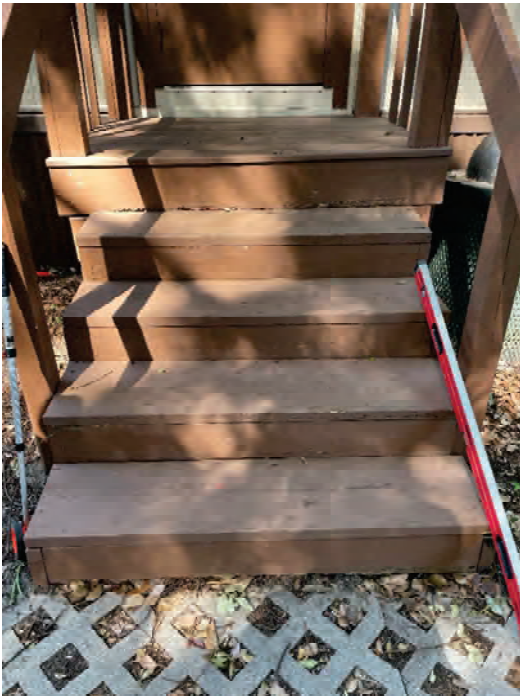
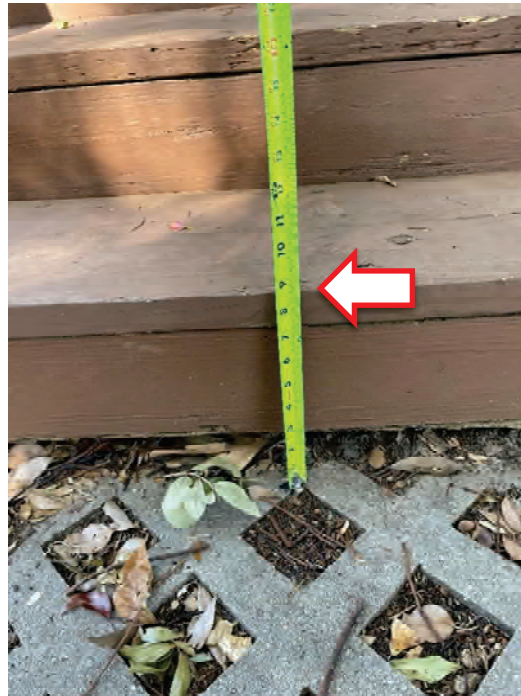
Figures 44 & 45: Classroom Egress Stair

Classroom has an egress stair for a second required egress door which is approximately 45" above grade. (Figures 44 & 45).

- ✘** Width: 40" (Min. 44" Egress Required)
 Landing: 40" x 50" <2% Slope (60" x 60" @ <2% Slope Allowed)
- ✘** Guardrail: 34" (Min. 42" Required)
 Picket Spacing: Varies (4" Max. allowed) (Figure 44)
- ✘** Handrail Height: 34" (34"-38" allowed FAC 505.4)
 Handrail Dia: Non-Compliant Design (1.5" Dia. required FAC 505.6)
 Handrail Extension: 0" (12" min. Required FAC 505.10)
 Handrail Clear: Non-Compliant Design (1.5" min. clearance required FAC 505.5) (Figure 44)

**Stair Riser:** 6.5" – 9.5" (Risers shall be a maximum of 7" in height and shall not vary between steps more than 3/8" over the course of the flight. FAC) *(Figure 45)*

**Stair Treads:** 11.5" (Treads shall be a minimum of 11" in depth and shall not vary between steps more than 3/8" over the course of the flight. FAC) *(Figure 45)*

**Door Clearance:** 3" (Clear space at Door Handle on pull side of door shall be a min. of 18", 24" preferred) *(Figure 44)*
- Possible Solution:** Stairs, railings, landing, position and height are not to code and do not meet minimum egress requirements. Full replacement of deck, ramp, landing, stairs and all railings is required. Construct new landing with min. 60" x 60" top and bottom landing, 42" guard rails for steps and deck with max. 4" spacing between pickets. Steps shall be less than 7" in height and a consistent dimension between risers. Treads shall be 12" with 1-1.5" nosings per code. Hand rails shall be installed on railings with a diameter of 1.5" with min. 2" clearance between the railing and the guardrail. Railings shall include extensions of 12" beyond last riser.

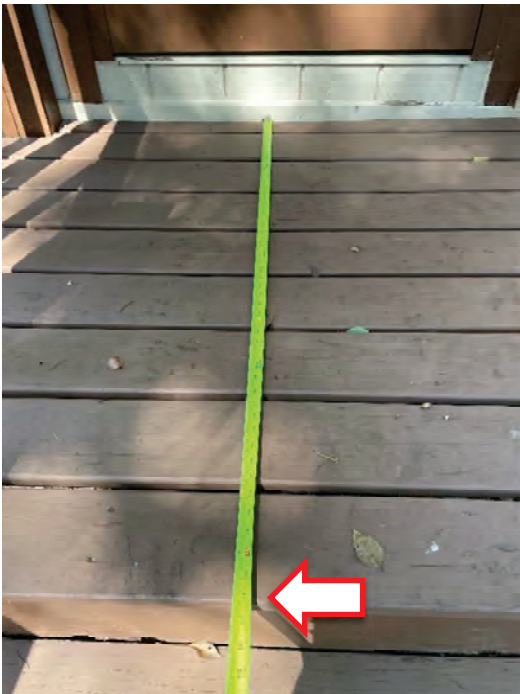
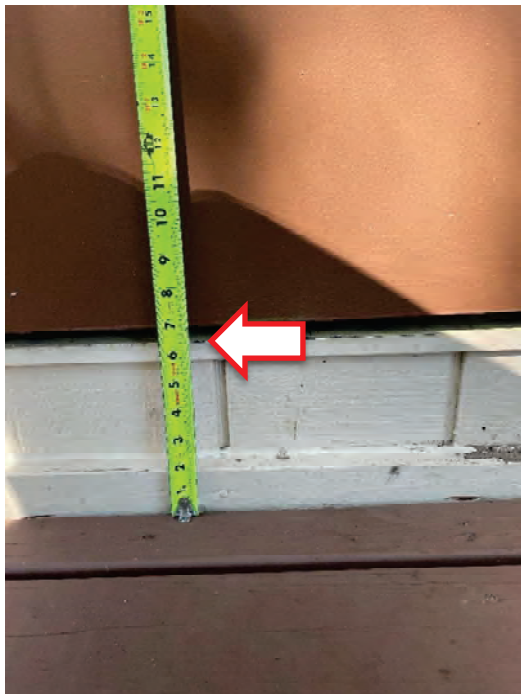
Figures 46 & 47: Classroom Egress Door Clearance and Threshold

**Threshold:** 6.5" change in elevation with no bevel (.5" allowed with a .5" bevel otherwise .25" maximum allowed FAC 303.2) *(Figure 47)*
-

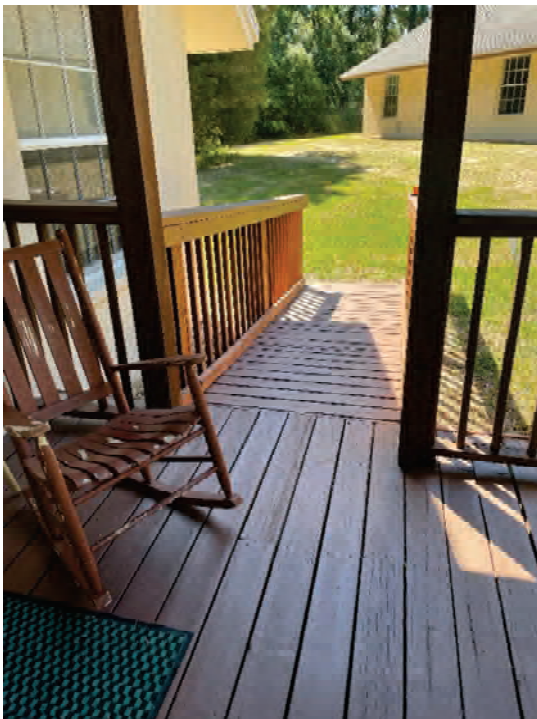
Figure 49: ADA Cottage #3 Location L Ramp

An accessible ramp exists to the accessible cottage on the south side of the cottage front porch. The ramp does not connect to a barrier free accessible path to accessible parking or site amenities. **(Figure 49)**

- +** Width: 40.5" (Min. 36" Width Required) Building has an estimated occupant load of 6 negating the 44" egress requirement.
 Length: 12'-6" (Max. 30' allowed)
- ×** Slopes: <2% Cross Slope & 9.4% Running Slope (Max. <2% Cross Slope and <8% Running Slope allowed)
- +** Landing: 60" x 60" <2% Slope (60" x 60" @ <2% Slope Allowed)
- ×** Guardrail: 38.25" (Min. 42" Required)
 Picket Spacing: 4-5/8" (4" Max. allowed)
 Handrail Dia: Non-Compliant Design (1.5" Dia. required FAC 505.6)
 Handrail Extension: 4" (12" min. Required FAC 505.10)
 Handrail Clear: Non-Compliant Design (1.5" min. clearance required FAC 505.5)
- +** Threshold: .25" change in elevation (.5" allowed with a .5" bevel otherwise .25" maximum allowed FAC 303.2) (*Figure 50*)

Cottage has a Stair/Ramp/Deck combination structure which is approximately 18" -30" above grade. (Figure 49).

<p>Width:</p> <p>Landing:</p> <p>✘ Trip Hazard:</p> <p>✘ Guardrail:</p> <p>Picket Spacing:</p> <p>Handrail Height:</p>	<p>+60" (Min. 44" Egress Required)</p> <p>60" x 60" <2% Slope (60" x 60" @ <2% Slope Allowed)</p> <p>.75" (<.25" Allowed for surfaces with changes in elevation)</p> <p>34" (Min. 42" Required)</p> <p>4" (4" Max. allowed) (Figure 49)</p> <p>34" (34"-38" allowed FAC 505.4)</p>
--	---

✘ Handrail Dia: Non-Compliant Design (1.5" Dia. required FAC 505.6)
 Handrail Extension: 4" (12" min. Required FAC 505.10)
 Handrail Clear: Non-Compliant Design (1.5" min. clearance required FAC 505.5) (Figure 49)

Possible Solution: Replace warped pressure treated deck boards at top landing (deck) and secure with stainless steel fasteners or Polyester Epoxy coated deck screws. Demolish and replace existing steps with Pressure treated steps set on concrete foundation or replace with concrete steps with 7" risers and 12" treads with 1" nosing on each step.

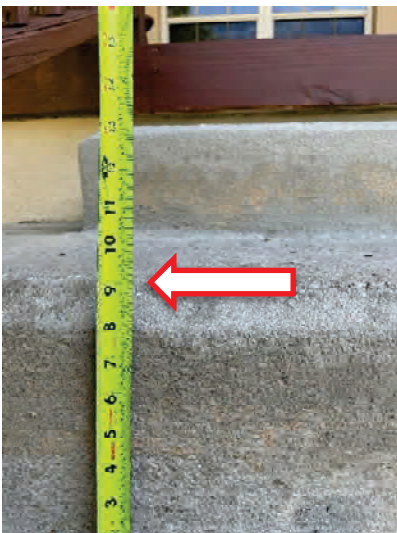
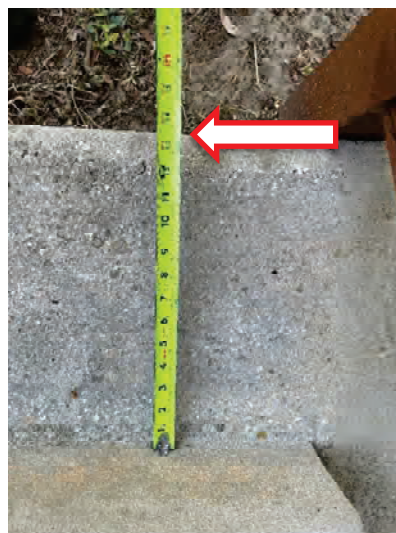
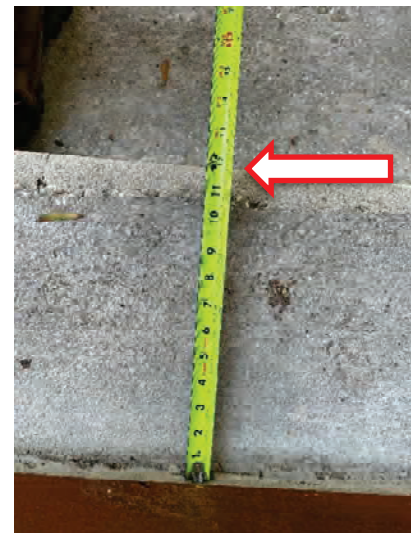
Figure 54, 55, 56: ADA Cottage #3 Step Risers and Treads

✘ Stair Riser: 7" – 9" (Risers shall be a maximum of 7" in height and shall not vary between steps more than 3/8" over the course of the flight. FAC) (Figure 54)

✘ Stair Treads: 12 -13.5" (Treads shall be a minimum of 11" in depth and shall not vary between steps more than 3/8" over the course of the flight. FAC) (Figure 55-56)

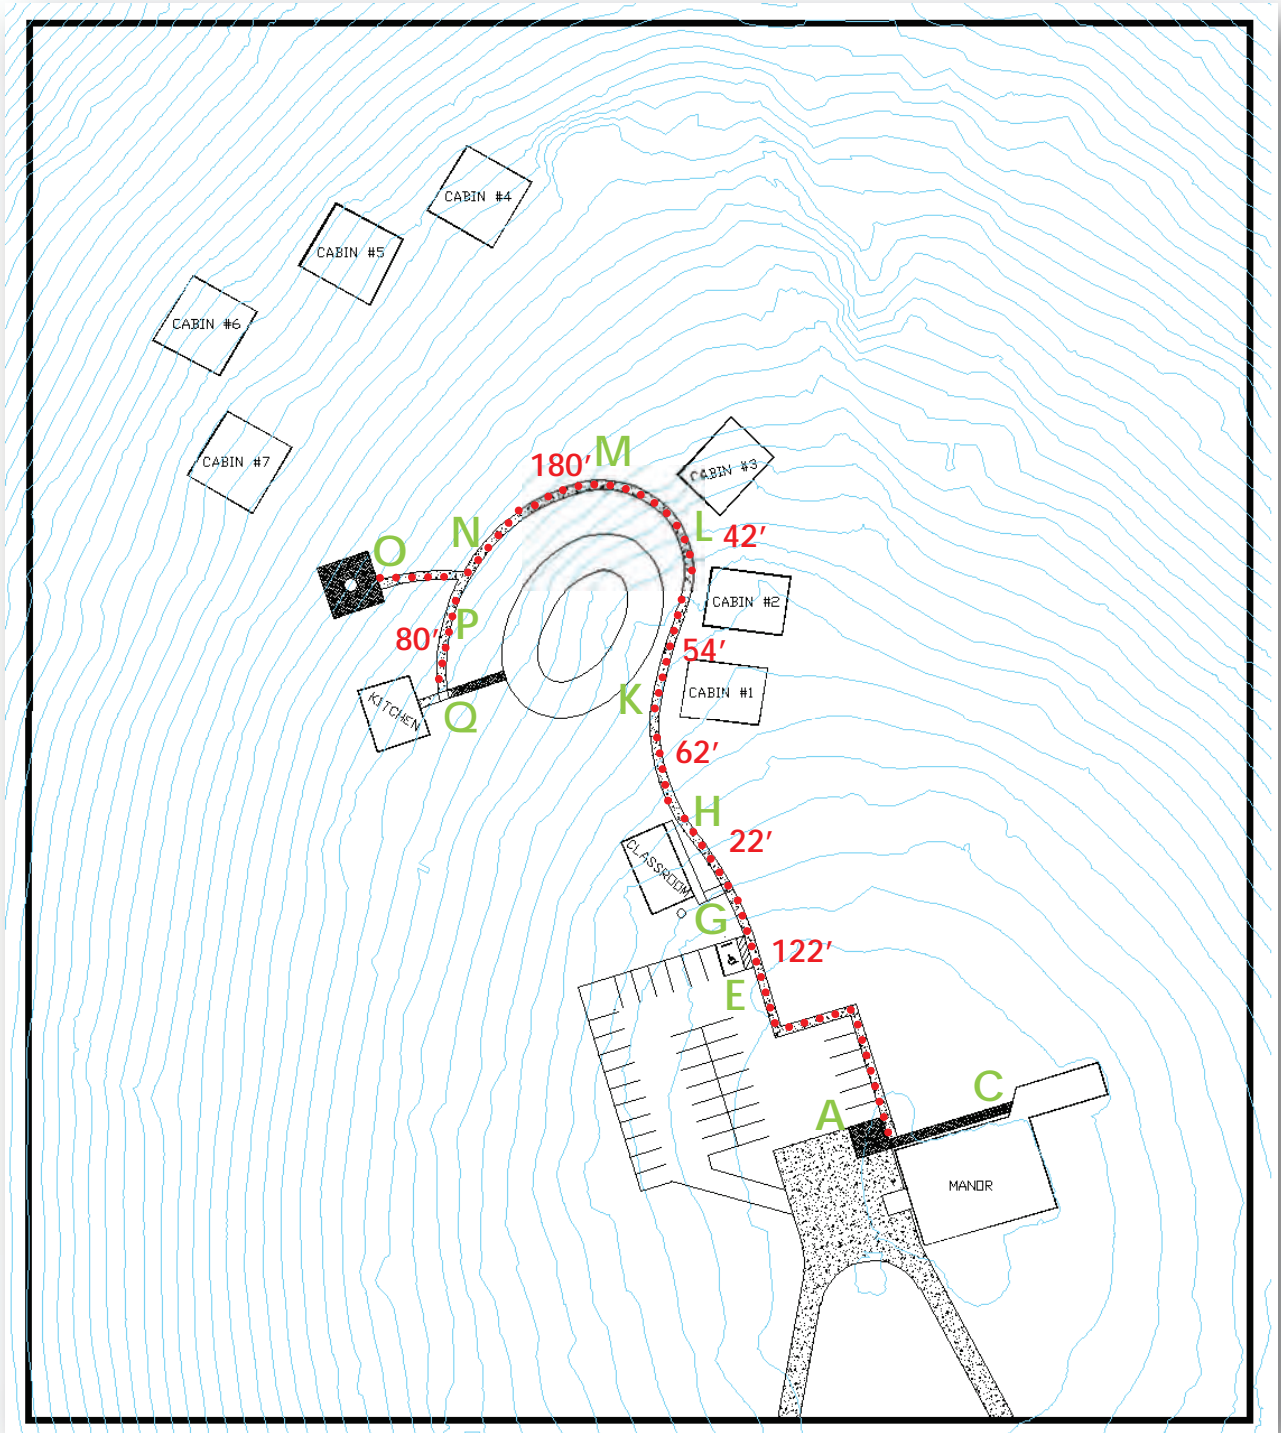
Figure 63: Accessible Path A-Q

H-Q Accessible Path: No Accessible Path exists connecting public spaces on the site to include the Manor House (B), Parking Area (A&E), Classroom Cottage 2 (K), Fire Pit (O) and Dining Hall (Q). Excluded from this requirement are cottages 4-7 which are not required to be on an accessible route as these are not accessible lodging. (Figure 63)

Slopes: A-E: <2% Slope in the direction of travel
 E-H: 3%-7% Slope in the direction of travel. (Requires arc in sidewalk path to reduce slope to <5%).
 H-K: 4% Slope in the direction of travel
 L-M-N: 4% Slope in the direction of travel
 N-P-Q: 5% Slope in the direction of travel. (Requires arc in sidewalk path to reduce slope to <5%).

An accessible path is required to have minimum lighting at the exterior of 0.2 Foot Candle (2.15 Lux) at the walking surface. (FBC 1008.2.1 Exception 2). Steps, landings and the sides of ramps shall be permitted to be marked with self-luminous materials in accordance with Sections 1025.2.1, 1025.2.2 and 1025.2.4 by systems listed in accordance with UL 1994. The exterior accessible path, building ramps, porches and landings were not observed in low natural lighting conditions with the exterior lighting fixtures on. It is recommended that the lighting levels be measured at the walking surfaces of the accessible path. *(Figure 63)*

Possible Solution: Install a 5'-0" wide concrete sidewalk (min. 4" thick @ 2500 psi with control joints in 5'-0" increments) from the Manor House to Dining Hall (connecting points A, D, E, G, H, K, O and Q). Potential path indicated in (Figures 56-57). Path shall be no greater than 5% in slope in the direction of travel with a maximum 2% cross slope which is possible in

the general path shown in Figure 6. The sidewalk can be curved to fit with the dynamics of the land, reduce slope to less than 5%. prevent abrupt changes in direction requiring landings and avoid trees and tree roots. (Figures 57-61, 63)

If lighting levels at the exterior accessible path measure less than 0.2 Foot Candle (2.15 Lux), install full-cut-off lighting fixtures intermittently to provide minimum lighting levels. Note, fixtures can be specified which are motion activated, solar powered with batteries which are ideal for commercial applications and can be mounted to poles. An electrical engineer is recommended for this phase of work.
