# **Limited Condition Assessment Report**

## **Linda Pederson Observation Tower**

**September 2, 2025**

**Subject: Limited Condition Assessment  
Observation Tower  
Linda Pedersen Park  
6340 Shoal Line Boulevard  
Spring Hill, FL 34607**

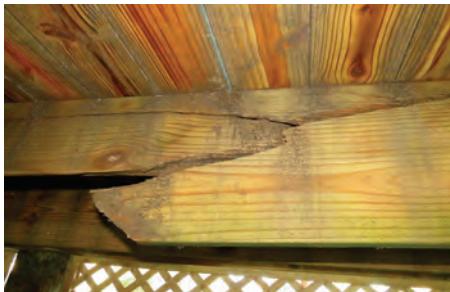
Exhibit 2 – section loss/separation along deck joist

During our assessment of the tower's current condition, BillerReinhart observed that the tower's structural components were exhibiting deterioration and damage in multiple locations. This includes section loss along lumber components (*Refer to Exhibit 2*), aged/deteriorated lumber components within the structure's deck, railings, stairways, and cladding (*Refer to Exhibits 3 and 4*), and heavy organic growth along decking and floor joists (*Refer to Exhibit 5*).

For the structure to be restored to safe operation, all the components exhibiting deterioration will need to be removed and replaced for public safety. This will expectedly include removal and replacement of the poles which support the stairway, deck systems, and lateral bracing of the tower.

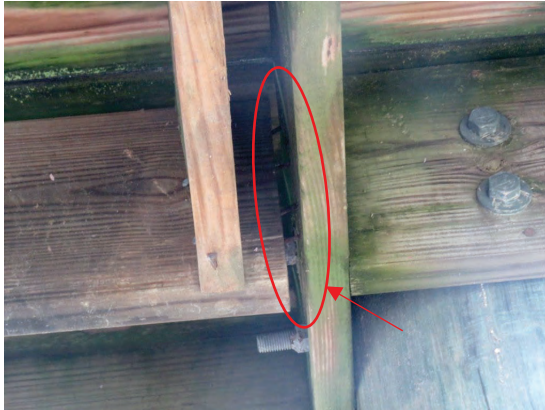
Exhibit 9 – Separation of end-nailed joist connection

building codes and safety standards. One example has been presented in the provided document *Linda Pedersen Observation Tower: Timeline*, prepared by Hernando County Department of Recreation. The document mentions an assessment of the tower conducted by a building official which reported that “end-nailed joists supporting the decking were observed to be dropping due to deteriorating fasteners (today’s codes require joist hangers).” During our condition assessment, BillerReinhart observed that most of the deck joists appeared to be end-nailed with some of the connections separating at isolated

locations (*Refer to Exhibit 9, circled in red*). The scope of work for the tower renovation will require installing new joist hangers at the deck joist connections. Furthermore, BillerReinhart observed metal joist hangers along the undersides of the 5<sup>th</sup> floor and 4<sup>th</sup> to 5<sup>th</sup> floor intermediate landing, likely installed to update the replaced joists to comply with current building codes (*Refer to Exhibit 10*).

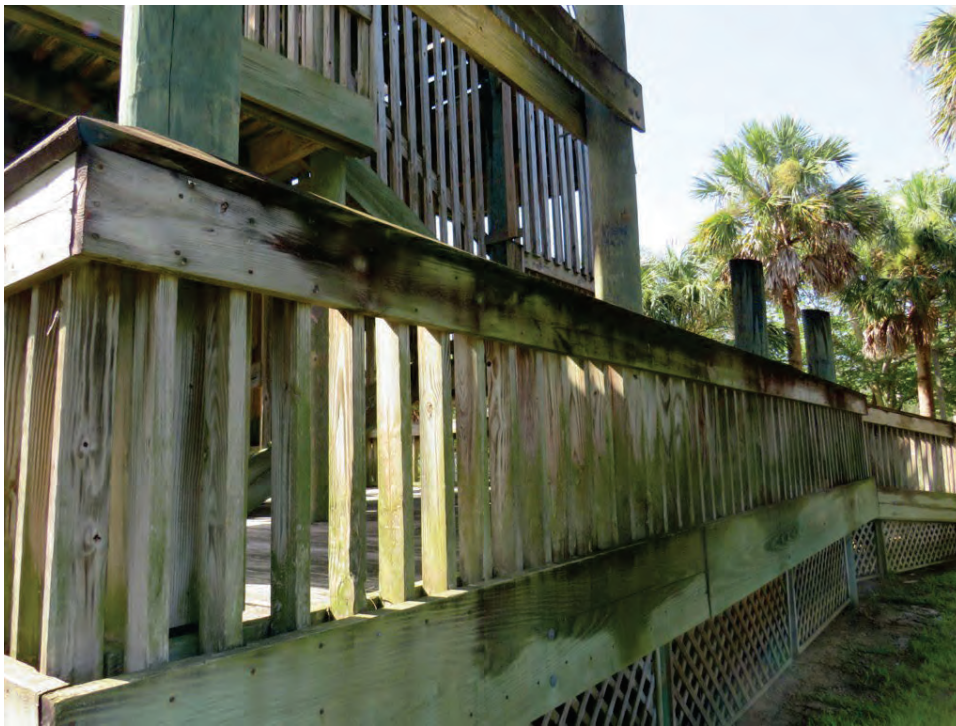
Figure A-5

| <b>Table A – Documented Observations</b> | |
|---|---|
| Organic growth and staining along the exterior rails, balusters, and fascia boards | <i>Figures A-5 and A-6</i> |

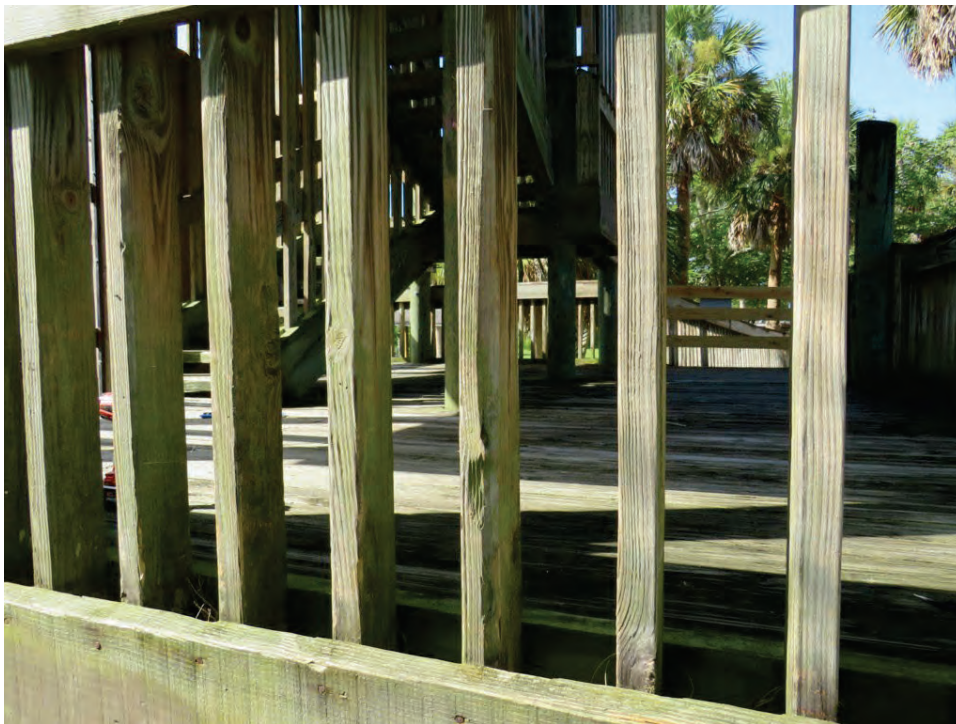
Figure A-7

| <b>Table A – Documented Observations</b> | |
|---|---|
| Surface wear and minor separation along the perimeter rail balusters | <i>Figures A-7 and A-8</i> |

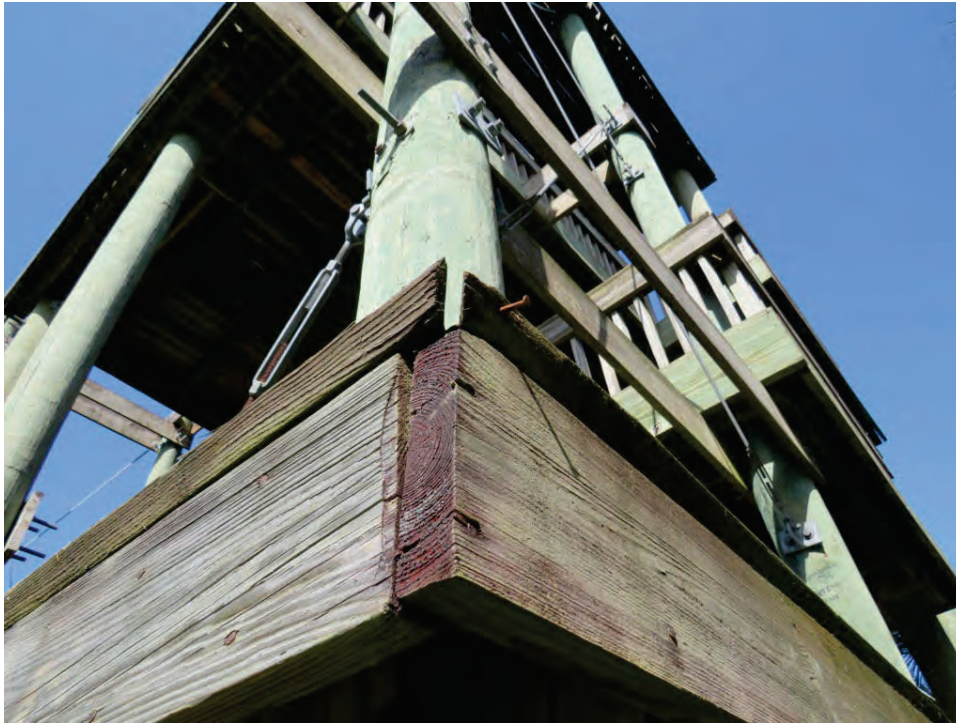
Figure A-10

| <b>Table A – Documented Observations</b> | |
|---|---|
| Missing or protruding fasteners along the perimeter railing caps, fascia boards, and balusters | <i>Figures A-10 and A-11</i> |

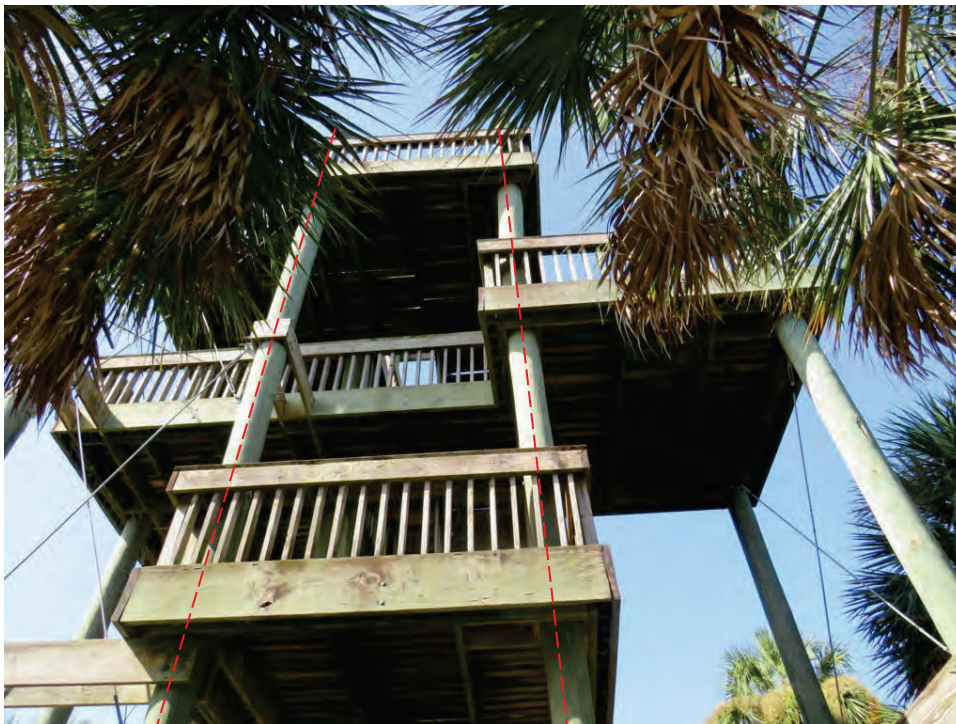
Figure A-13

| <b>Table A – Documented Observations</b> | |
|---|---|
| Separations along lumber poles surfaces | <i>Figures A-12 and A-13</i> |

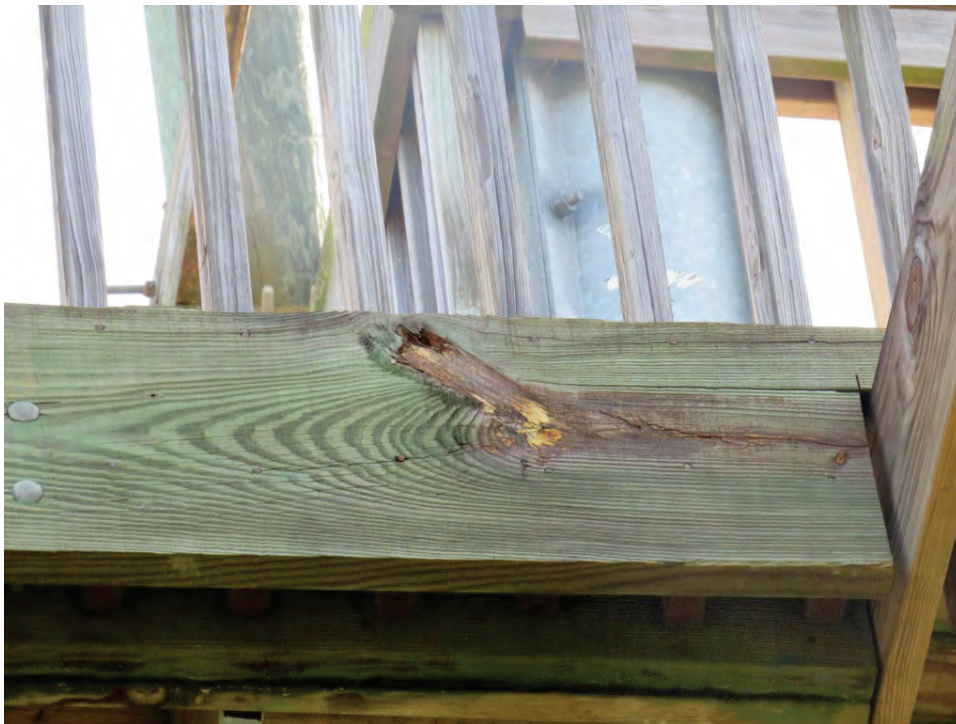
Figure A-17

| <b>Table A – Documented Observations</b> | |
|---|---|
| Surficial decay along the lower fascia board along the south elevation of the 3 <sup>rd</sup> level railing | <i>Figure A-17</i> |

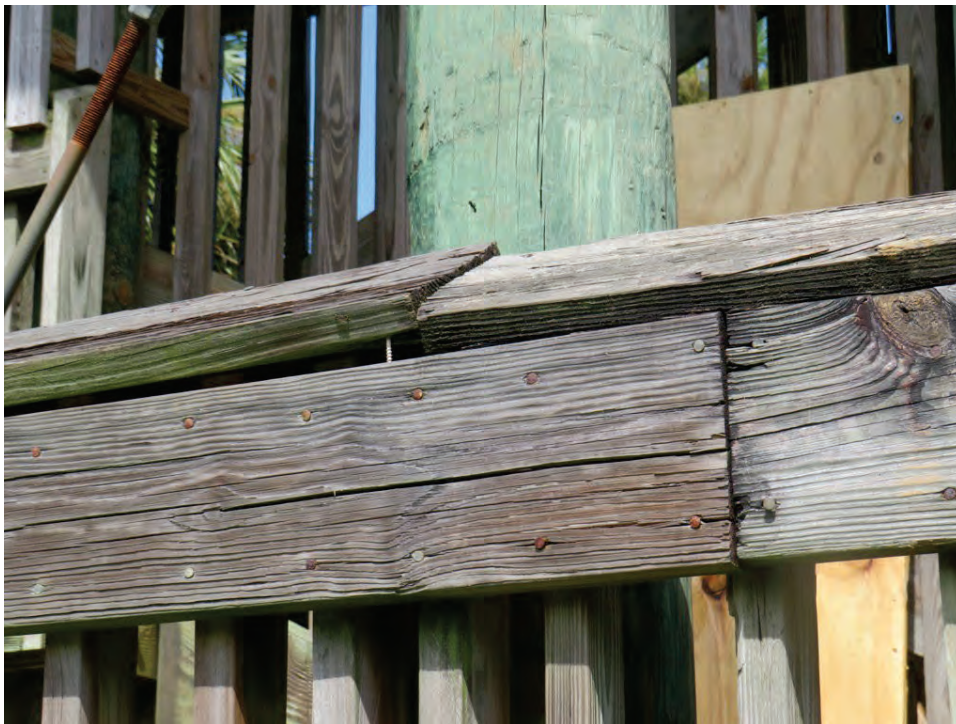
Figure A-19

| Separation between the fascia boards along the east elevation of the 1 <sup>st</sup> level | <i>Figure A-19</i> |

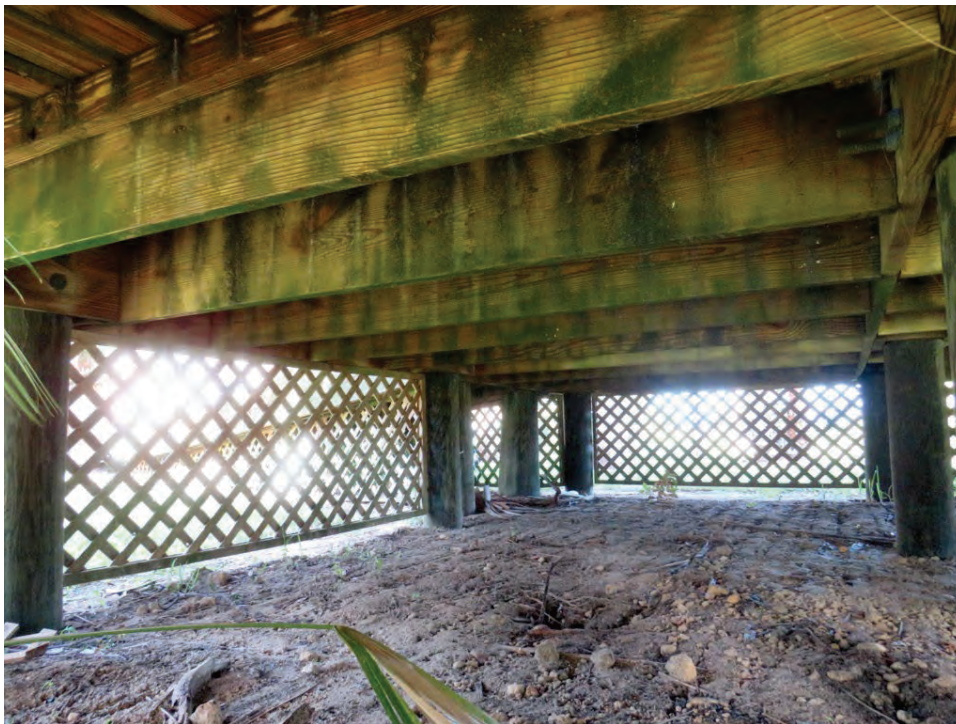
Figure A-21

| Separation, deflection, missing fasteners, and holes between the lateral bracing at the 3 <sup>rd</sup> pole from the north along the east elevation | <i>Figure A-21</i> |

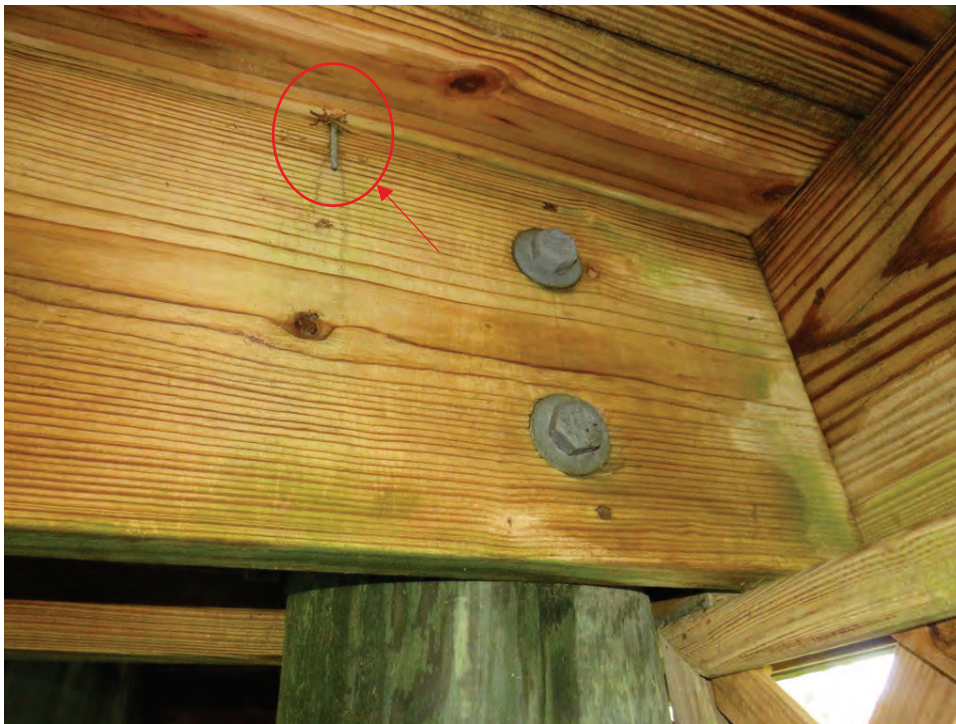
Figure A-29

| Overdriven bolts at sporadic column to joist connections | <i>Figure A-29</i> |

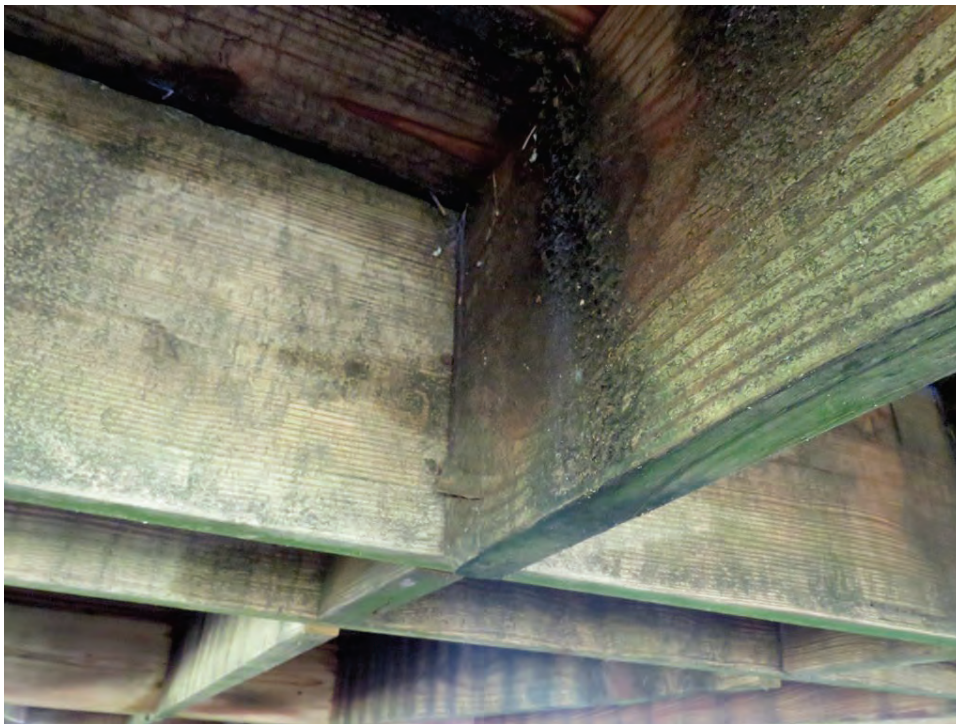
Figure A-35

| Separation at bottom of 3 <sup>rd</sup> joist from the west within the southmost column span | <i>Figure A-35</i> |

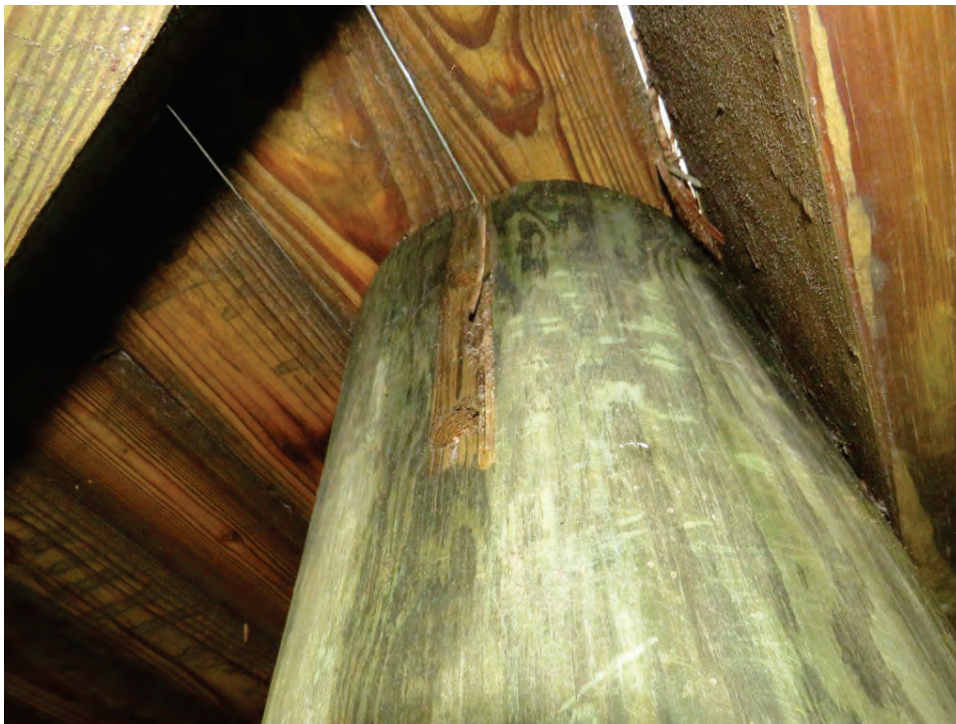
Figure A-37

| Separation along the base of the northwest pole | <i>Figure A-37</i> |

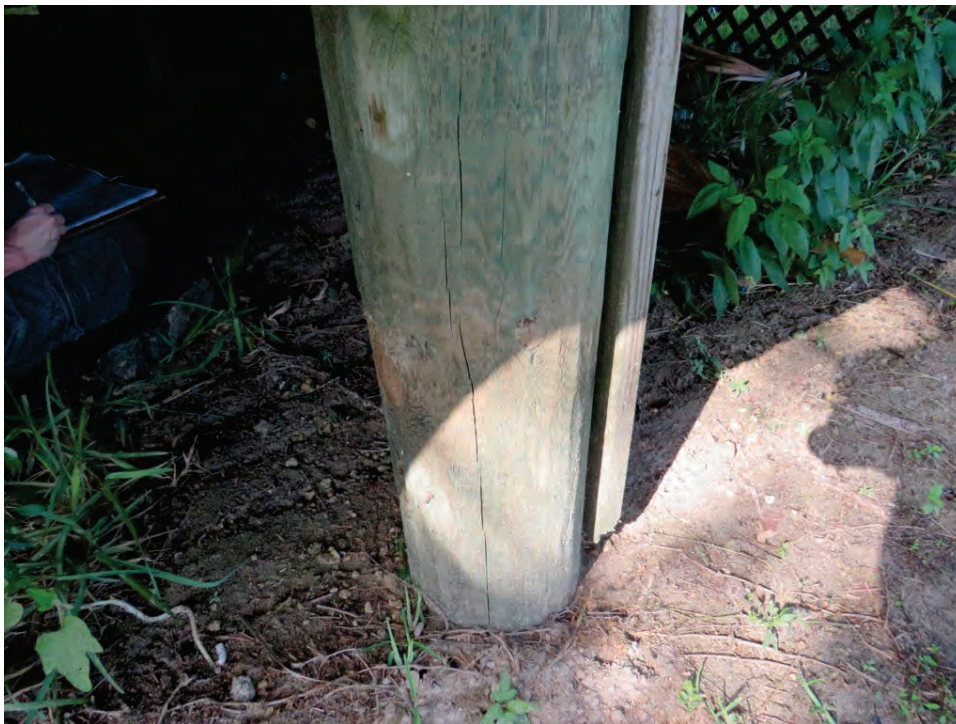
Figure A-39

| Left-in-place nail along the 2 <sup>nd</sup> pole from the south along the east elevation (circled in red) | <i>Figure A-39</i> |
| Discoloration at sporadic locations along the base of poles | <i>Figures A-39 through A-42</i> |

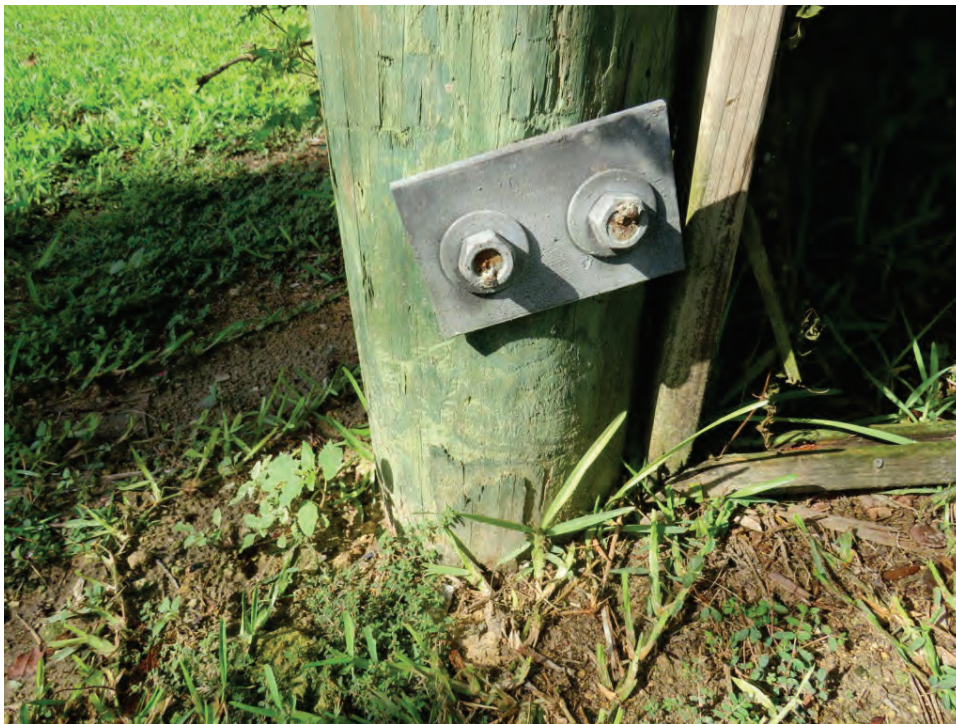
Figure A-41

| Separation along the base of the 3 <sup>rd</sup> pole from the south along the east elevation | <i>Figure A-41</i> |

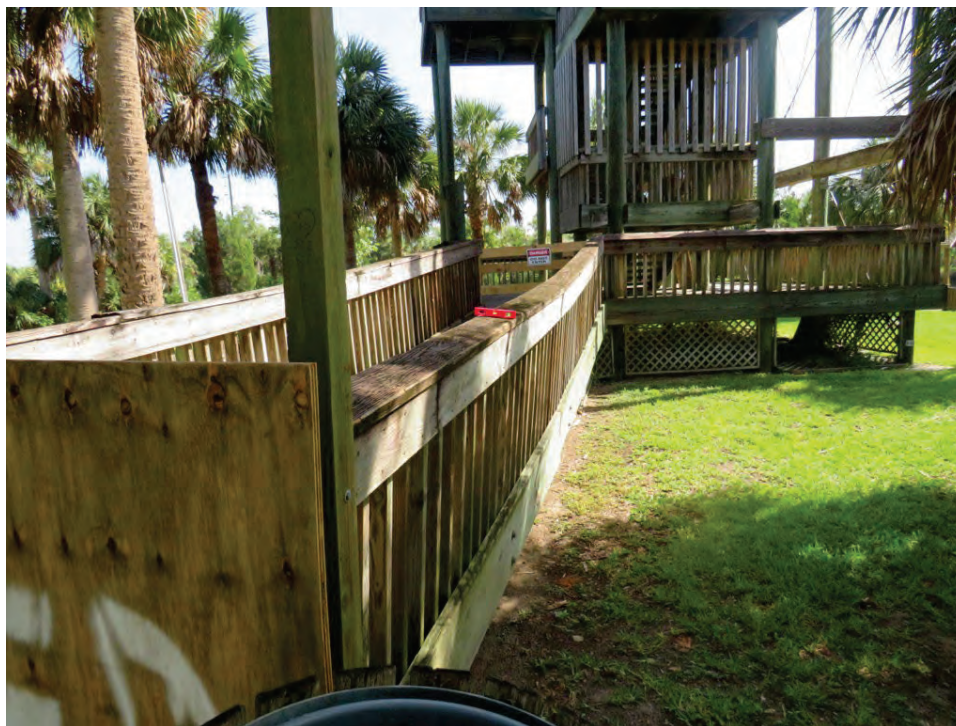
Figure A-43

| Overall photograph of 1 <sup>st</sup> level entrance ramp | <i>Figure A-43</i> |

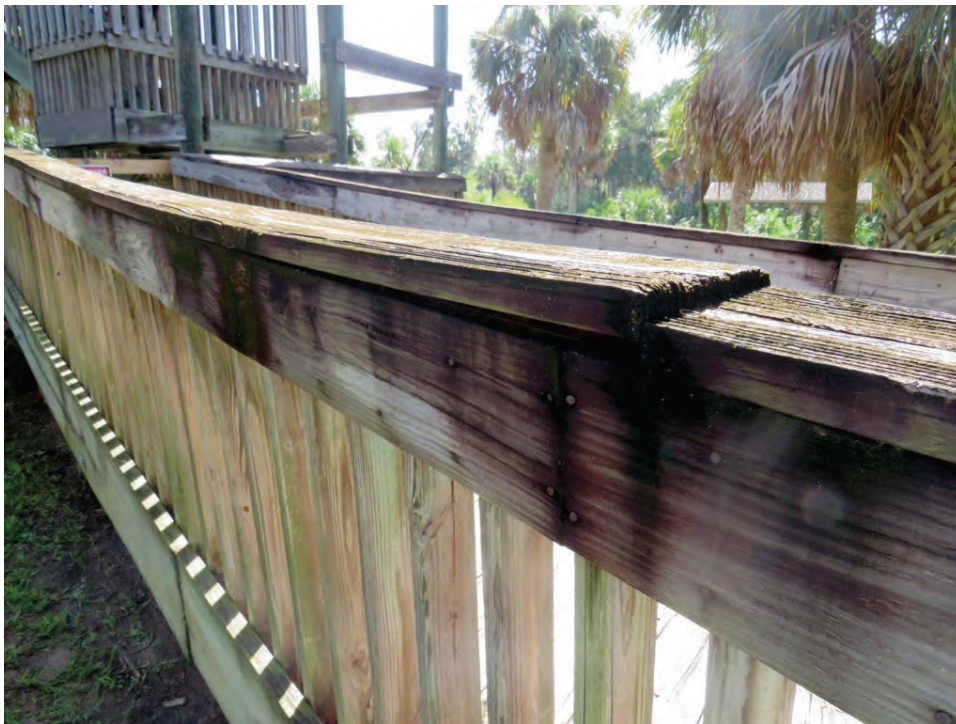
Figure A-45

| The east side railing exhibited lateral displacement | <i>Figures A-44 and A-45</i> |

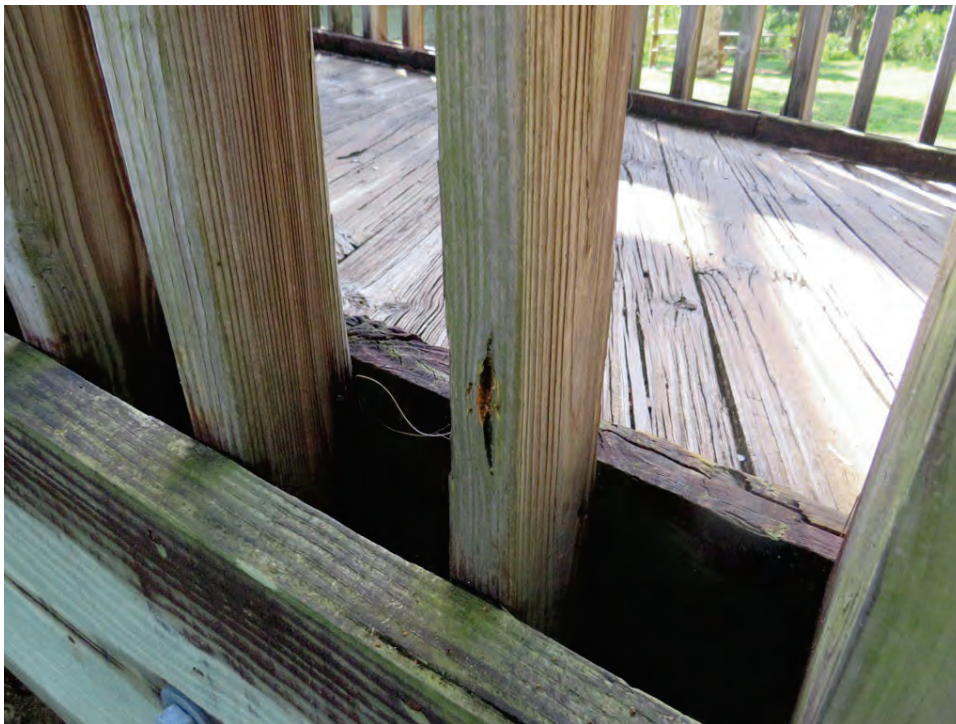
Figure A-47

| Sporadic areas of separation/splits, section loss, and deterioration along railing balusters | <i>Figures A-47 and A-48</i> |

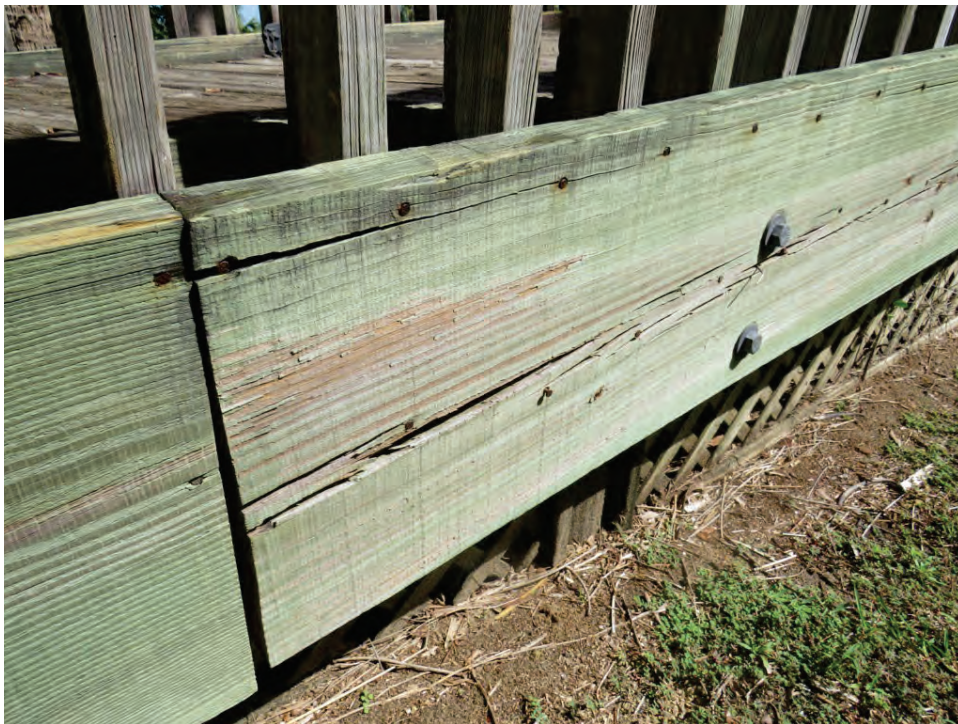
Figure A-49

| Organic growth with loose fasteners at sporadic locations along the exterior rails | <i>Figure A-49</i> |

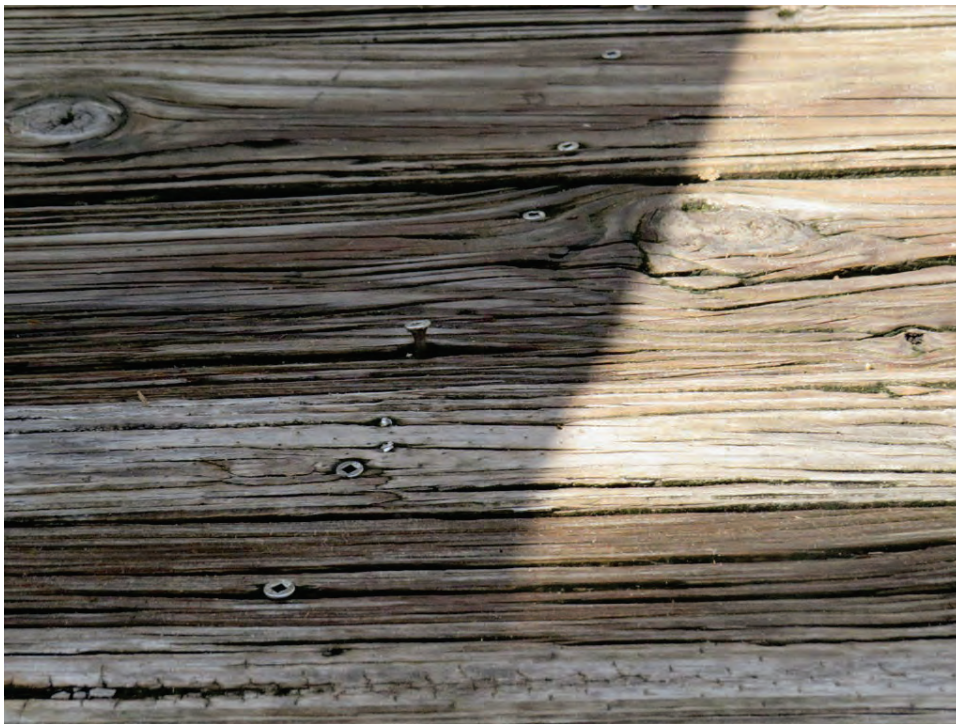
Figure A-53

| Deteriorated deck boards with loose fasteners along entrance ramp | <i>Figures A-53 and A-54</i> |

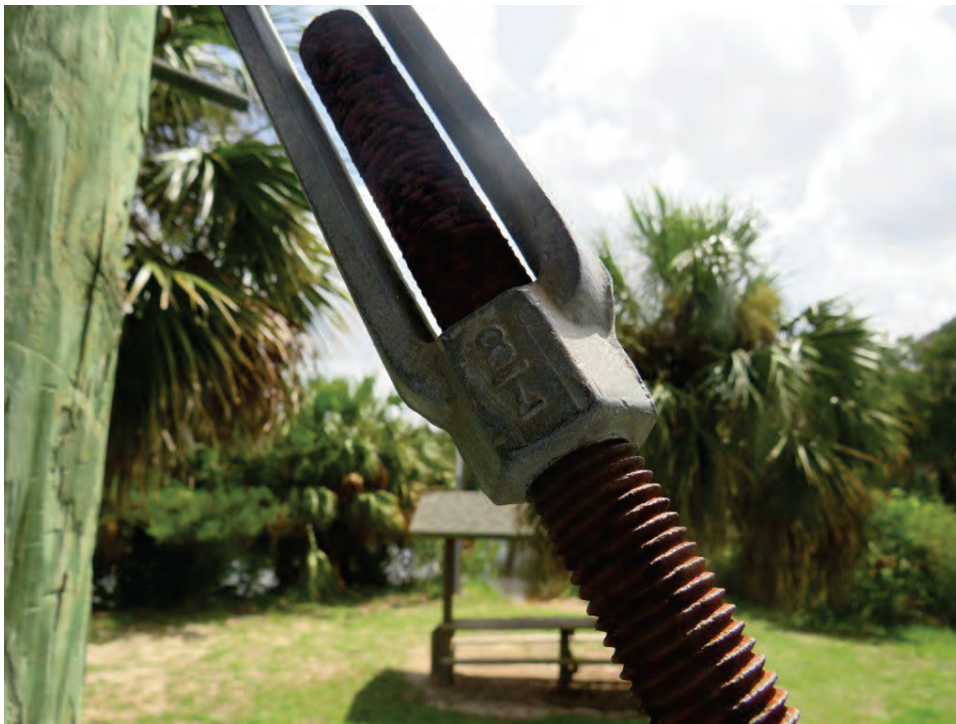
Figure A-77

| Deteriorated/weathered paint at sporadic locations along the poles | <i>Figure A-77</i> |

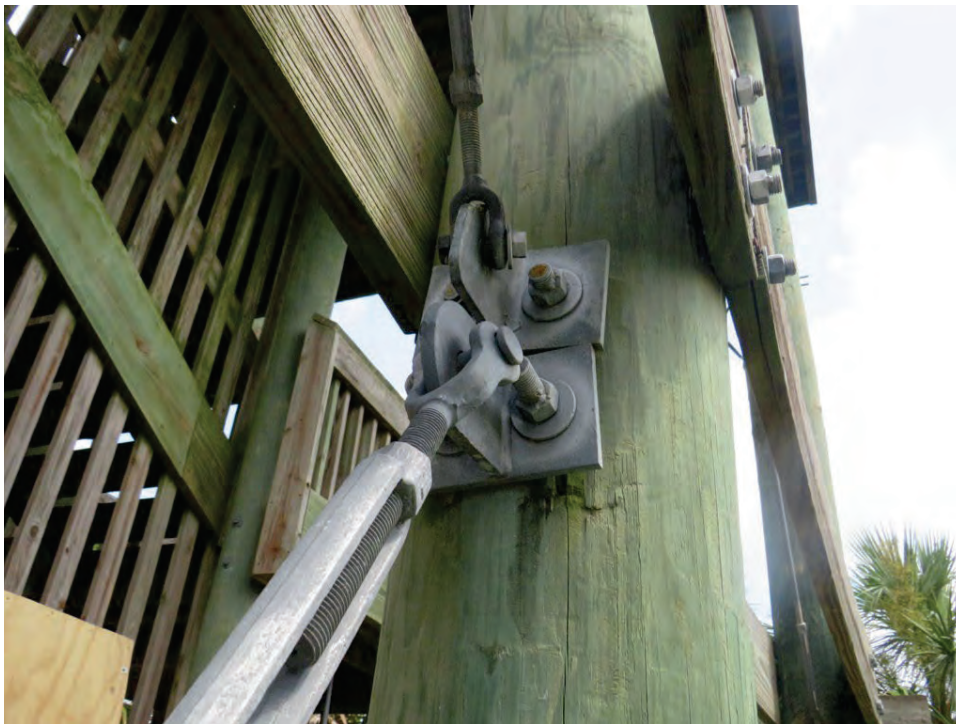
Figure A-79

| Minor surface corrosion along lateral bracing components and fasteners | <i>Figures A-78 and A-79</i> |

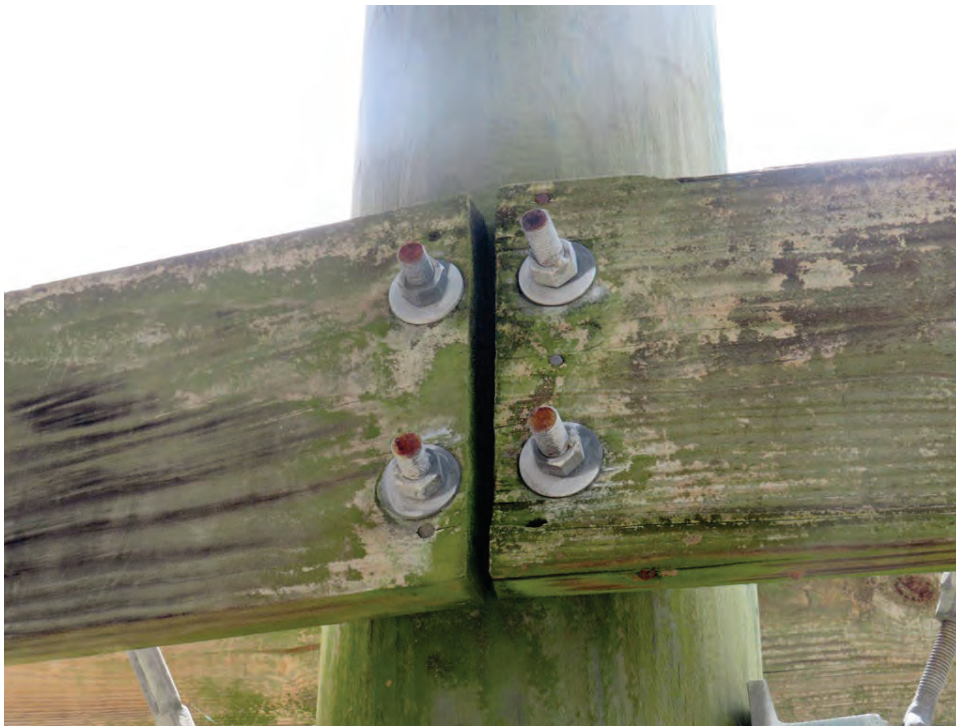
Figure A-80

| Minor displacement/separation at lateral bracing to pole connections | <i>Figures A-80 and A-81</i> |

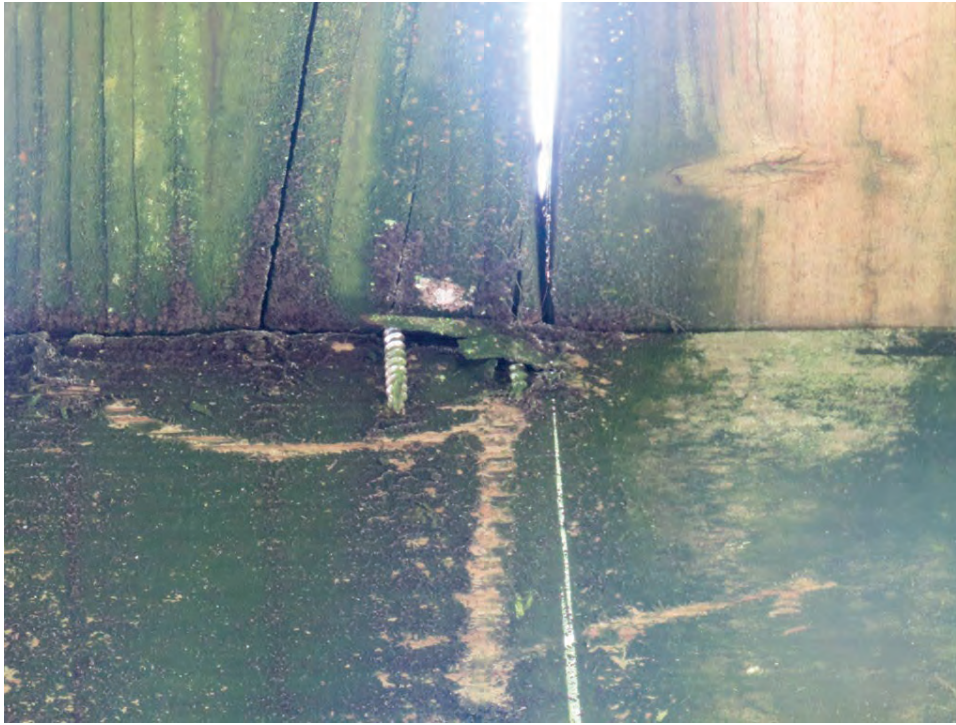
Figure A-88

| Deterioration/voids were observed at the top of the lumber poles | <i>Figures A-87 and A-88</i> |
