## **Weeki Wachee River SAV Restoration Project**

### **Month 11 Maintenance Report**

FDEP PERMIT NUMBER: 27-0192455-004-EI

April 27<sup>th</sup>, 2026

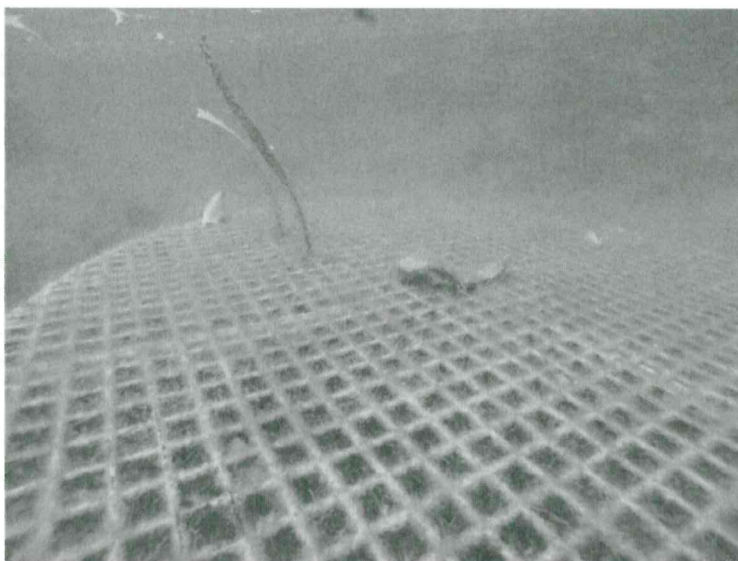
The eleventh monthly maintenance event for the Weeki Wachee River SAV Restoration Project occurred on April 9<sup>th</sup>, 2026. The GrowSAV™ Herbivory Exclusion Devices exhibited light levels of biofouling, consisting mainly of settled sediments, filamentous algae and entrapped leaf litter. Sea & Shoreline biologists removed biofouling from the top and side mesh of the devices using stiff-bristled brushes (Figures 1 & 2).

**Figure 1.** Example of biofouling on GrowSAV™ device

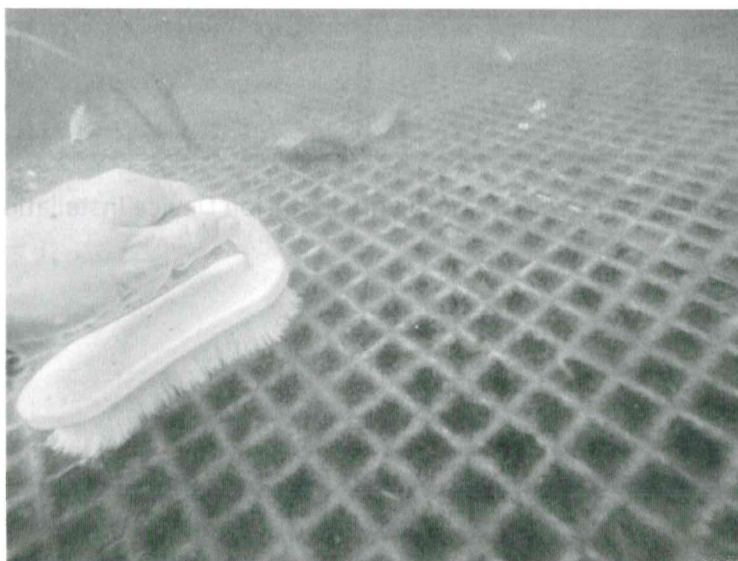
**Figure 2.** Example of biofouling removal.

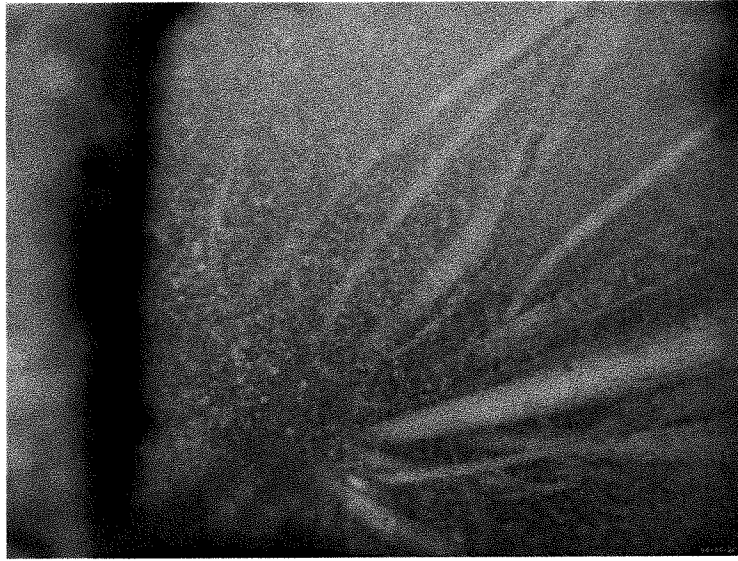
The estimated success rate of *V. neotropicalis* within GrowSAV™ Herbivory Exclusion Devices has remained consistent with the previous month, with approximately 65% of the devices exhibiting successful growth. The canopy height of protected units has remained unchanged, varying from 15 cm to upwards of 60 cm. Canopy heights of unprotected units were consistent with previous months (approx. 5 cm), likely due to increased grazing pressure during the winter months (Figure 3). Unprotected units remain short but continue to display signs of lateral expansion throughout the river. Increased expansion is expected as we continue into warmer months.

**Figure 3.** Example of protected units.

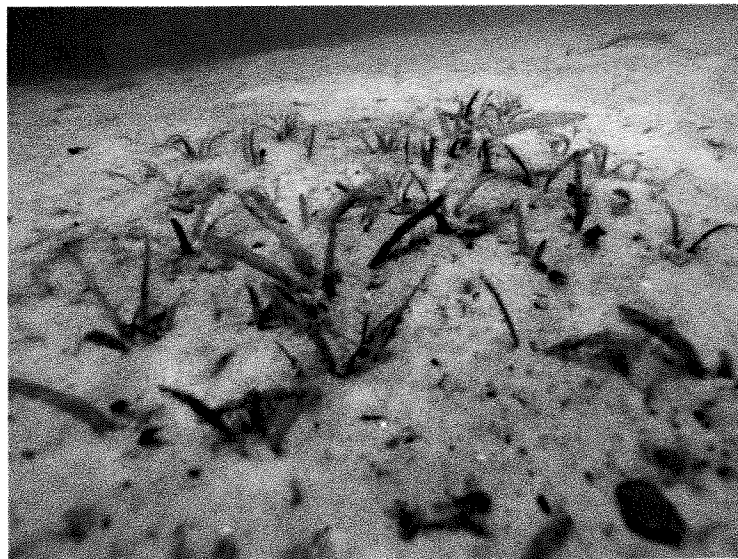
**Figure 4.** Example of unprotected units.

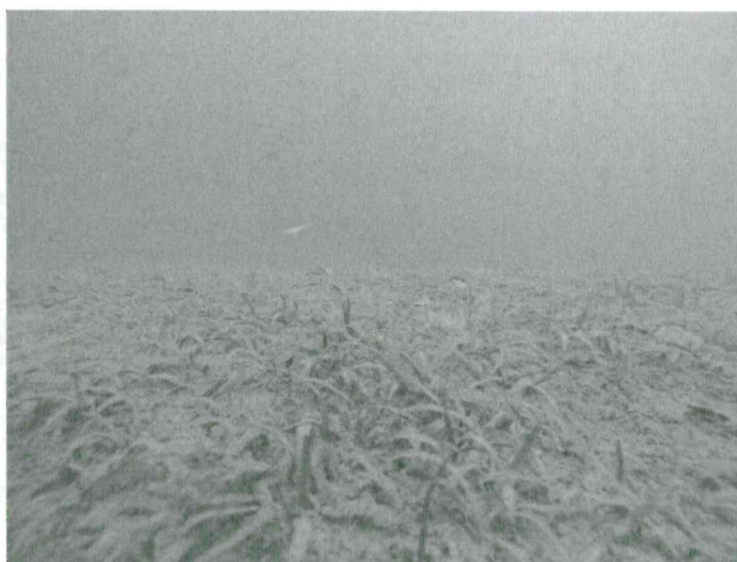
**Figure 5.** Example of unprotected planting units.

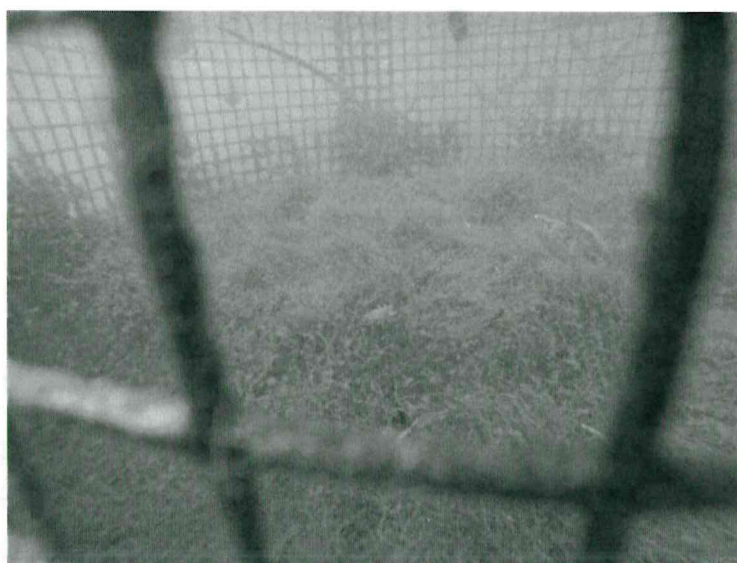
Supplemental planting units installed at site 5 were observed in approximately 10% of the GrowSAV™ Devices. A dense *Chaetomorpha* bloom again was observed at site 5 during this event, covering almost 90% of the total area where GrowSAV Devices are installed (Figure 6). The bloom was also observed at site 4 during this event, covering less than 10 percent of the area. *Chaetomorpha* usually blooms when there are excess nutrients in the system and prefer higher salinity levels. In addition to the increased salinity at site 5 that is likely contributing to the low survival rate, the algae is also smothering shorter, juvenile plants. The *Chaetomorpha* was gently swept out of each device

**Figure 6.** Example of algae present inside of GrowSAV Device.

The *Chaetomorpha* bloom at sites 4 and 5 will continue to be monitored, any algae that builds up within the devices will be gently swept out. It is recommended that *Ruppia maritima* is added at site 5, where salinity has proved to be a rate limiting factor, as *R. maritima* has a higher salinity tolerance. Maintenance will continue for the remaining month, with the next event taking place in May of 2026.
