Weeki Wachee River SAV Restoration Project

Month 5 Maintenance Report

Prepared On:
November 6th, 2025

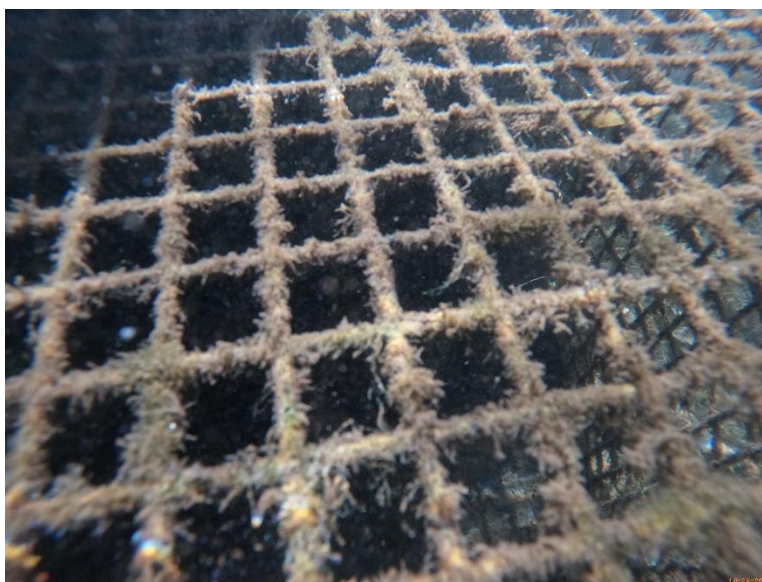
The fifth monthly maintenance event for the Weeki Wachee River SAV Restoration Project occurred on October 24th, 2025. The GrowSAV™ Herbivory Exclusion Devices exhibited light to moderate levels of biofouling, consisting mainly of settled sediments and attached filamentous algae. Sea & Shoreline biologists removed biofouling from the top and side mesh on mask and snorkel using stiff-bristled scrub brushes.

Figure 1. Example of biofouling prior to removal.

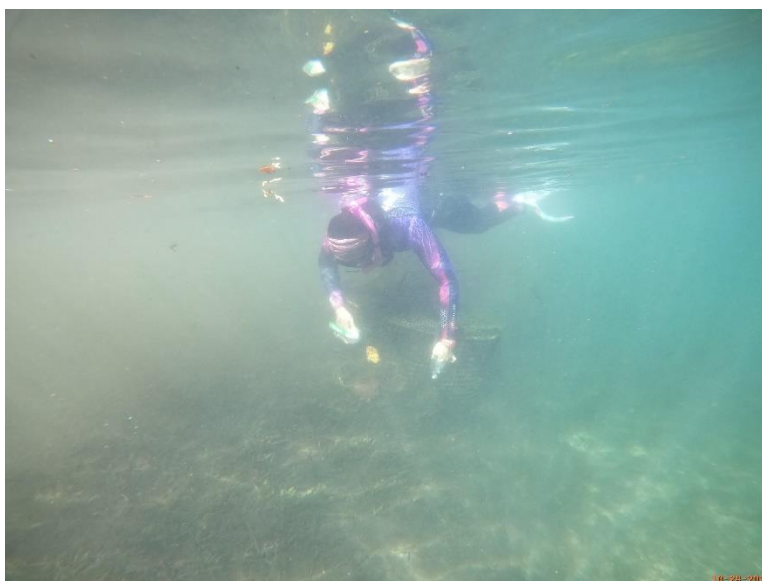
Figure 2. Example of Sea & Shoreline biologist removing biofouling.

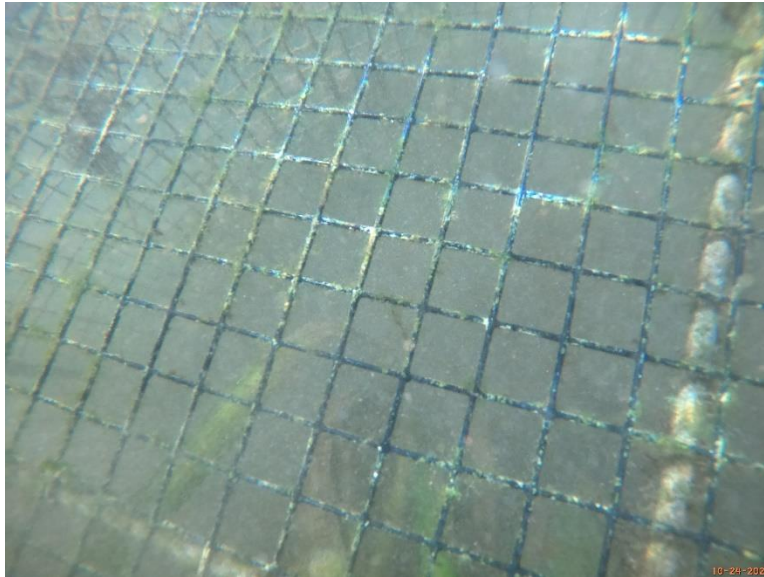
Figure 3. Example of GrowSAV Device after biofouling removal.

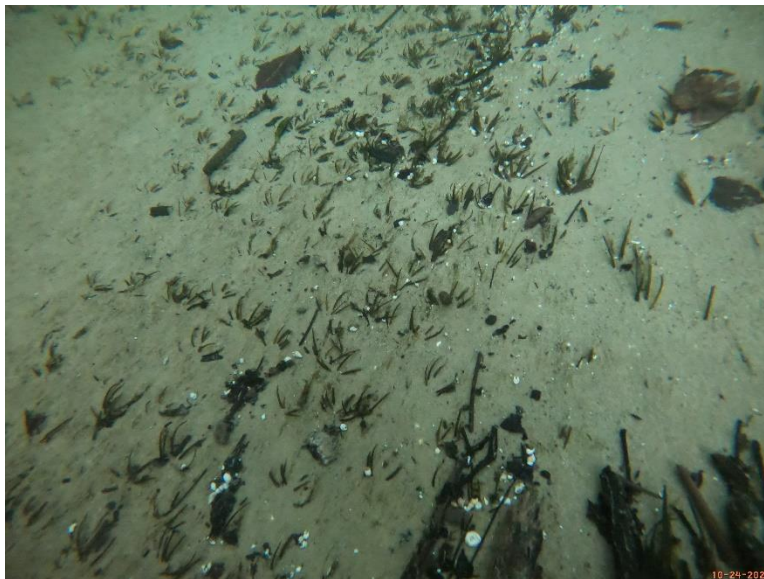
Figure 4. Example of unprotected units showing signs of lateral expansion.

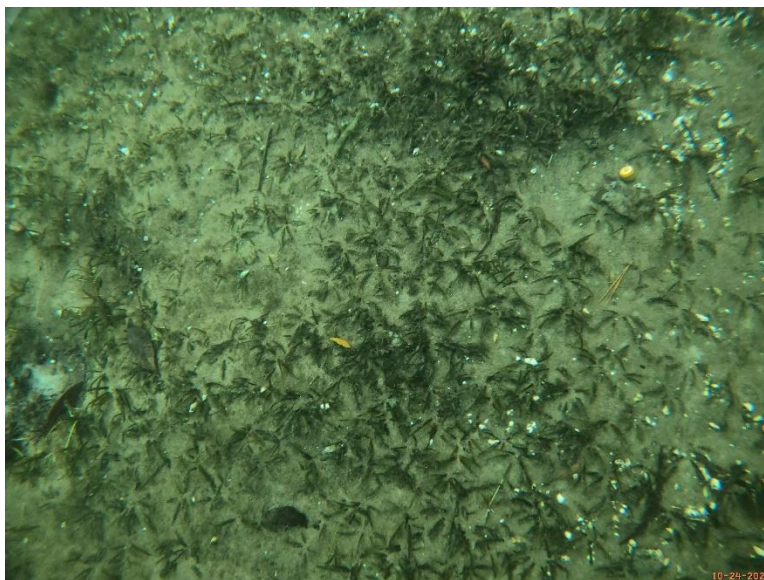
Figure 5. Example of unprotected planting units.

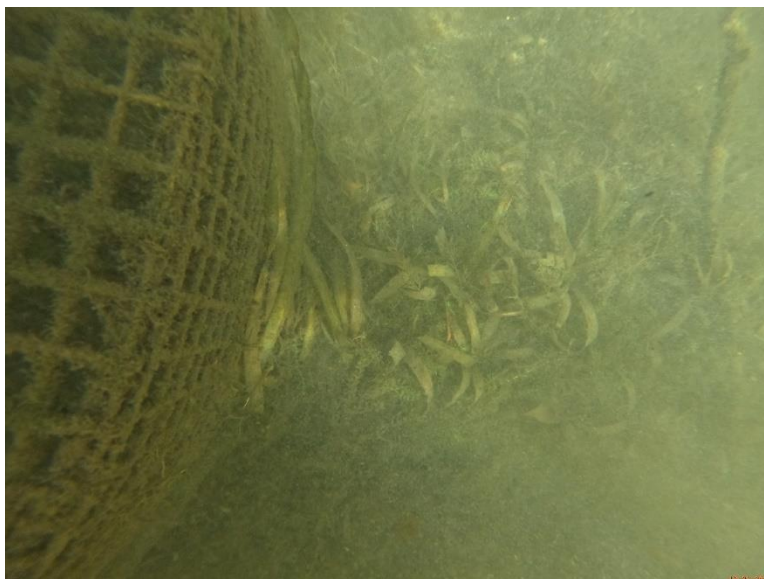
The blade height of protected units varies from 40 cm to 90 cm, with most units extending well beyond the top of their associated device. Signs of lateral expansion beyond protective devices were also observed throughout approximately 80% of devices, with some units expanding up to 4 feet from their device (**Figure 6**). Visible signs of lateral expansion were observed in unprotected planting units and new growth was observed in certain areas throughout the restoration footprint (**Figures 4 & 5**). New growth of unprotected units has taken off throughout the middle, deeper portions of the river, where recreational activity poses less of a threat to establishment.

Figure 6. Example of protected units expanding beyond their associated device.

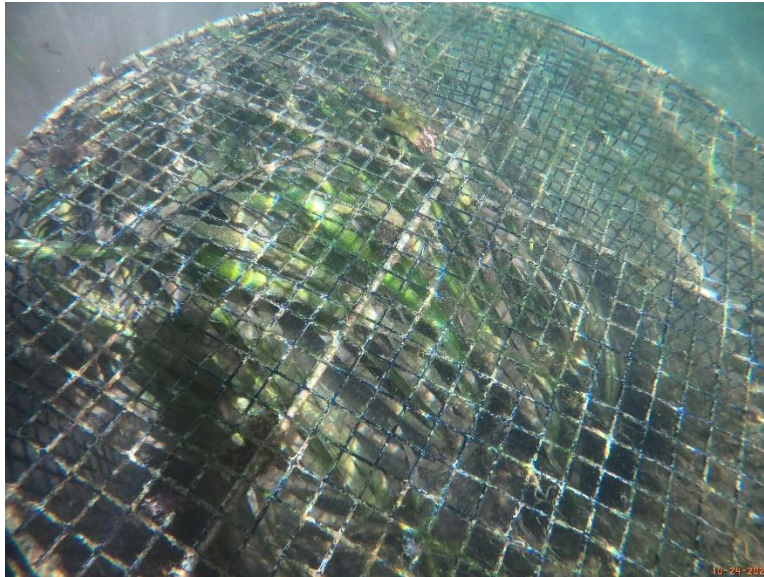
Figure 7. Example of protected planting units.

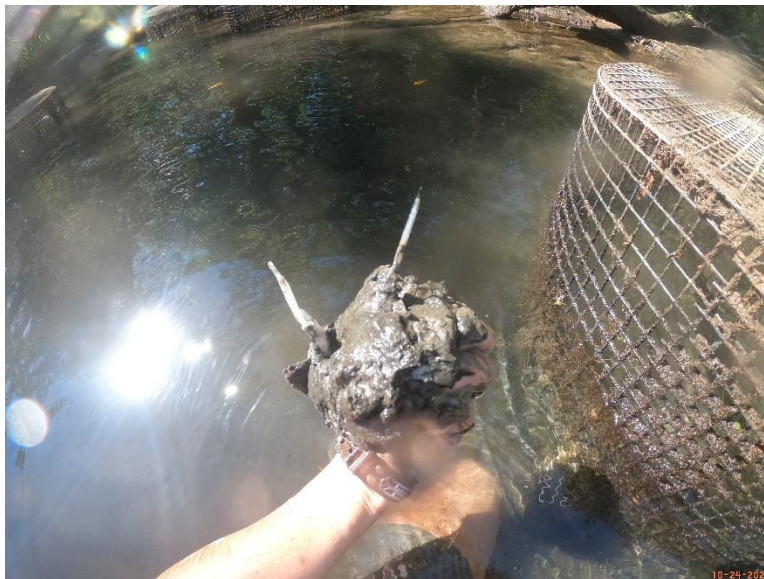
Five months after installation, both unprotected and protected planting units are showing very encouraging signs of growth and expansion throughout the river. It is estimated that *V. neotropialis* is present in 110/132 (83%) of the GrowSAV™ Herbivory Exclusion Devices, with coverages ranging from 2 to 4 on the Braun-Blanquet coverage scale. The overall survival rate of protected units has decreased since the last maintenance event. After the recent King Tide event, it is evident that protected units located at the most downstream site (site 5) suffered from the saltwater intrusion. Blade tissue of protected units at site 5 was completely gone, and the only plant material was found underneath the top layer of sediment (**Figure 8**). These planting units will be monitored for any signs of regrowth.

Figure 8. Example of protected planting units found at site 5.

It is recommended that supplemental planting take place at site 5 to help jumpstart the recovery of planting units in this area. Planting units used at site 5 will be comprised of a more salt tolerant variety of *Vallisneria* which will be able to withstand the salinity fluctuations that this area experiences. Maintenance will continue for the next seven months, with the sixth event taking place in November 2025.
