South

BROOKSVILLE

FINDING

NECESSITY

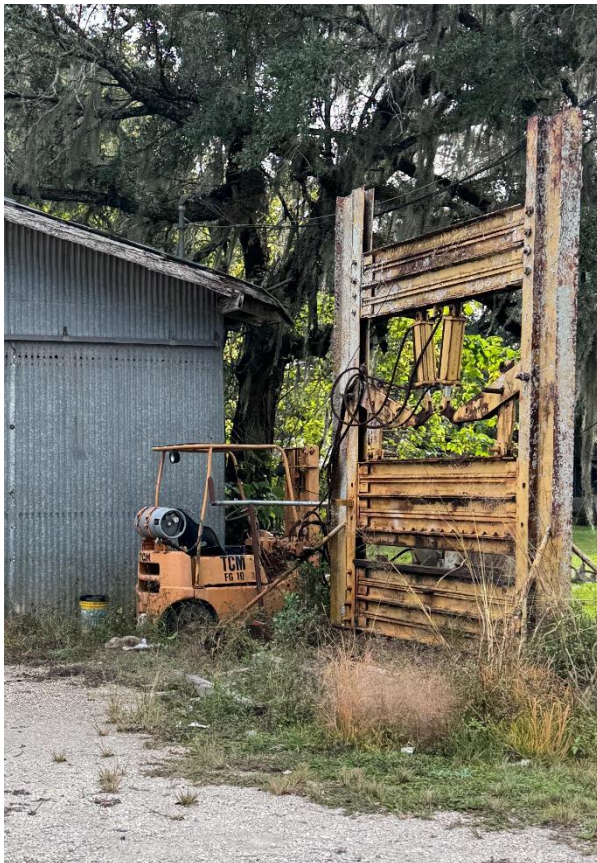
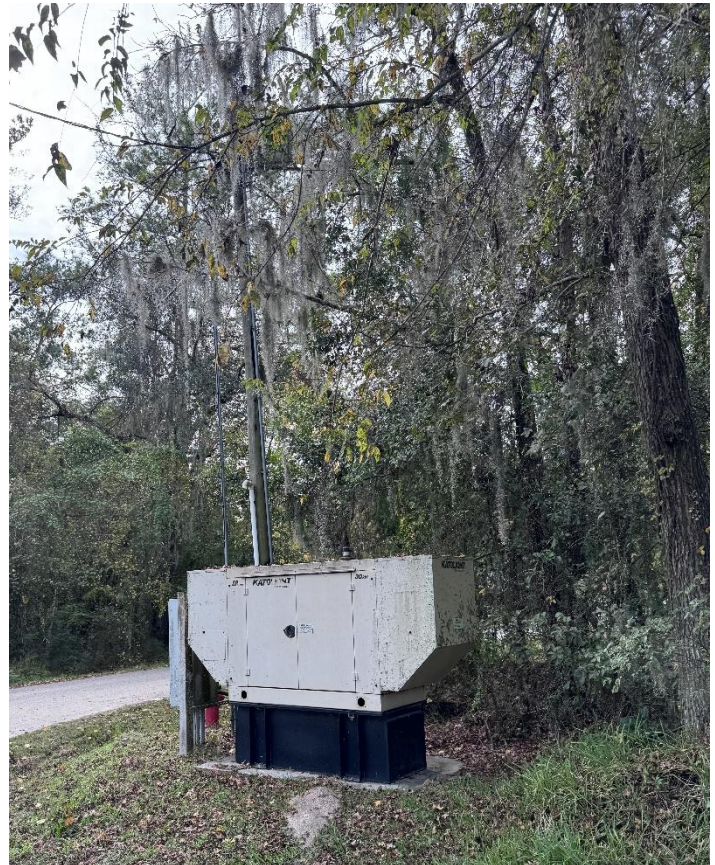
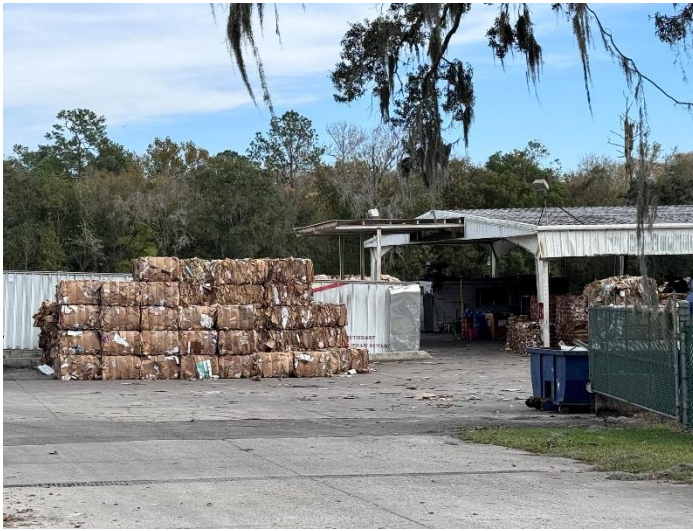
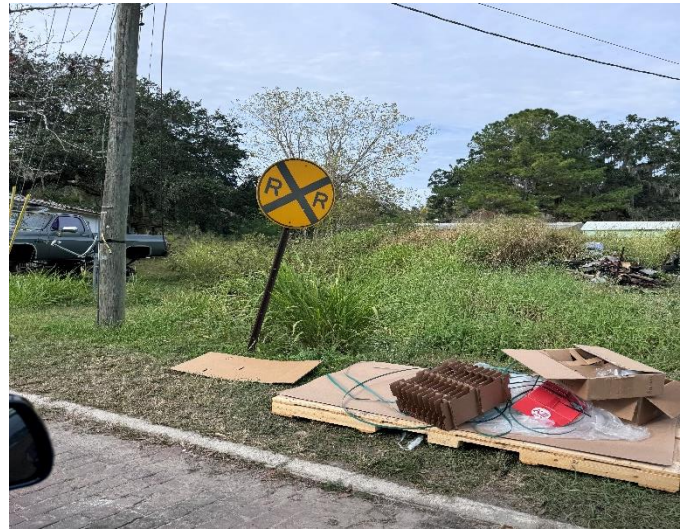
Throughout the Study Area, there are risks for fire due to overgrown vegetation, especially when near overhead powerlines or other electrical power sources. Without regular maintenance to the vegetation, particularly in right-of-way or greenbelt areas, lightning or downed powerlines could easily cause a fire that could spread to surrounding parcels. There is also a diesel generator located along Main Street, near Dr. Martin Luther King Jr. Boulevard, which could cause a potential fire hazard, as it is located near large trees and overgrown brush. One of the properties, which conducts manufacturing along Dr. Martin Luther King Jr. Boulevard, has an electrified piece of equipment which has overgrown vegetation around its base. The property looks to be maintained on an irregular basis which has potential to cause heightened fire risks. Another property has an abandoned filling station on it which can cause risks of fire as well as environmental risks with remaining fuel tanks.

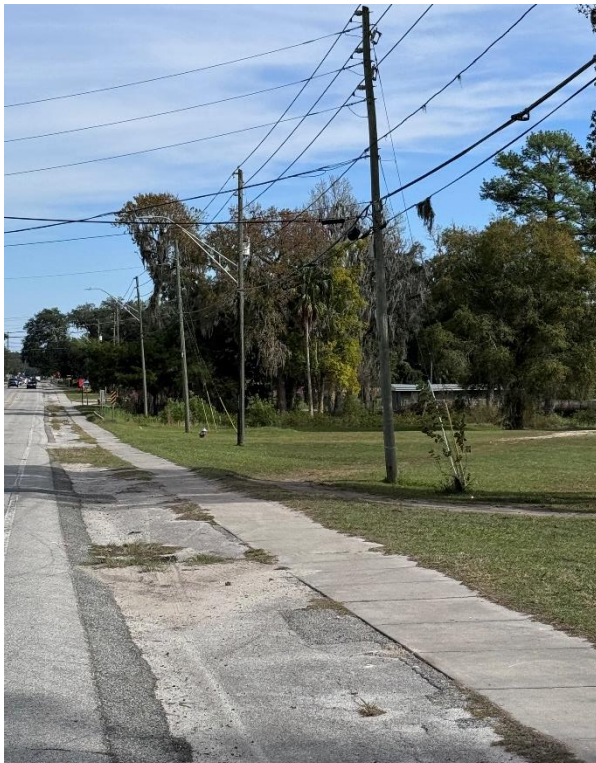
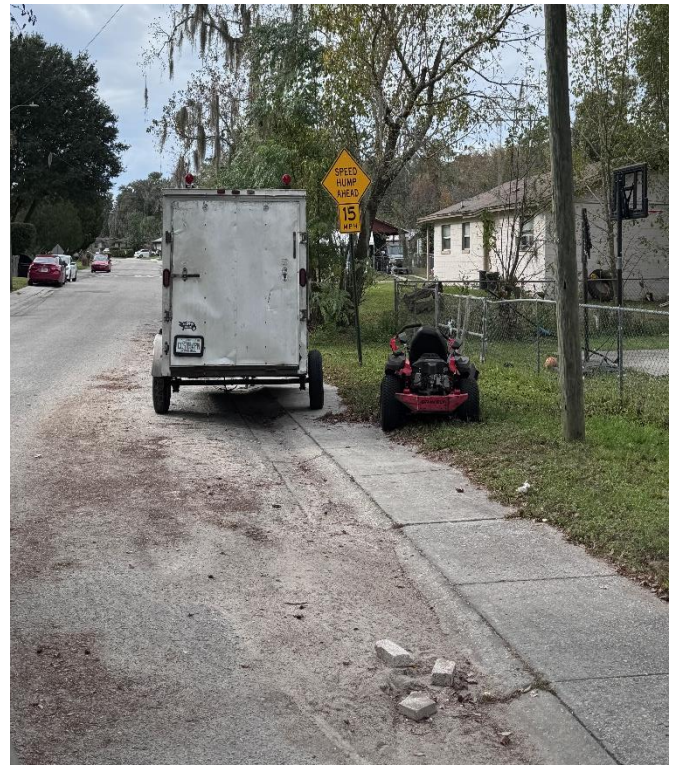
There are several unsafe and unsanitary conditions in the Study Area. Several homes are either abandoned or have been left in a state of disrepair which could be dangerous to the public (trash in the yard, damaged roofs, broken windows, etc.). Some infrastructure in the Study Area also causes unsafe and unsanitary conditions. Roadways are in different states of repair with some roadways not being paved, a lack of shoulders along rights-of-way, and potholes or cracked asphalt. Stormwater infrastructure is also creating unsafe and unsanitary conditions with flooding and standing water which can provide ample breeding grounds for mosquitos and infectious diseases.

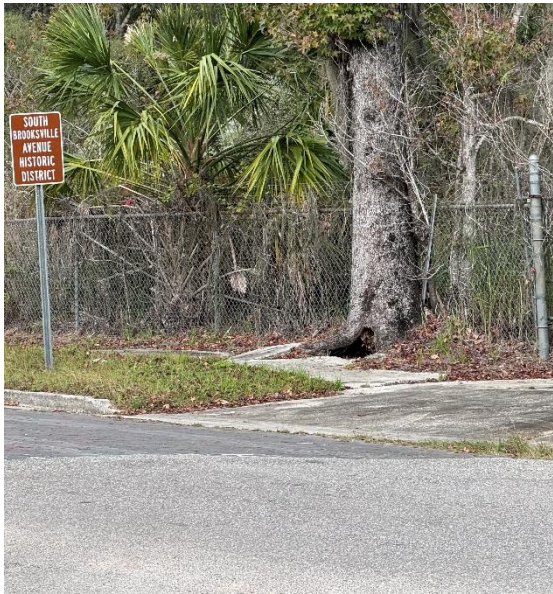
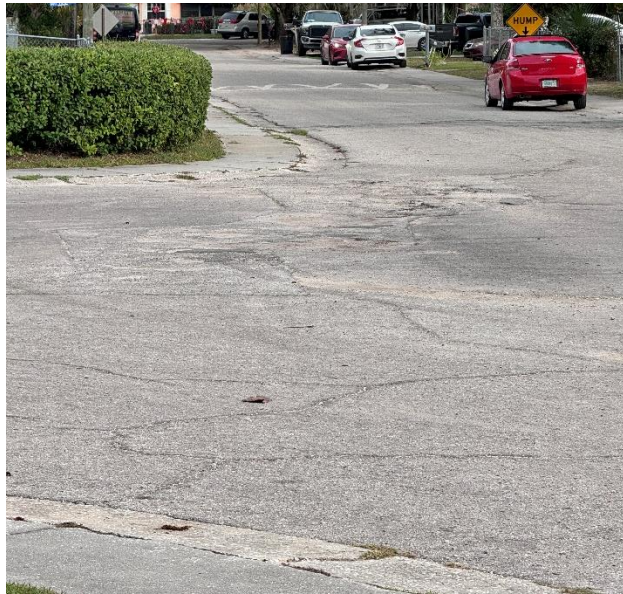
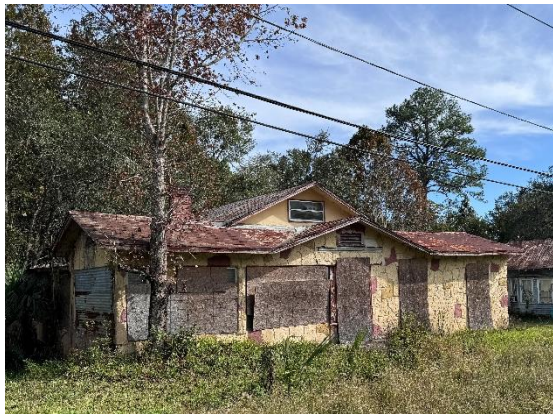
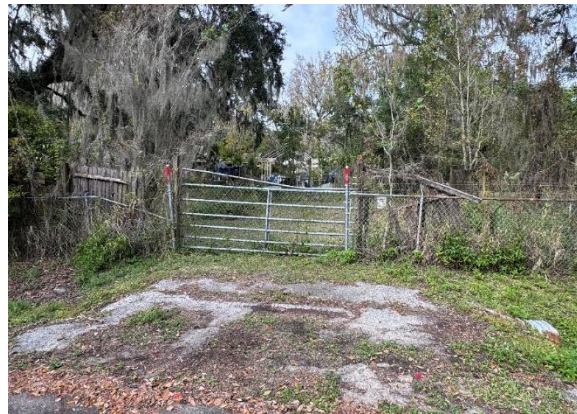
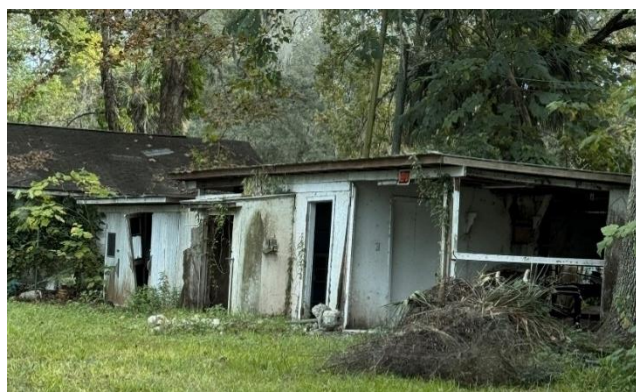
The deterioration of site or other improvements is primarily determined by the physical conditions of buildings or site improvements, including their evaluated useful lives. Deterioration is seen in the roadways, limited pedestrian infrastructure, and residential homes. Many roadways were observed to have potholes and major cracks, and the shoulders of the roads have vegetation growing throughout. Many sidewalks are broken, uneven, and have large holes in them. Residences have overgrown vegetation, damaged roofs, and boarded windows, and some buildings are in complete disrepair with little prospect of renovation. These conditions impact the perception of the Study Area and may prevent business owners or potential residents from choosing to locate in the area. The observed deterioration of sites or other improvements within the Study Area satisfy the definition for a condition of "blight."
