South

BROOKSVILLE

FINDING

NECESSITY

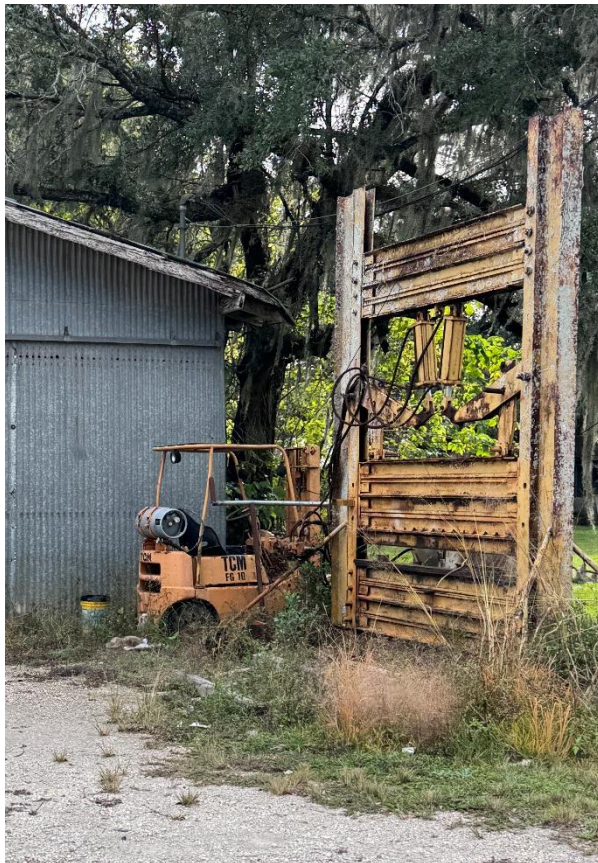
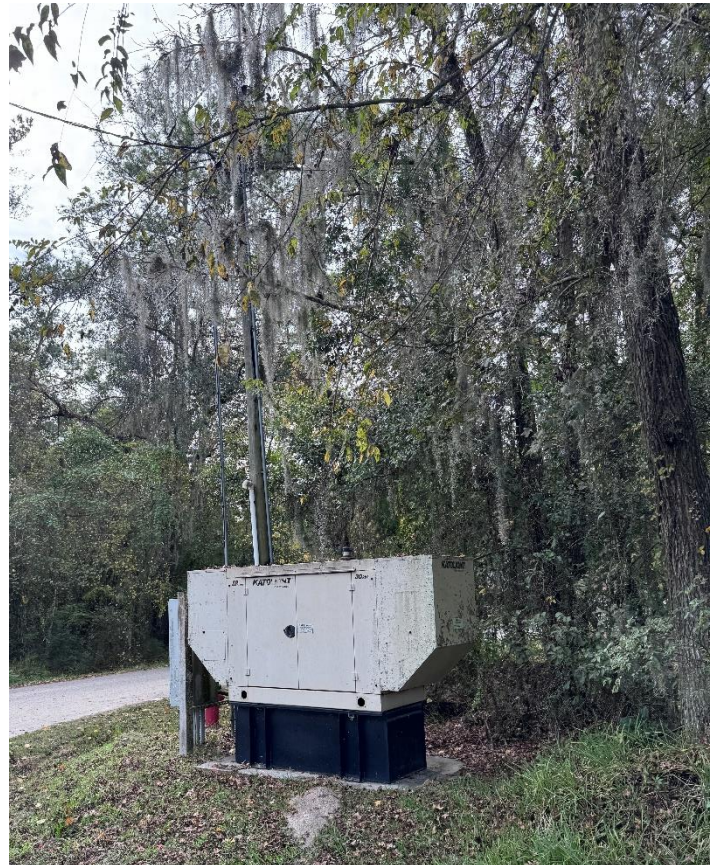
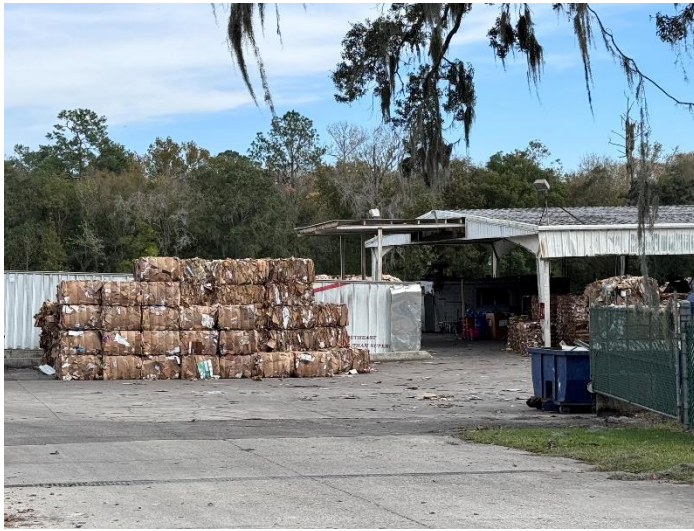
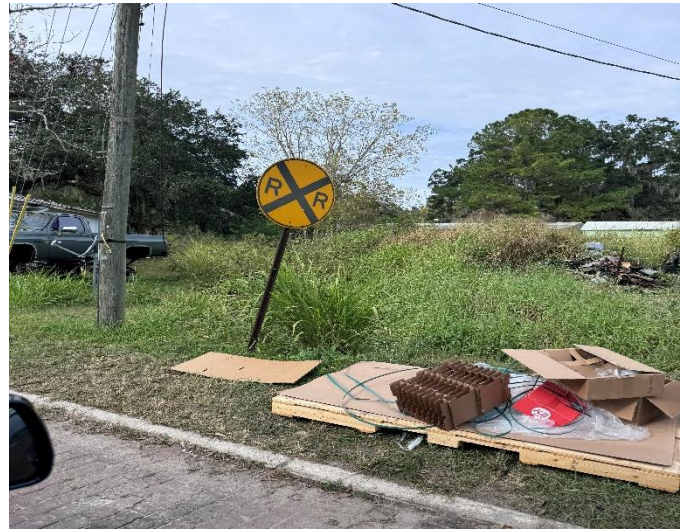
Throughout the Study Area, there are risks for fire due to overgrown vegetation, especially when near overhead powerlines or other electrical power sources. Without regular maintenance to the vegetation, particularly in right-of-way or greenbelt areas, lightning or downed powerlines could easily cause a fire that could spread to surrounding parcels. There is also a diesel generator located along Main Street, near Dr. Martin Luther King Jr. Boulevard, which could cause a potential fire hazard, as it is located near large trees and overgrown brush. One of the properties, which conducts manufacturing along Dr. Martin Luther King Jr. Boulevard, has an electrified piece of equipment which has overgrown vegetation around its base. The property looks to be maintained on an irregular basis which has potential to cause heightened fire risks. Another property has an abandoned filling station on it which can cause risks of fire as well as environmental risks with remaining fuel tanks.

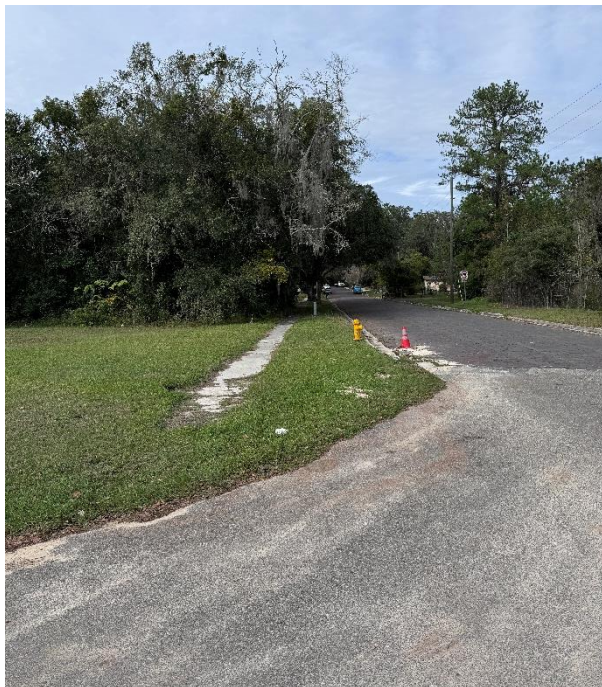
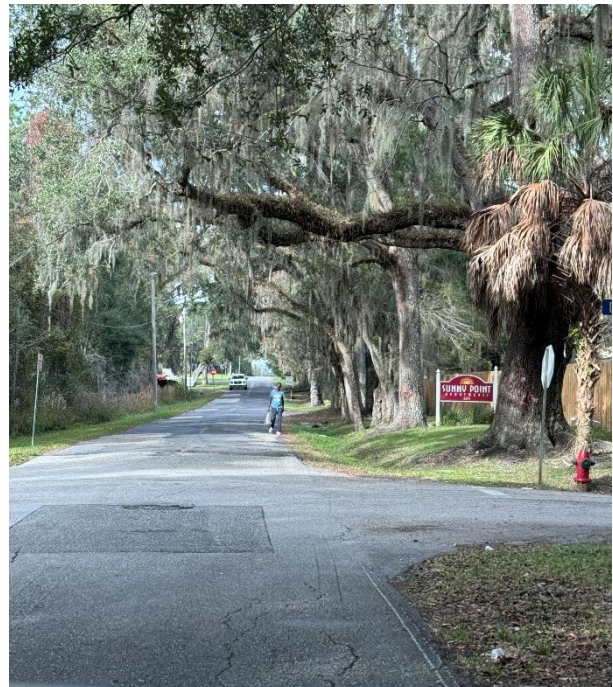
Defective or inadequate street layout is determined by the size and arrangement of transportation infrastructure and supporting facilities. The street layout in the Study Area does not sufficiently serve the lots as many lots south of Martin Luther King Jr. Boulevard do not have public street access. If these lots were to be redeveloped, there would be significant costs to the developer to provide adequate right-of-way and access points. In addition, the pedestrian infrastructure is lacking. Many roads do not have sidewalks, nor marked crossings, and where sidewalks are present, they tend to be in disrepair, as can be seen below. **Figure 2** shows the road layout within the Study Area. The observed defective street layout and roadways facilities within the Study Area satisfy the definition for a condition of “blight.”

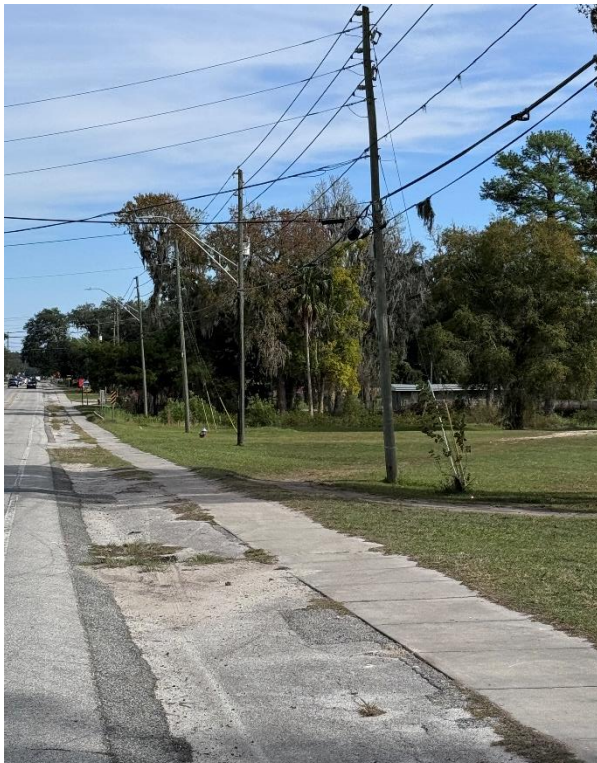
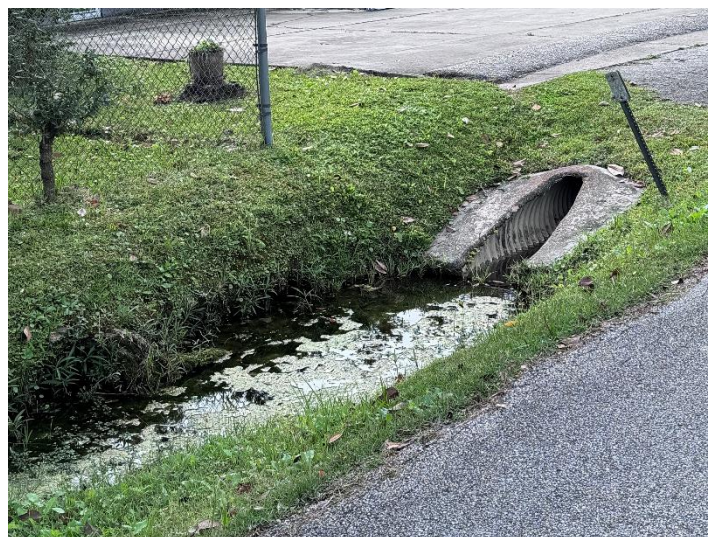
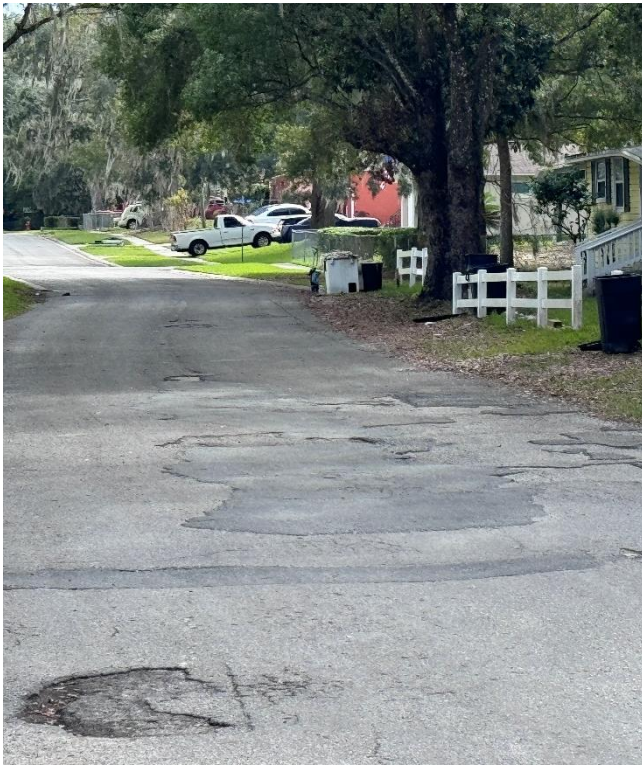
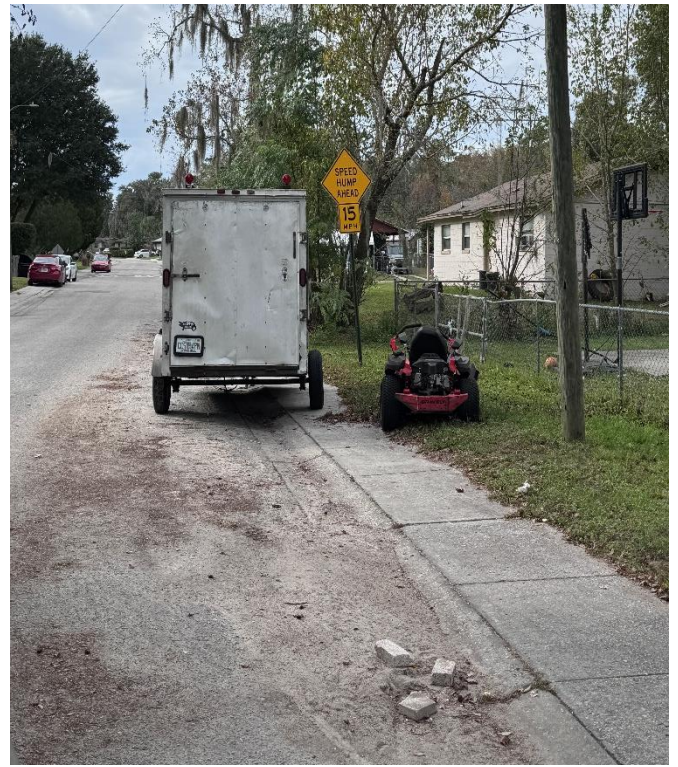
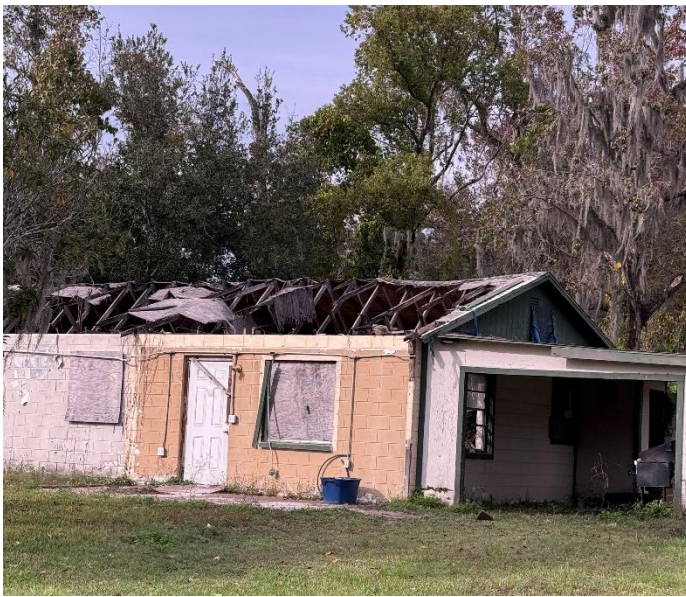
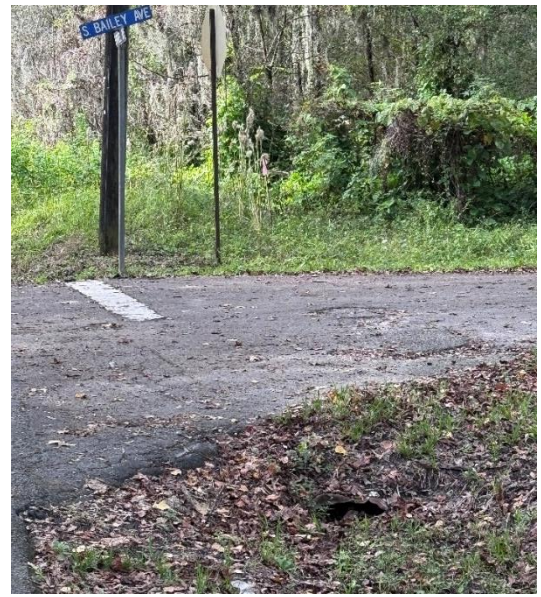
There are several unsafe and unsanitary conditions in the Study Area. Several homes are either abandoned or have been left in a state of disrepair which could be dangerous to the public (trash in the yard, damaged roofs, broken windows, etc.). Some infrastructure in the Study Area also causes unsafe and unsanitary conditions. Roadways are in different states of repair with some roadways not being paved, a lack of shoulders along rights-of-way, and potholes or cracked asphalt. Stormwater infrastructure is also creating unsafe and unsanitary conditions with flooding and standing water which can provide ample breeding grounds for mosquitos and infectious diseases.

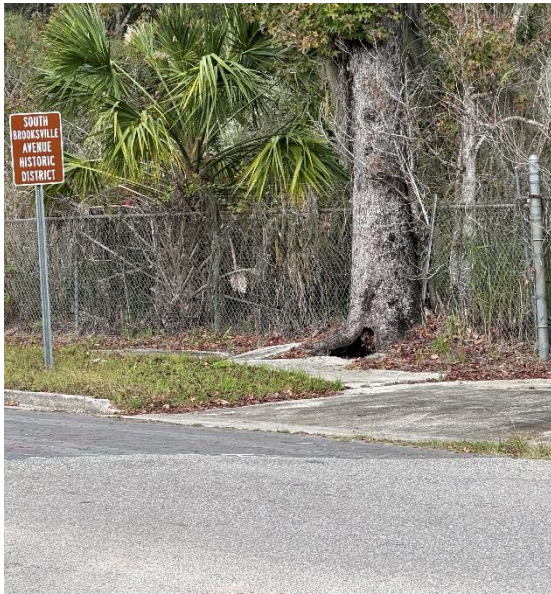
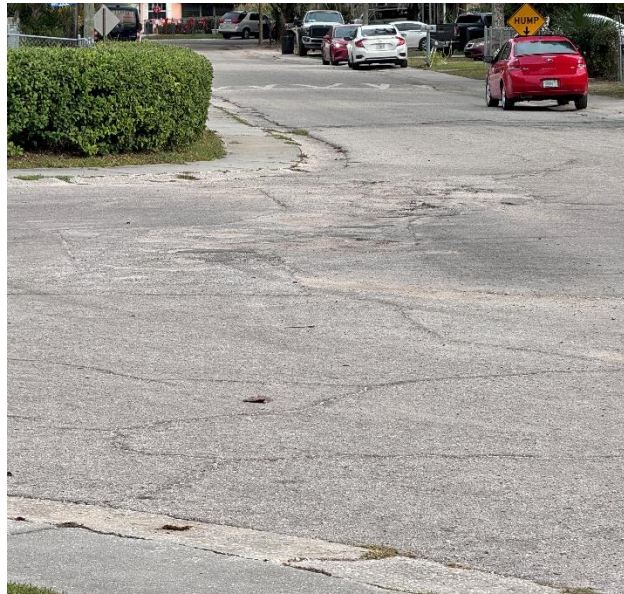
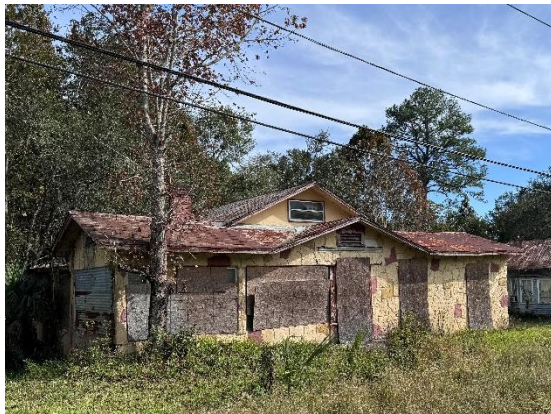
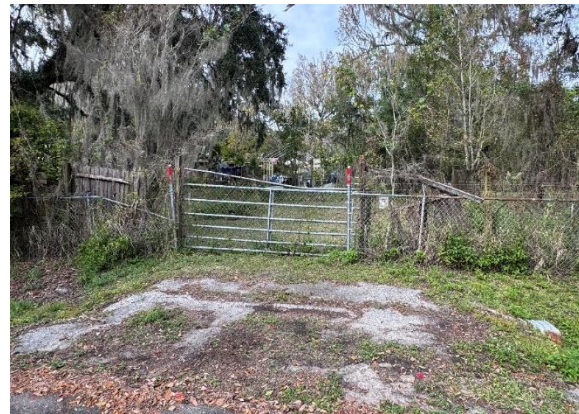
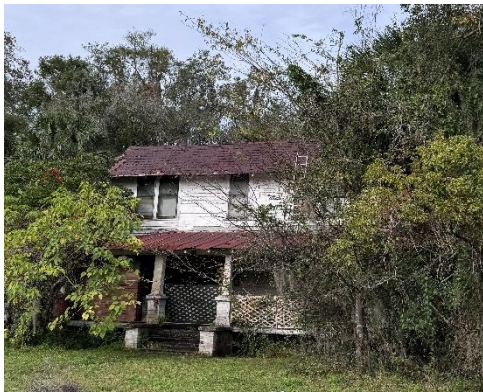
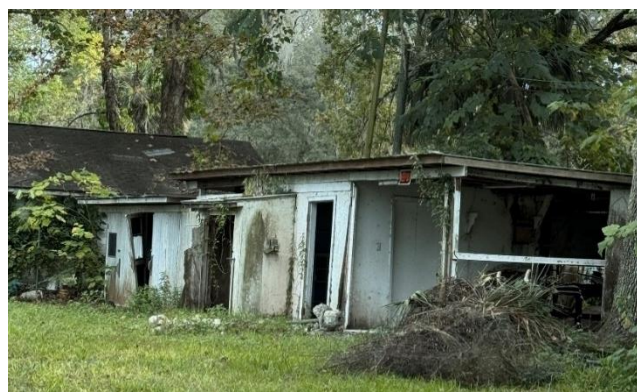
The deterioration of site or other improvements is primarily determined by the physical conditions of buildings or site improvements, including their evaluated useful lives. Deterioration is seen in the roadways, limited pedestrian infrastructure, and residential homes. Many roadways were observed to have potholes and major cracks, and the shoulders of the roads have vegetation growing throughout. Many sidewalks are broken, uneven, and have large holes in them. Residences have overgrown vegetation, damaged roofs, and boarded windows, and some buildings are in complete disrepair with little prospect of renovation. These conditions impact the perception of the Study Area and may prevent business owners or potential residents from choosing to locate in the area. The observed deterioration of sites or other improvements within the Study Area satisfy the definition for a condition of "blight."
