Weeki Wachee River SAV Restoration Project

Month 4 Maintenance Report

FDEP PERMIT NUMBER: 27-0192455-004-EI

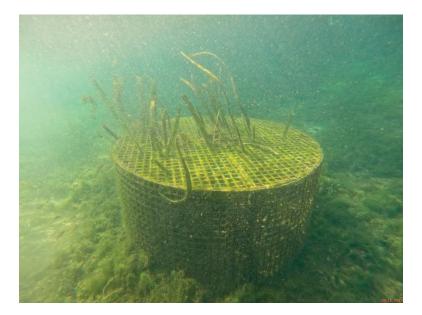
Figure 1. Example of biofouling prior to removal.

The fourth monthly maintenance event for the Weeki Wachee River SAV Restoration Project occurred on September 29th, 2025. The GrowSAV™ Herbivory Exclusion Devices exhibited light to moderate levels of biofouling, consisting mainly of settled sediments and attached filamentous algae. Sea & Shoreline biologists removed biofouling from the top and side mesh on mask and snorkel using stiff-bristled scrub brushes.

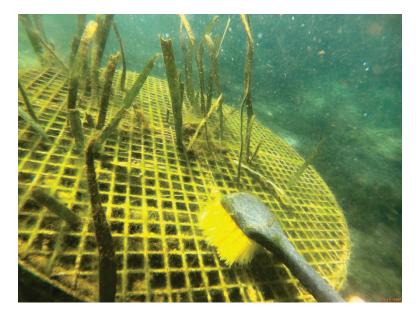
Figure 2. Example of Sea & Shoreline biologist removing biofouling.

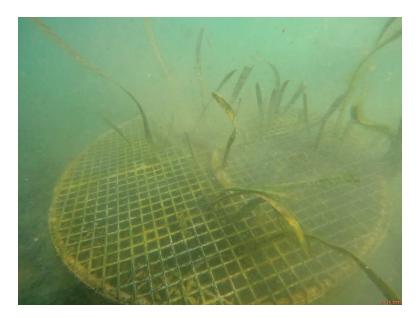
Figure 3. Example of GrowSAV Device after biofouling removal.

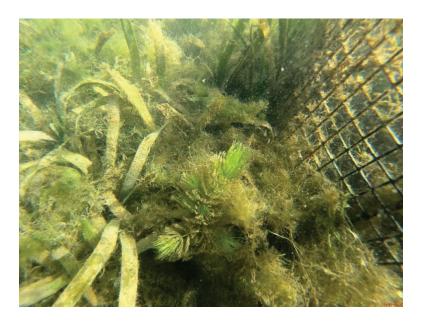
Figure 6. Example of protected units expanding beyond their associated device.

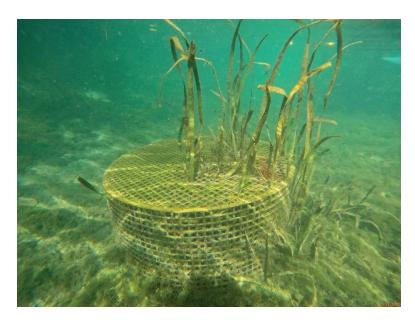
Figure 7. Example of protected units extending beyond their associated device.

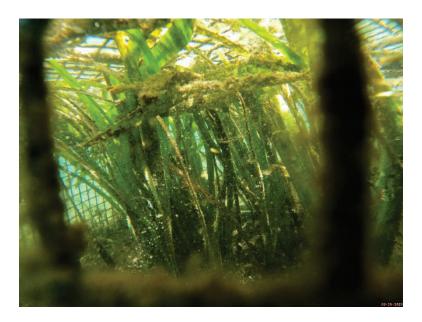
Figure 8. Example of protected planting units.
