Weeki Wachee River SAV Restoration Project

Month 2 Maintenance Report

FDEP PERMIT NUMBER: 27-0192455-004-EI

Prepared On:
August 20th, 2025

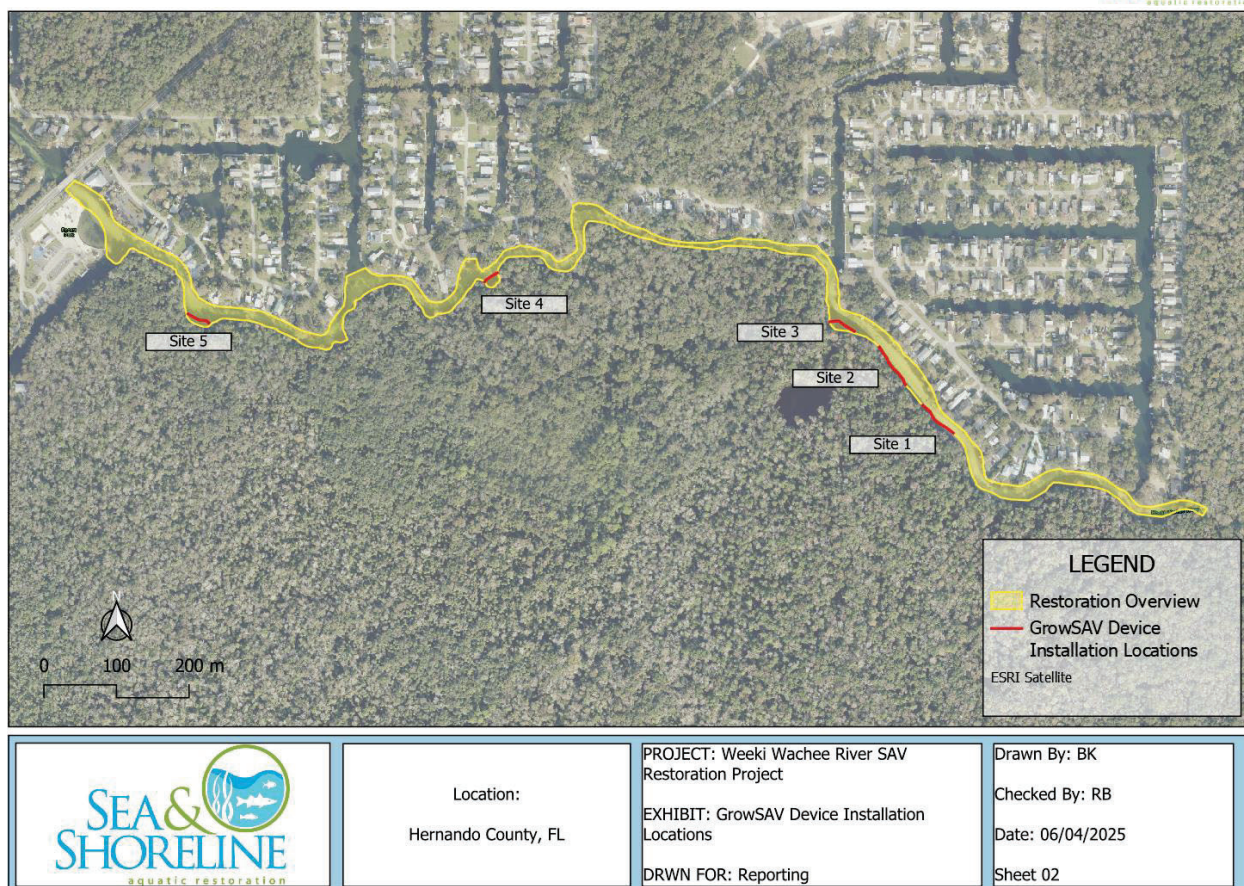
Map 2 – Overview of GrowSAV™ Herbivory Exclusion Device Installation Locations.

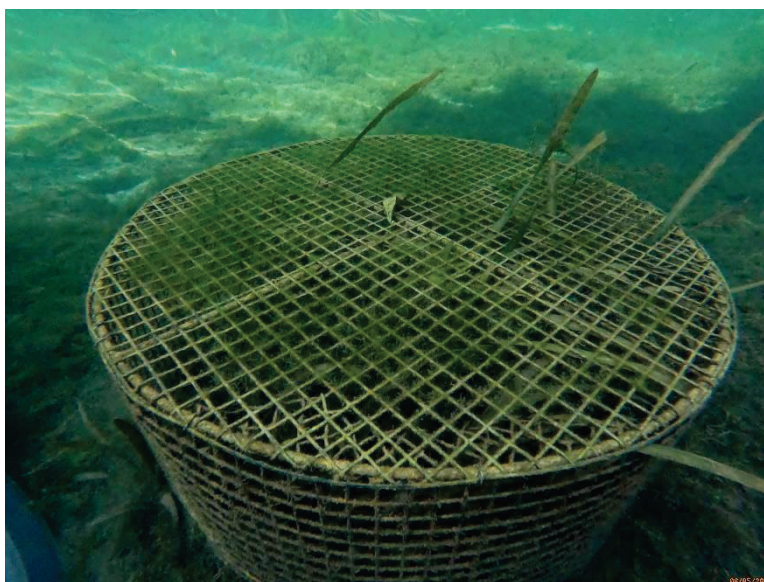
The second monthly maintenance event for the Weeki Wachee River SAV Restoration Project occurred on August 5th, 2025. The GrowSAV™ Herbivory Exclusion Devices exhibited light to moderate levels of biofouling. The biofouling primarily consisted of settled sediments and attached filamentous algae; all devices remained in place. Sea & Shoreline biologists removed biofouling from the top and side mesh on mask and snorkel using stiff-bristled scrub brushes.

Figure 1. Example of biofouling prior to removal.

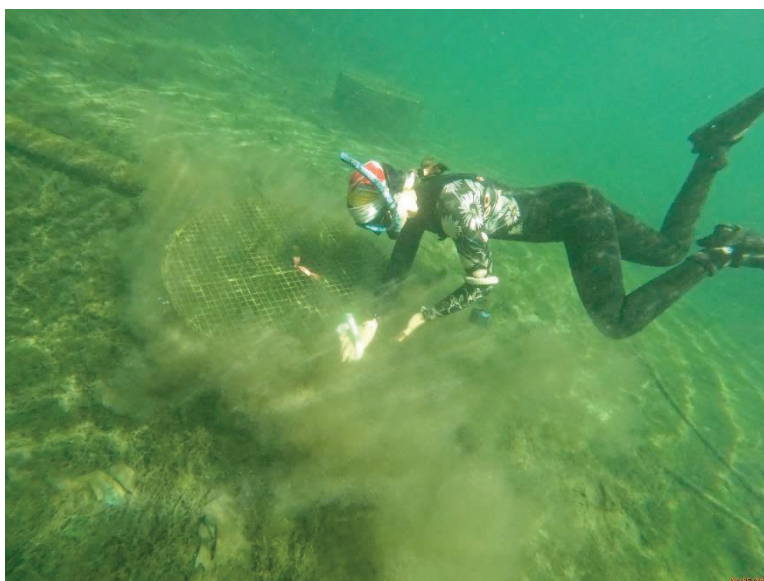
Figure 2. Example of Sea & Shoreline biologist removing biofouling.

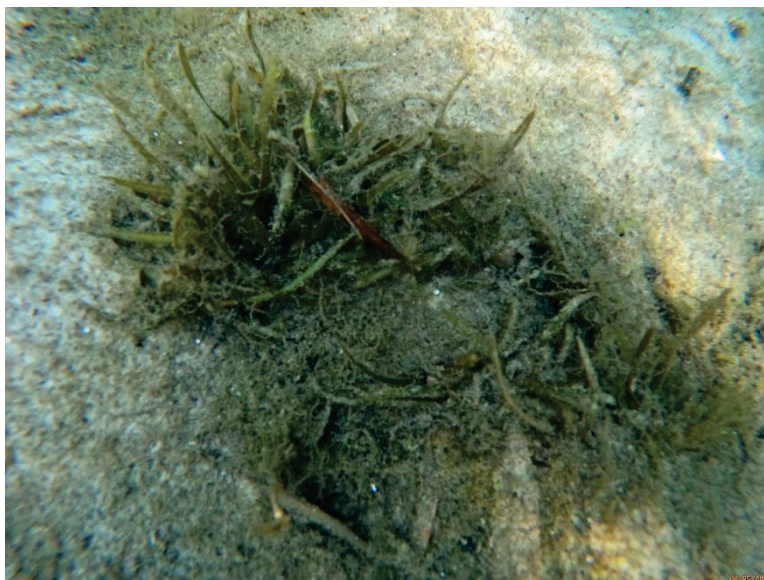
Figure 5. Example of unprotected planting units.

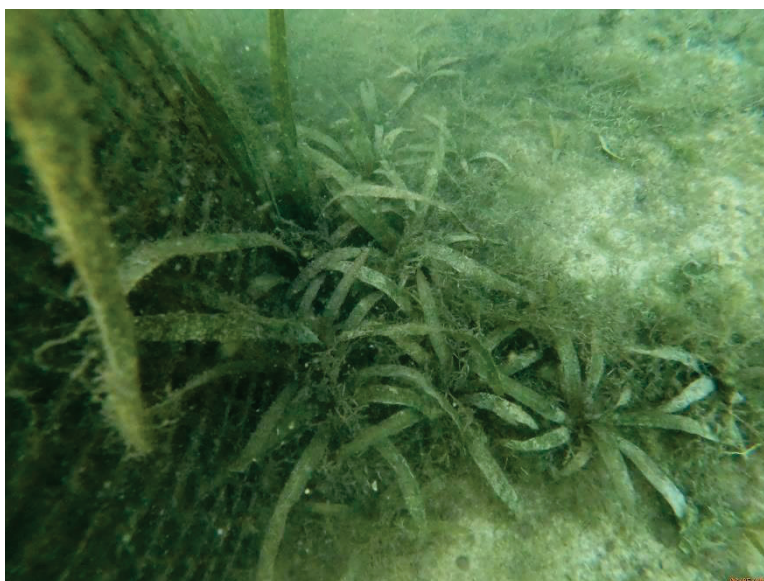
Figure 6. Example of protected units expanding beyond their associated device.

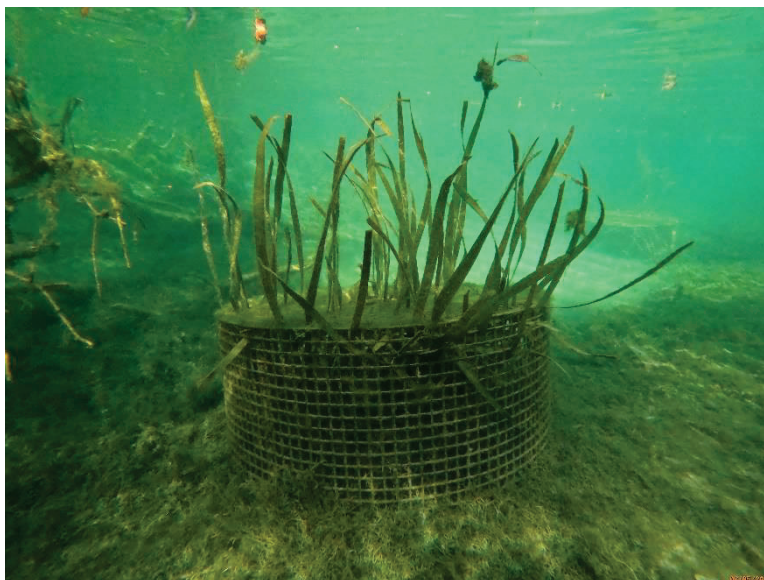
Figure 7. Example of protected units extending beyond their associated device.
