South

BROOKSVILLE

FINDING

NECESSITY

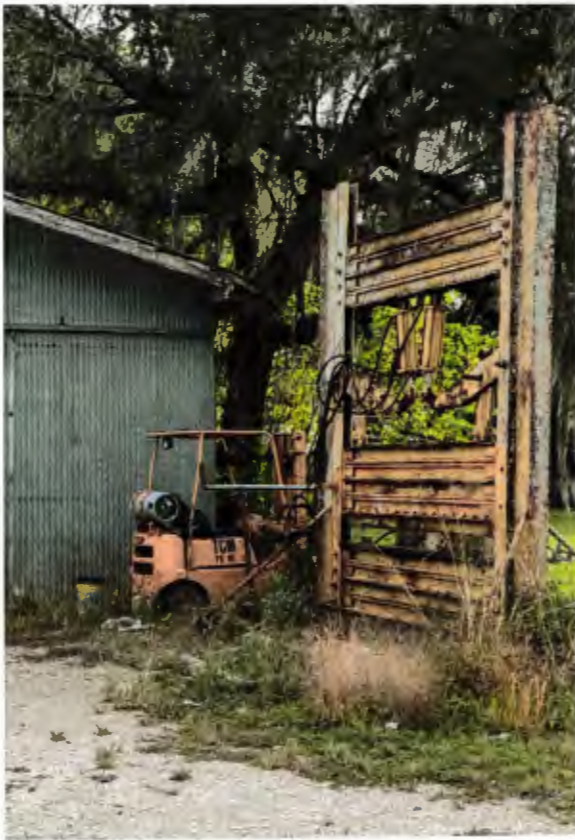
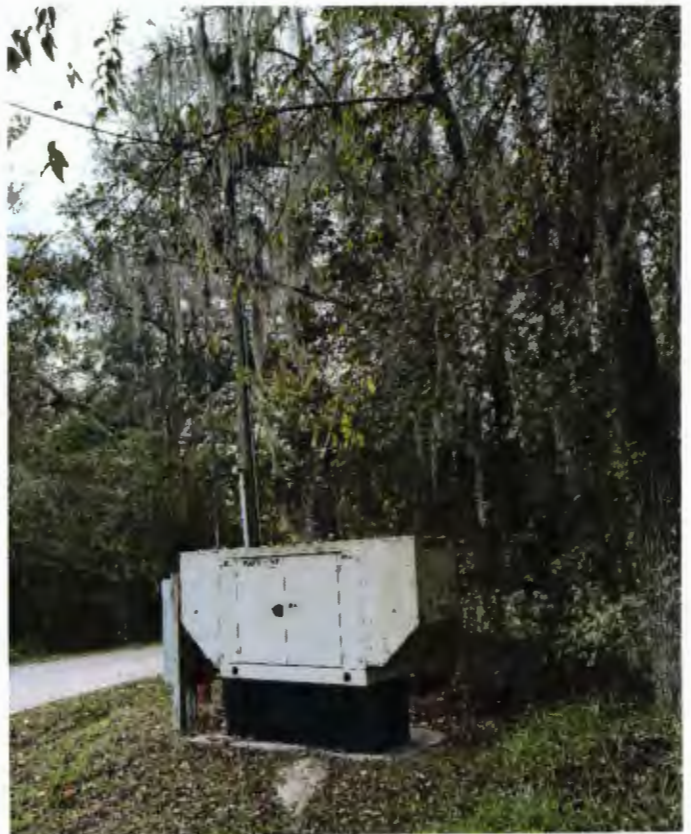
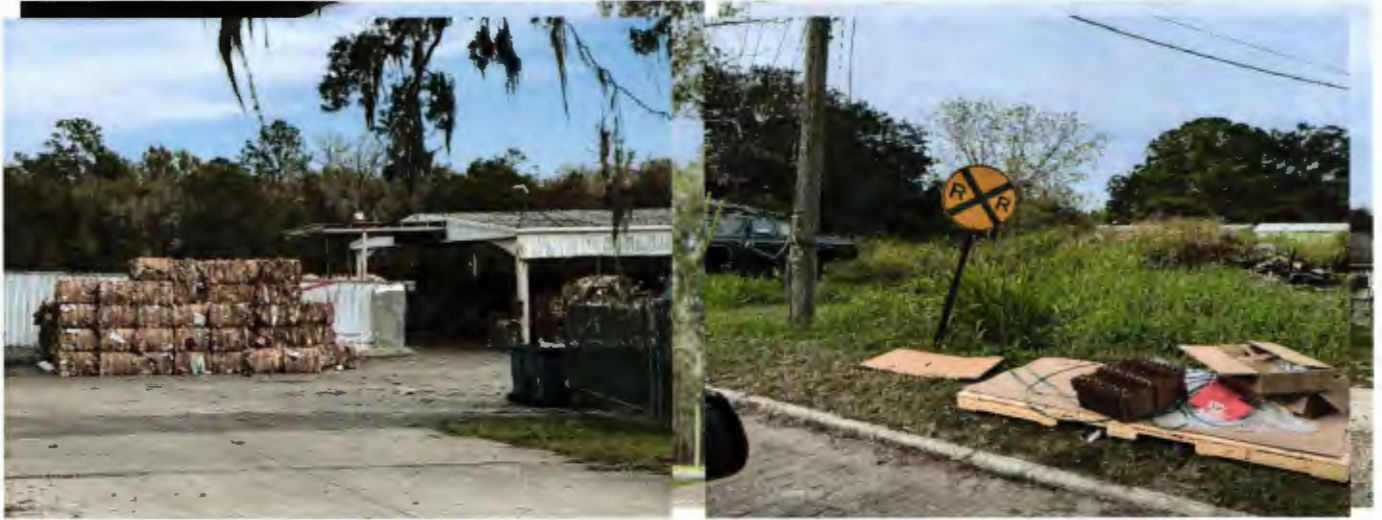
Throughout the Study Area, there are risks for fire due to overgrown vegetation, especially when near overhead powerlines or other electrical power sources. Without regular maintenance to the vegetation, particularly in right-of-way or greenbelt areas, lightning or downed powerlines could easily cause a fire that could spread to surrounding parcels. There is also a diesel generator located along Main Street, near Dr. Martin Luther King Jr. Boulevard, which could cause a potential fire hazard, as it is located near large trees and overgrown brush. One of the properties, which conducts manufacturing along Dr. Martin Luther King Jr. Boulevard, has an electrified piece of equipment which has overgrown vegetation around its base. The property looks to be maintained on an irregular basis which has potential to cause heightened fire risks. Another property has an abandoned filling station on it which can cause risks of fire as well as environmental risks with remaining fuel tanks.

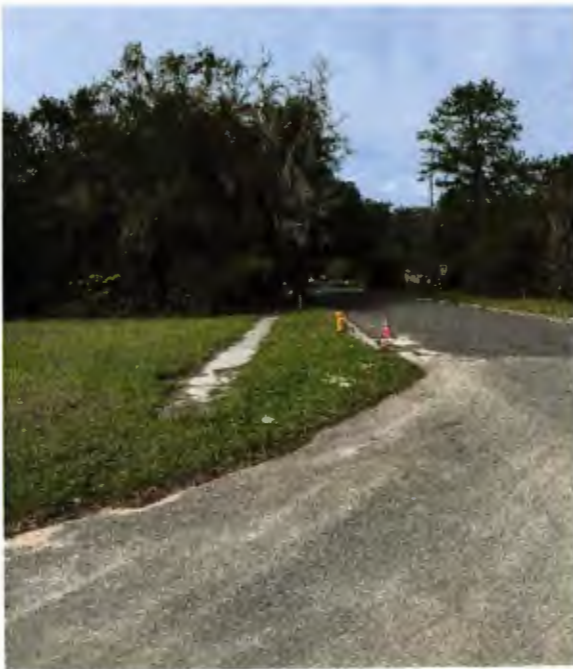
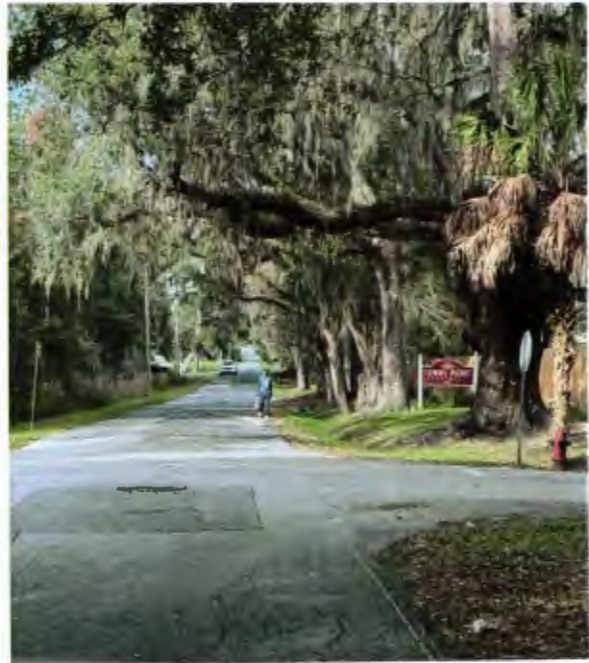
Defective or inadequate street layout is determined by the size and arrangement of transportation infrastructure and supporting facilities. The street layout in the Study Area does not sufficiently serve the lots as many lots south of Martin Luther King Jr. Boulevard do not have public street access. If these lots were to be redeveloped, there would be significant costs to the developer to provide adequate right-of-way and access points. In addition, the pedestrian infrastructure is lacking. Many roads do not have sidewalks, nor marked crossings, and where sidewalks are present, they tend to be in disrepair, as can be seen below. **Figure 2** shows the road layout within the Study Area. The observed defective street layout and roadways facilities within the Study Area satisfy the definition for a condition of "blight."

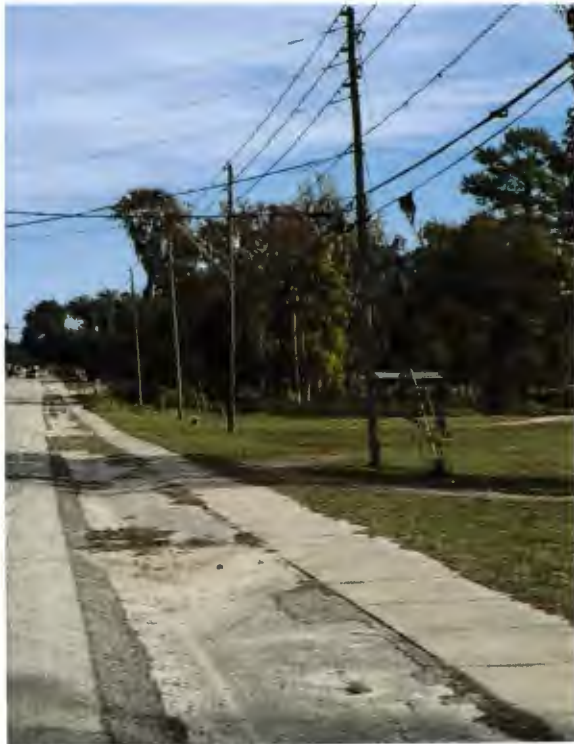
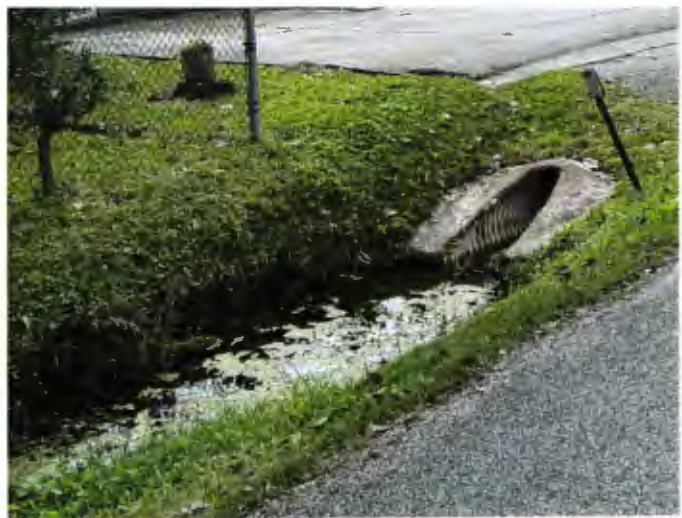
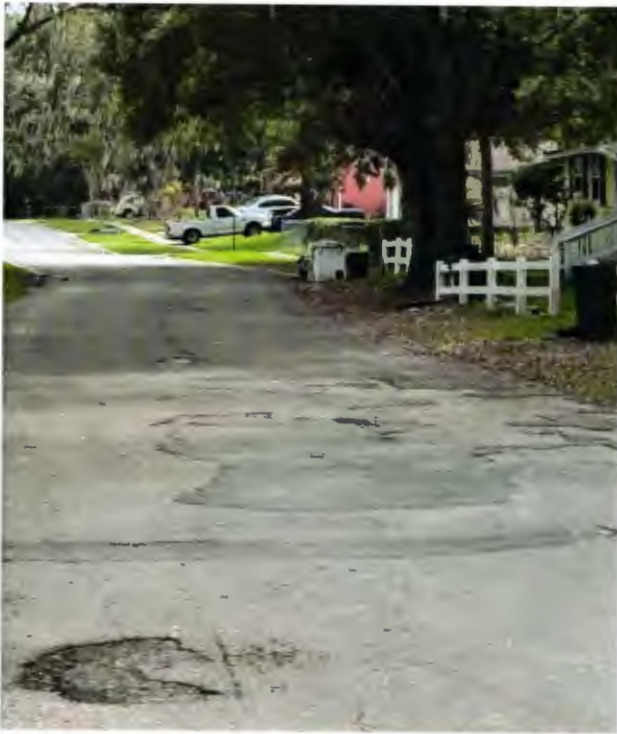
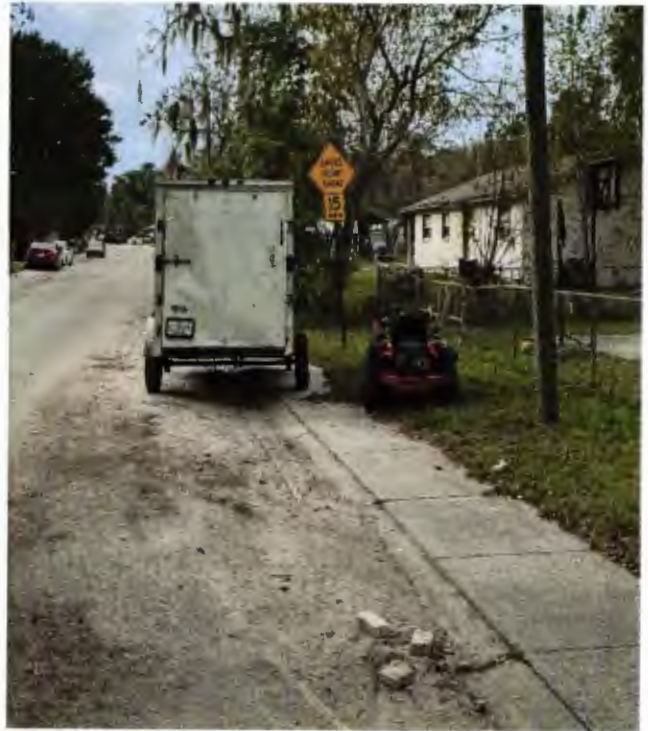
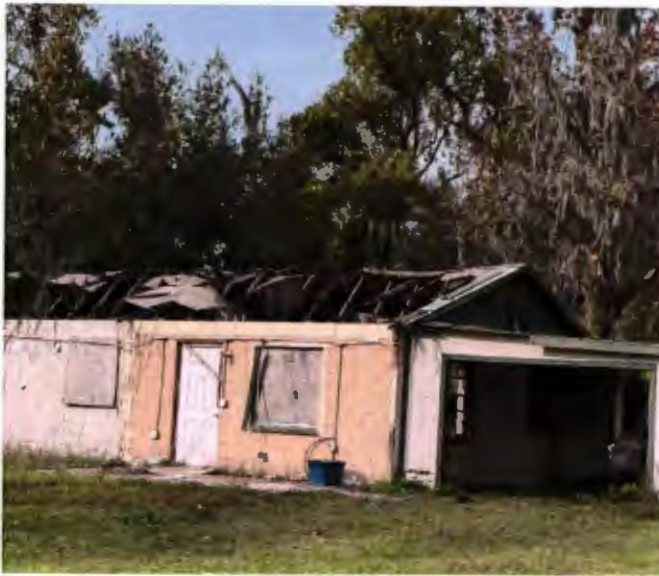
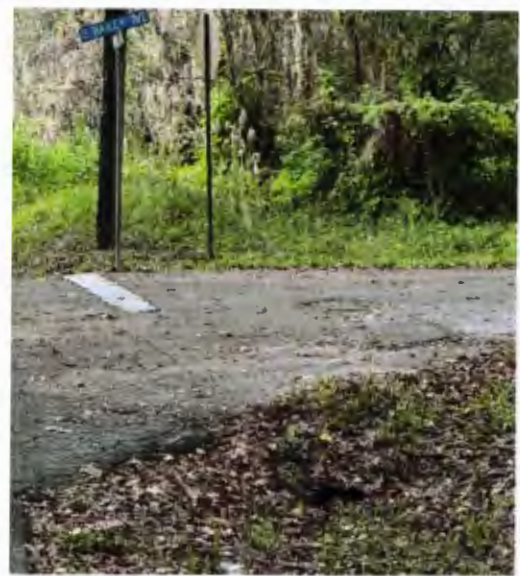
There are several unsafe and unsanitary conditions in the Study Area. Several homes are either abandoned or have been left in a state of disrepair which could be dangerous to the public (trash in the yard, damaged roofs, broken windows, etc.). Some infrastructure in the Study Area also causes unsafe and unsanitary conditions. Roadways are in different states of repair with some roadways not being paved, a lack of shoulders along rights-of-way, and potholes or cracked asphalt. Stormwater infrastructure is also creating unsafe and unsanitary conditions with flooding and standing water which can provide ample breeding grounds for mosquitos and infectious diseases.

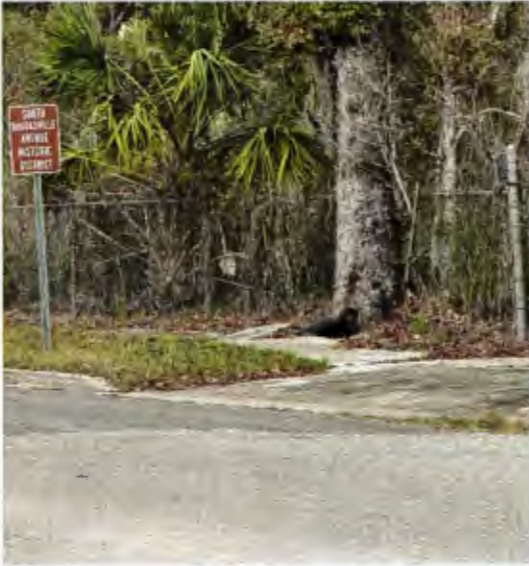
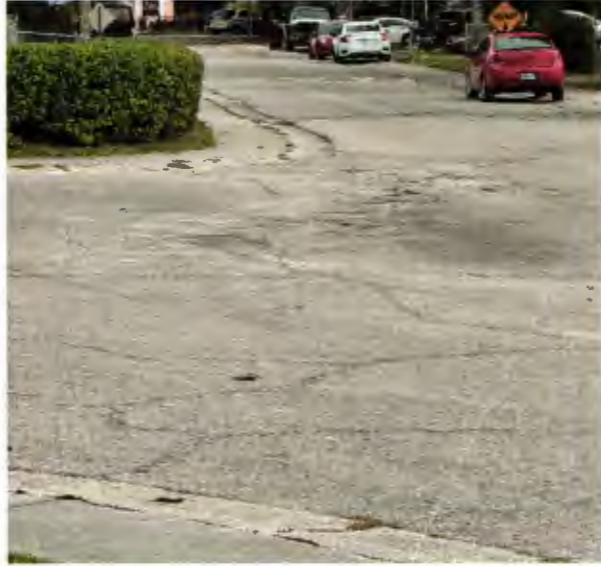
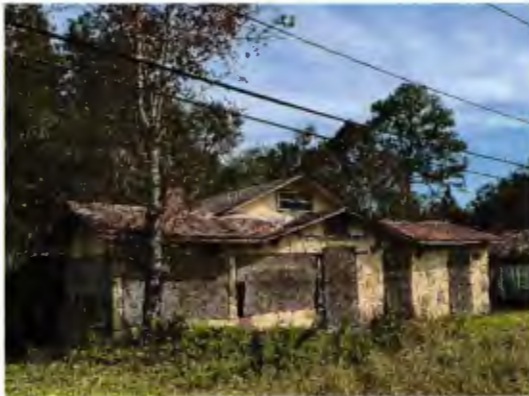
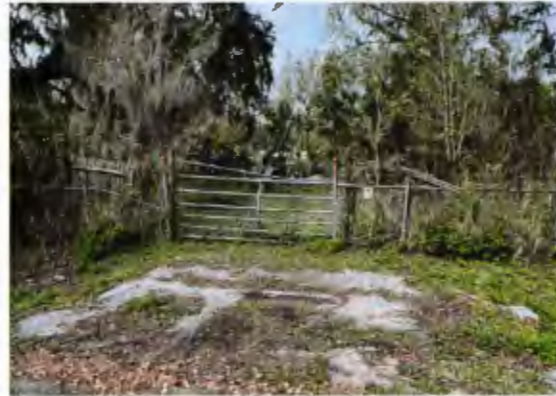
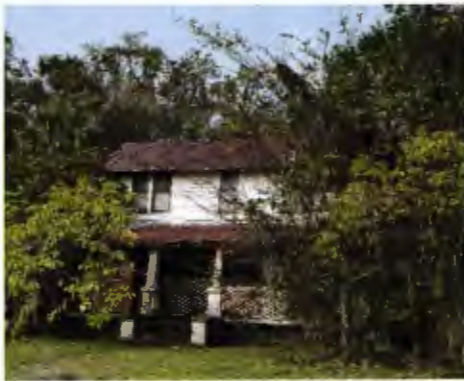
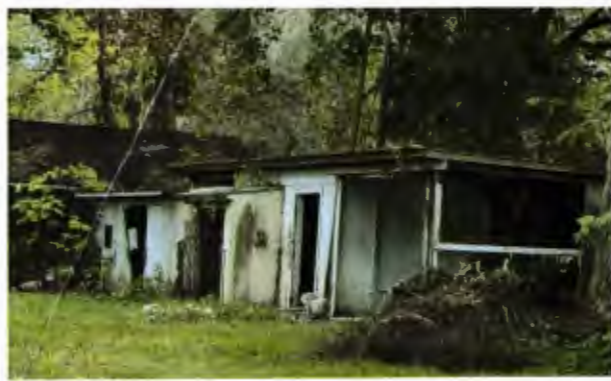
The deterioration of site or other improvements is primarily determined by the physical conditions of buildings or site improvements, including their evaluated useful lives. Deterioration is seen in the roadways, limited pedestrian infrastructure, and residential homes. Many roadways were observed to have potholes and major cracks, and the shoulders of the roads have vegetation growing throughout. Many sidewalks are broken, uneven, and have large holes in them. Residences have overgrown vegetation, damaged roofs, and boarded windows, and some buildings are in complete disrepair with little prospect of renovation. These conditions impact the perception of the Study Area and may prevent business owners or potential residents from choosing to locate in the area. The observed deterioration of sites or other improvements within the Study Area satisfy the definition for a condition of "blight."
