South

BROOKSVILLE

FINDING

NECESSITY

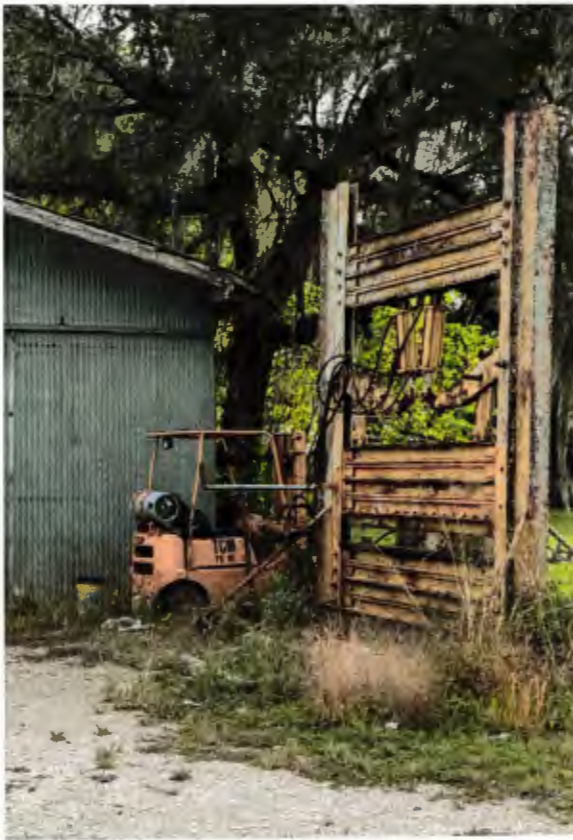
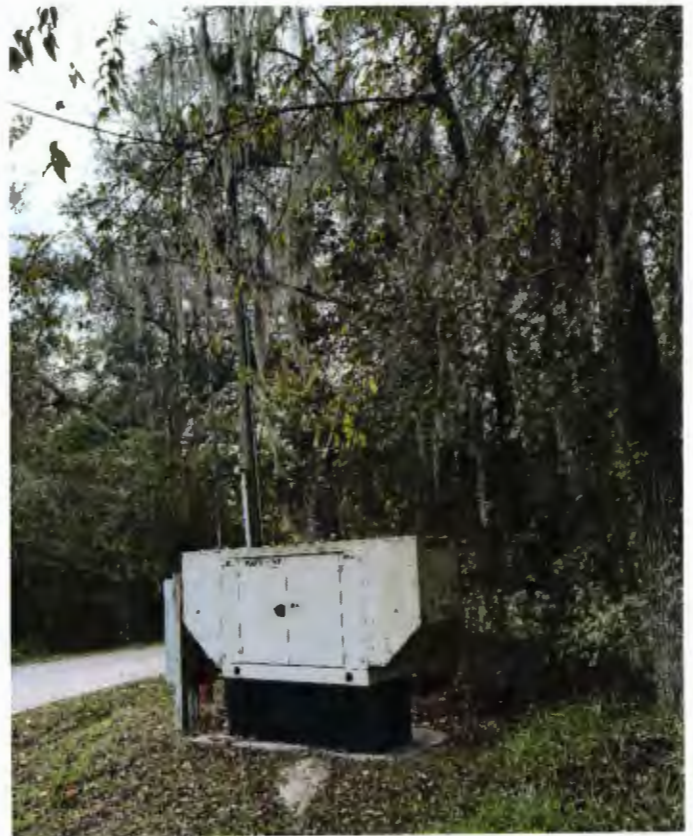
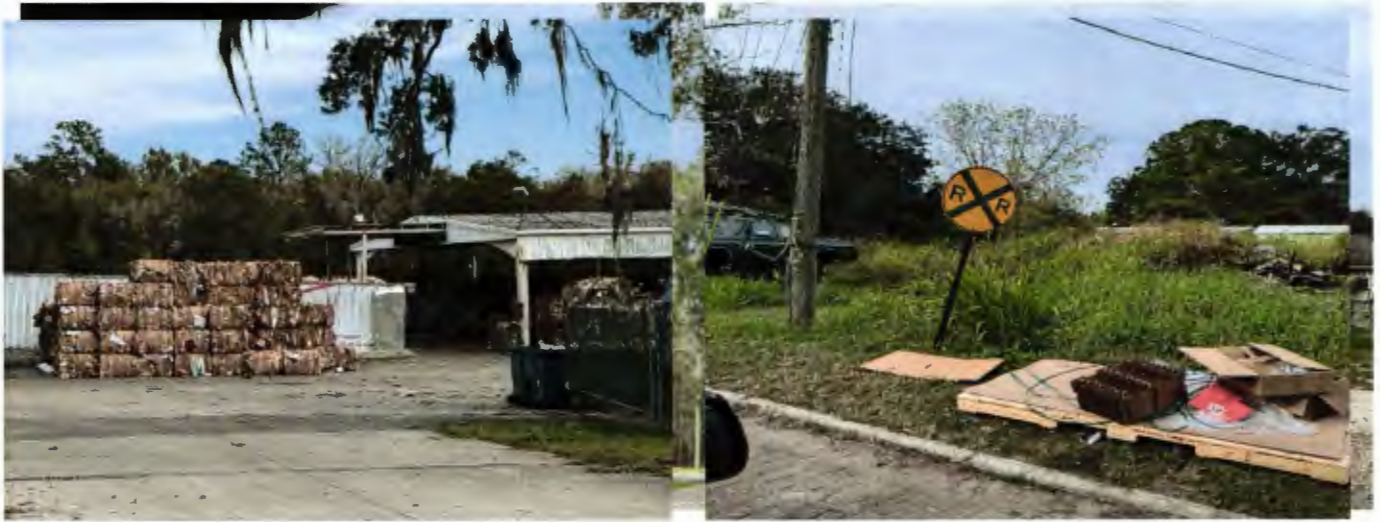
Throughout the Study Area, there are risks for fire due to overgrown vegetation, especially when near overhead powerlines or other electrical power sources. Without regular maintenance to the vegetation, particularly in right-of-way or greenbelt areas, lightning or downed powerlines could easily cause a fire that could spread to surrounding parcels. There is also a diesel generator located along Main Street, near Dr. Martin Luther King Jr. Boulevard, which could cause a potential fire hazard, as it is located near large trees and overgrown brush. One of the properties, which conducts manufacturing along Dr. Martin Luther King Jr. Boulevard, has an electrified piece of equipment which has overgrown vegetation around its base. The property looks to be maintained on an irregular basis which has potential to cause heightened fire risks. Another property has an abandoned filling station on it which can cause risks of fire as well as environmental risks with remaining fuel tanks.

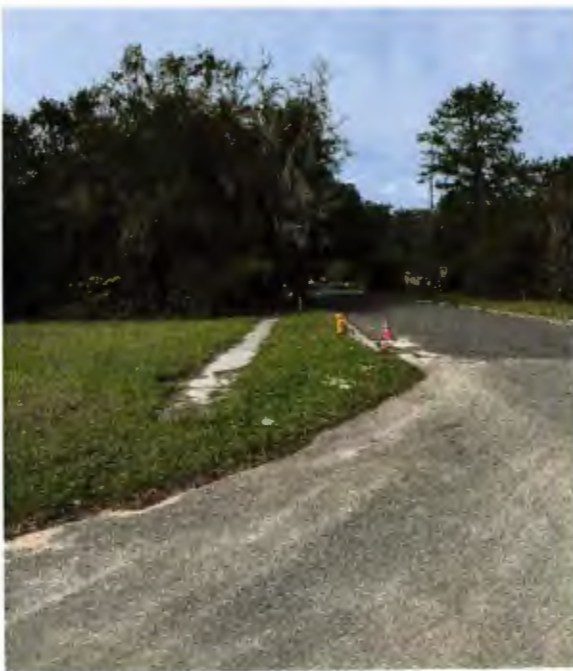
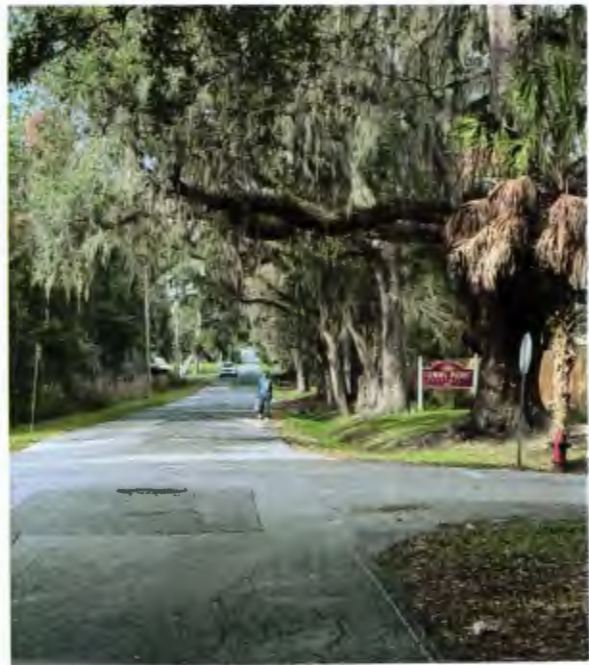
Defective or inadequate street layout is determined by the size and arrangement of transportation infrastructure and supporting facilities. The street layout in the Study Area does not sufficiently serve the lots as many lots south of Martin Luther King Jr. Boulevard do not have public street access. If these lots were to be redeveloped, there would be significant costs to the developer to provide adequate right-of-way and access points. In addition, the pedestrian infrastructure is lacking. Many roads do not have sidewalks, nor marked crossings, and where sidewalks are present, they tend to be in disrepair, as can be seen below. **Figure 2** shows the road layout within the Study Area. The observed defective street layout and roadways facilities within the Study Area satisfy the definition for a condition of "blight."

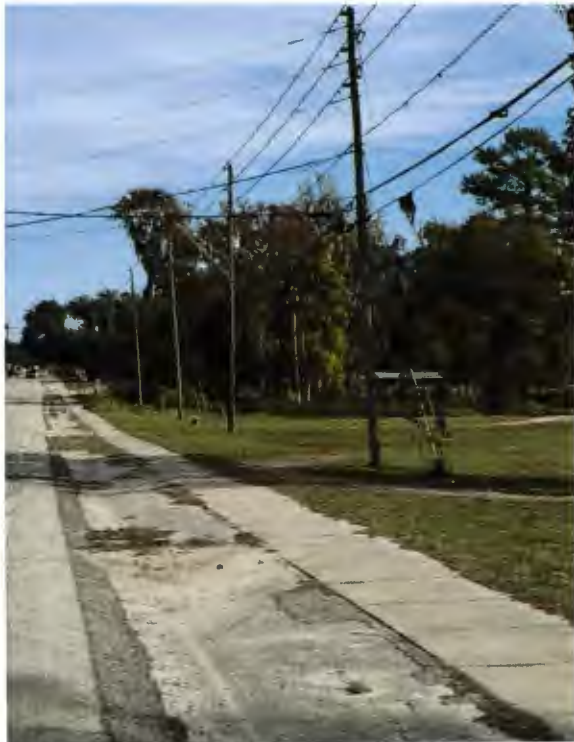
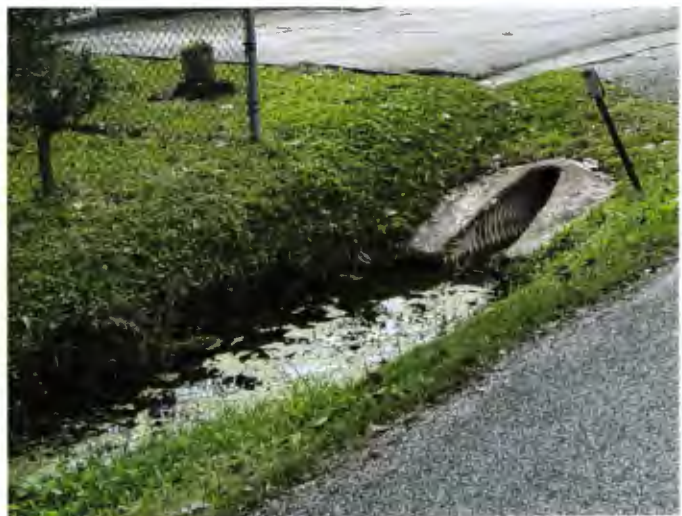
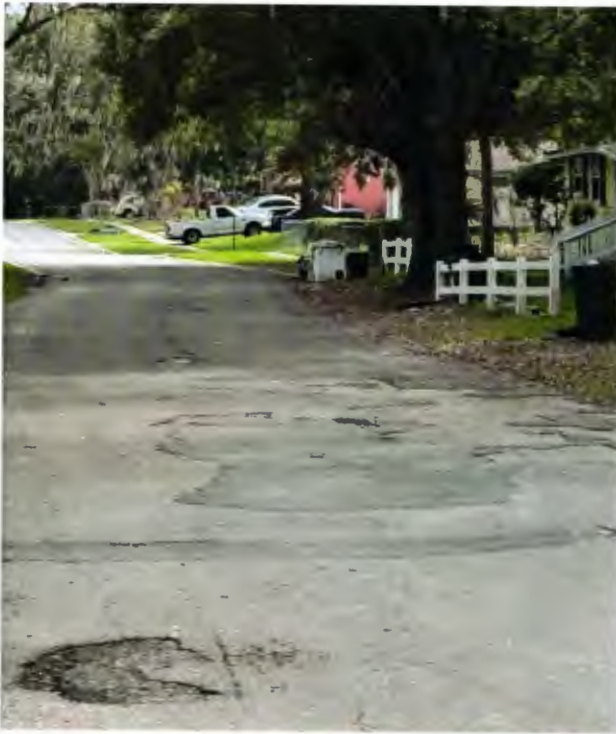
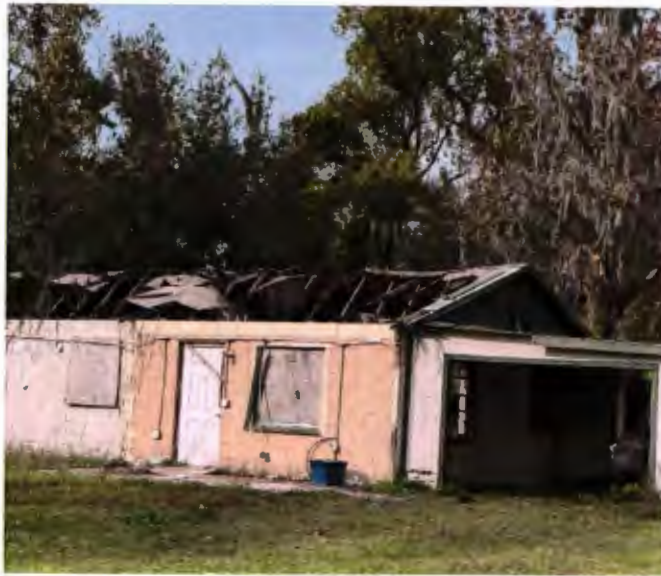
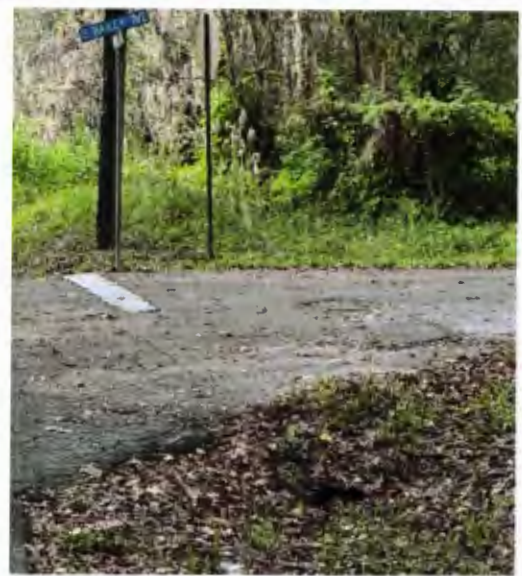
There are several unsafe and unsanitary conditions in the Study Area. Several homes are either abandoned or have been left in a state of disrepair which could be dangerous to the public (trash in the yard, damaged roofs, broken windows, etc.). Some infrastructure in the Study Area also causes unsafe and unsanitary conditions. Roadways are in different states of repair with some roadways not being paved, a lack of shoulders along rights-of-way, and potholes or cracked asphalt. Stormwater infrastructure is also creating unsafe and unsanitary conditions with flooding and standing water which can provide ample breeding grounds for mosquitos and infectious diseases.
