Weeki Wachee River SAV Restoration Project

Month 3 Maintenance Report

Prepared On: August 27th, 2025

Prepared By: Sea & Shoreline, LLC 4331 Cockroach Bay Rd Ruskin, FL 33570

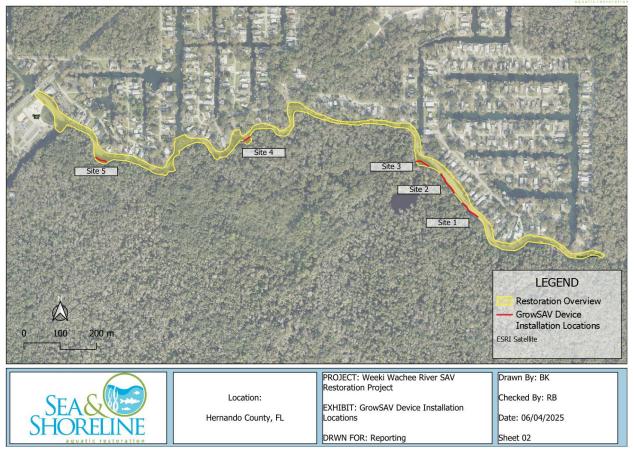
Map 2 – Overview of GrowSAV™ Herbivory Exclusion Device Installation Locations.

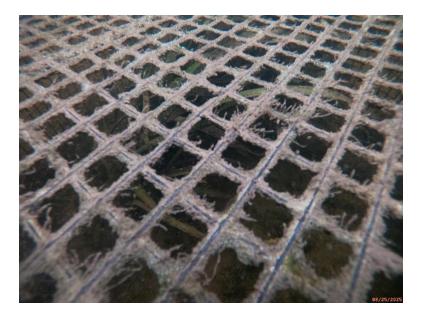
The third monthly maintenance event for the Weeki Wachee River SAV Restoration Project occurred on August 25th, 2025. The GrowSAV™ Herbivory Exclusion Devices exhibited light to moderate levels of biofouling, consisting mainly of settled sediments and attached filamentous algae. Sea & Shoreline biologists removed biofouling from the top and side mesh on mask and snorkel using stiff-bristled scrub brushes.

Figure 1. Example of biofouling prior to removal.

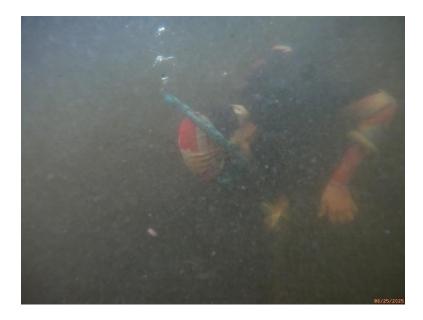
Figure 2. Example of Sea & Shoreline biologist removing biofouling.

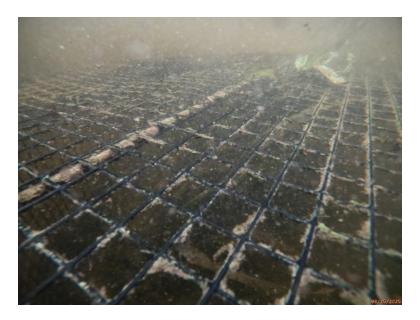
Figure 3. Example of GrowSAV Device after biofouling removal.

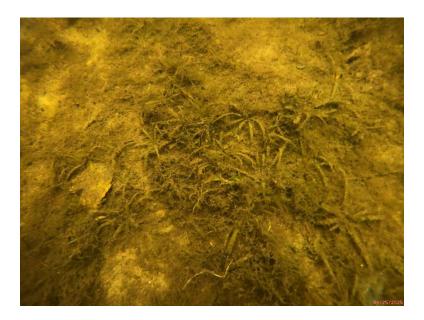
Just three months after installation, both unprotected and protected planting units are showing very encouraging signs of growth and expansion throughout the river. Again, it is estimated that *V. neotropicalis* is present in 130/132 (98%) of the GrowSAV™ Herbivory Exclusion Devices, with coverages ranging from 1 to 4 on the Braun-Blanquet coverage scale. The blade height of protected units varies from 20 to 75 cm, with some units extending well beyond the top of their associated device (**Figure 7**). Signs of lateral expansion beyond protective devices were also observed throughout approximately 70% of devices (**Figure 6**). Protected planting units still have greater blade heights than the surrounding unprotected units, which is expected due to grazing pressure in the area. Despite this, blade heights of unprotected units range anywhere from 5 to 25 cm, with an average of 10 cm. Visible signs of lateral expansion were observed in unprotected planting units throughout the restoration footprint (**Figure 4**).

Figure 4. Example of unprotected units showing signs of lateral expansion.

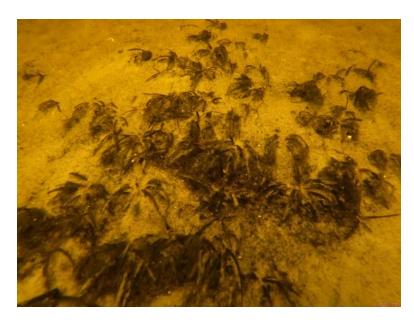
Figure 5. Example of unprotected planting units.

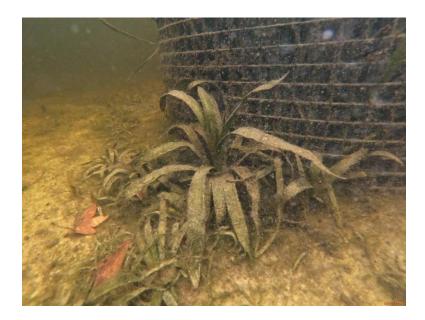
Figure 6. Example of protected units expanding beyond their associated device.

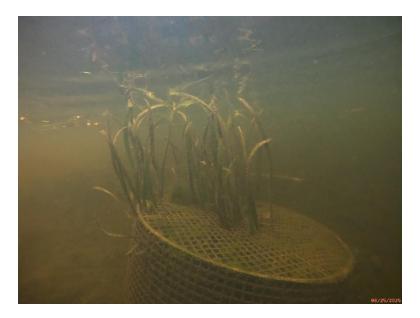
Figure 7. Example of protected units extending beyond their associated device.

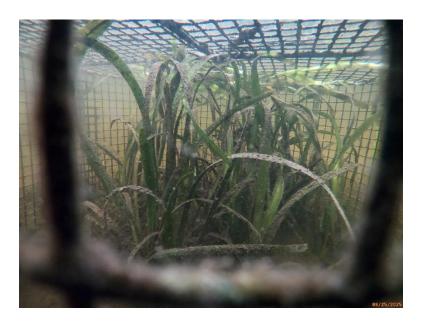
Figure 8. Example of protected planting units.
