## **Weeki Wachee River SAV Restoration Project**

### **Month 3 Maintenance Report**

FDEP PERMIT NUMBER: 27-0192455-004-EI

Prepared On:  
August 27<sup>th</sup>, 2025

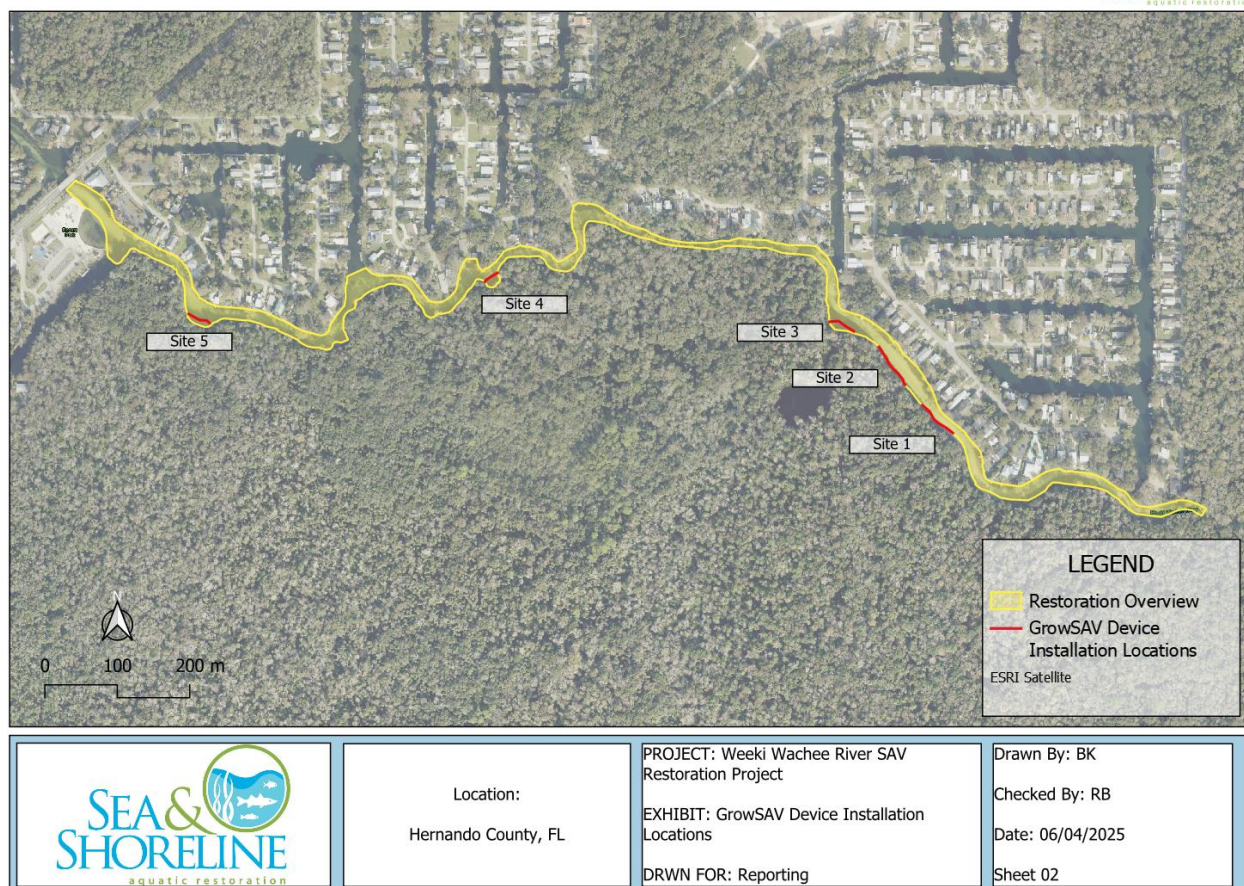
**Map 2 – Overview of GrowSAV™ Herbivory Exclusion Device Installation Locations.**

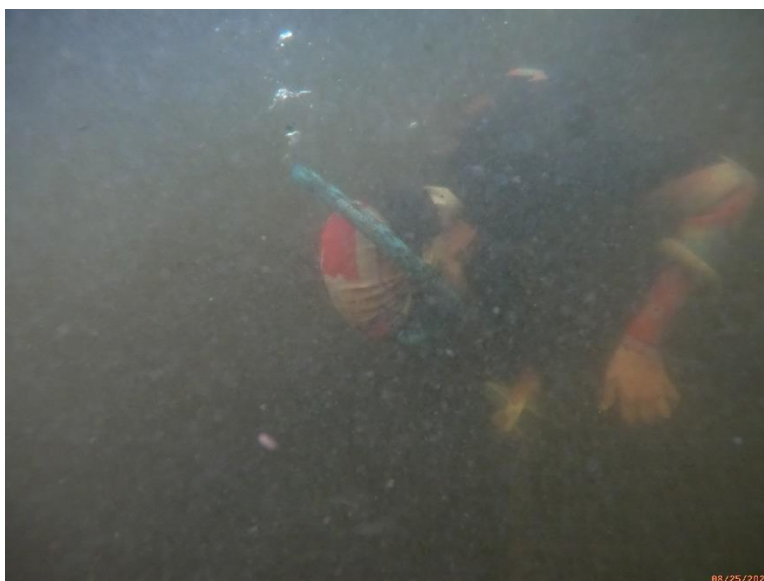
The third monthly maintenance event for the Weeki Wachee River SAV Restoration Project occurred on August 25<sup>th</sup>, 2025. The GrowSAV™ Herbivory Exclusion Devices exhibited light to moderate levels of biofouling, consisting mainly of settled sediments and attached filamentous algae. Sea & Shoreline biologists removed biofouling from the top and side mesh on mask and snorkel using stiff-bristled scrub brushes.

**Figure 2.** Example of Sea & Shoreline biologist removing biofouling.

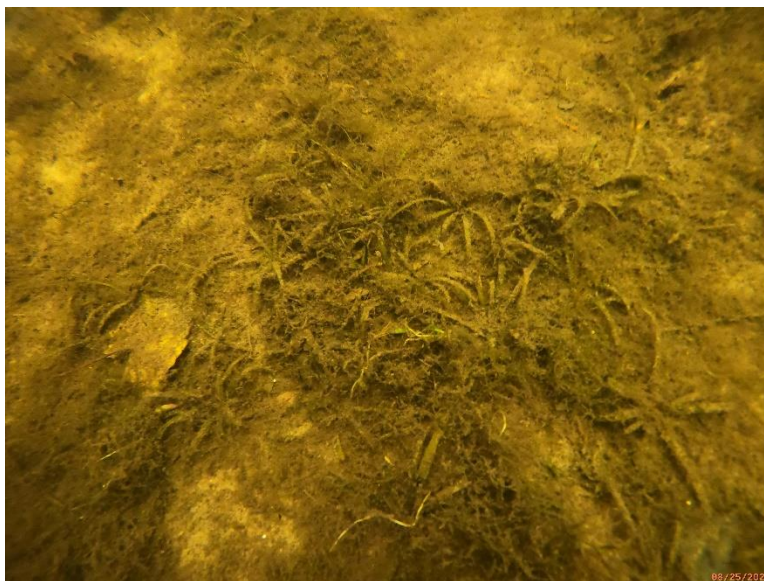
Just three months after installation, both unprotected and protected planting units are showing very encouraging signs of growth and expansion throughout the river. Again, it is estimated that *V. neotropicalis* is present in 130/132 (98%) of the GrowSAV™ Herbivory Exclusion Devices, with coverages ranging from 1 to 4 on the Braun-Blanquet coverage scale. The blade height of protected units varies from 20 to 75 cm, with some units extending well beyond the top of their associated device (**Figure 7**). Signs of lateral expansion beyond protective devices were also observed throughout approximately 70% of devices (**Figure 6**). Protected planting units still have greater blade heights than the surrounding unprotected units, which is expected due to grazing pressure in the area. Despite this, blade heights of unprotected units range anywhere from 5 to 25 cm, with an average of 10 cm. Visible signs of lateral expansion were observed in unprotected planting units throughout the restoration footprint (**Figure 4**).

**Figure 4.** Example of unprotected units showing signs of lateral expansion.

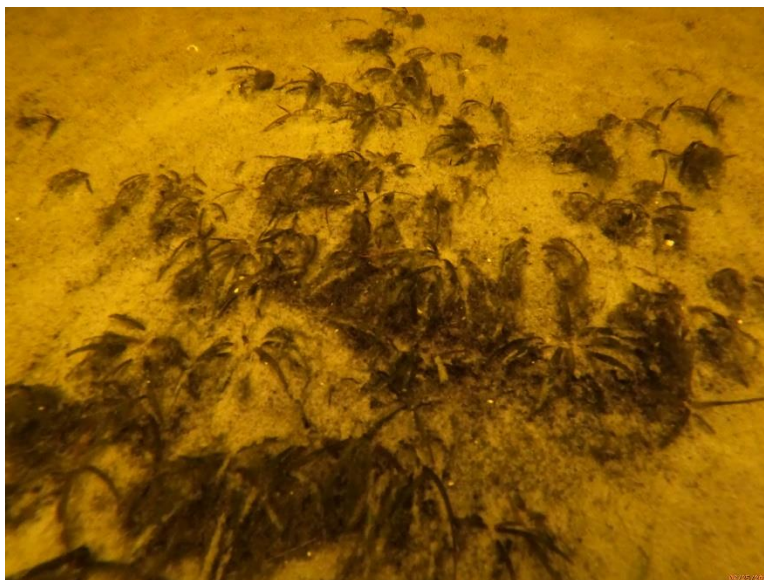
**Figure 5.** Example of unprotected planting units.

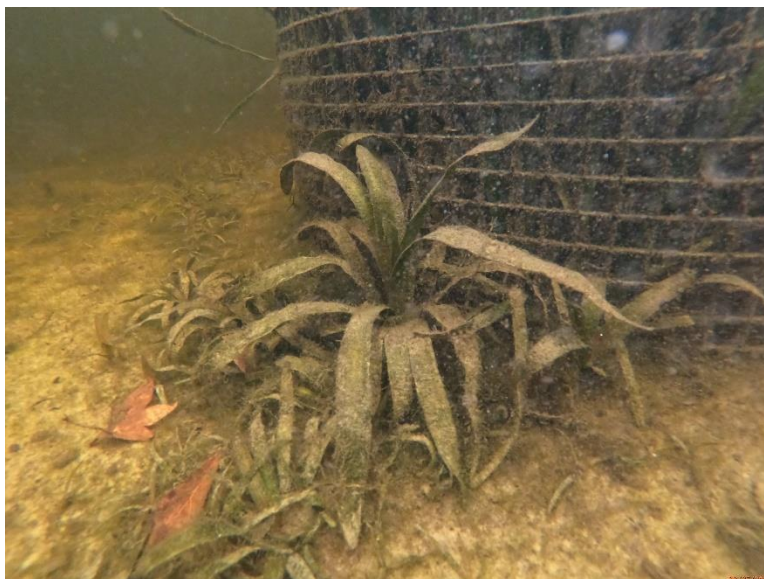
**Figure 6.** Example of protected units expanding beyond their associated device.

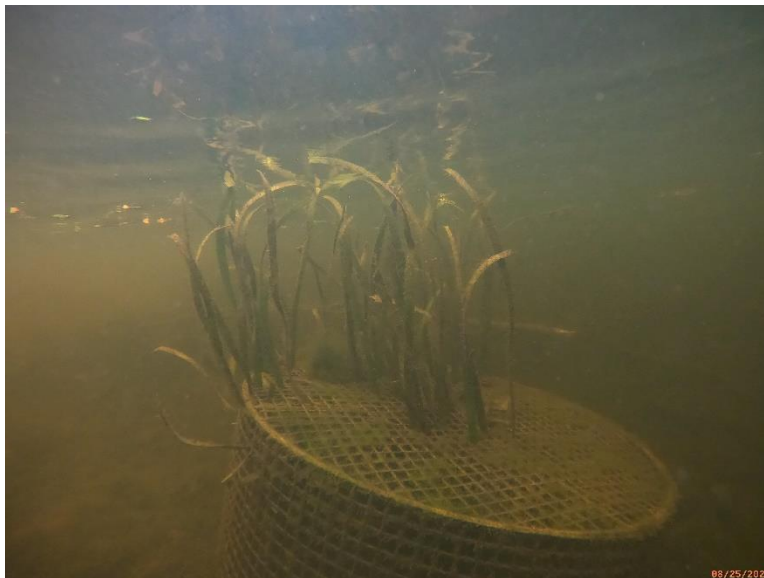
**Figure 7.** Example of protected units extending beyond their associated device.

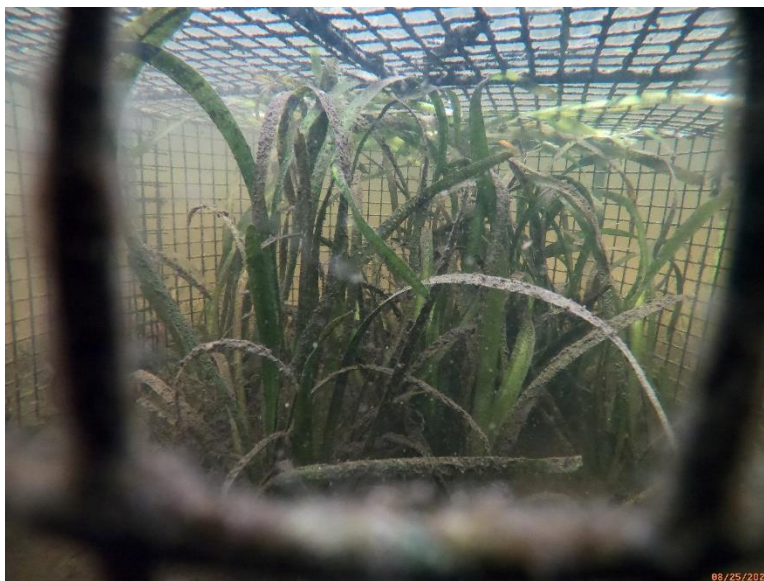
**Figure 8.** Example of protected planting units.
