## Weeki Wachee River SAV Restoration Project

### Month 6 Maintenance & Supplemental Planting Report

FDEP PERMIT NUMBER: 27-0192455-004-EI

USACE PERMIT NUMBER: SAJ-2019-01203

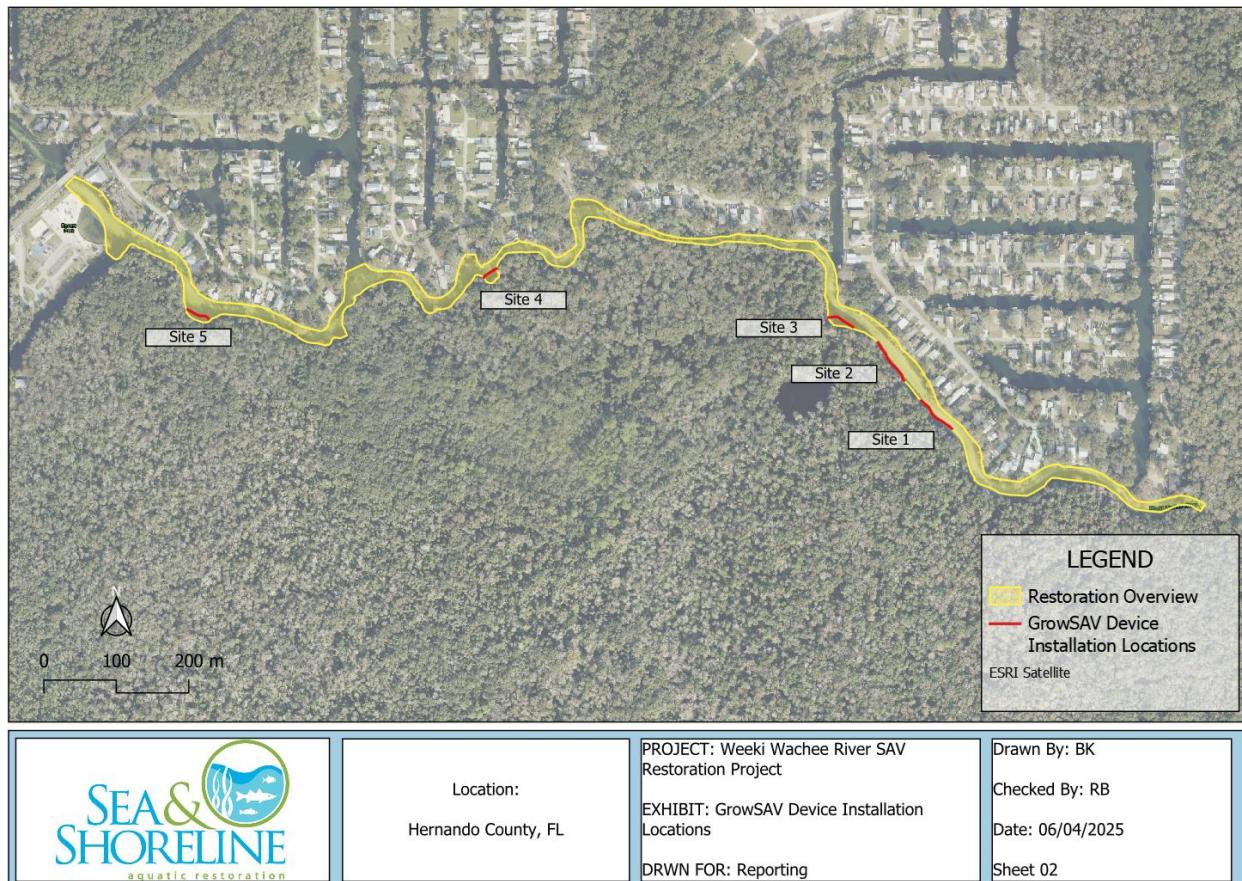
**Map 2 – Overview of GrowSAV™ Herbivory Exclusion Device Installation Locations.**

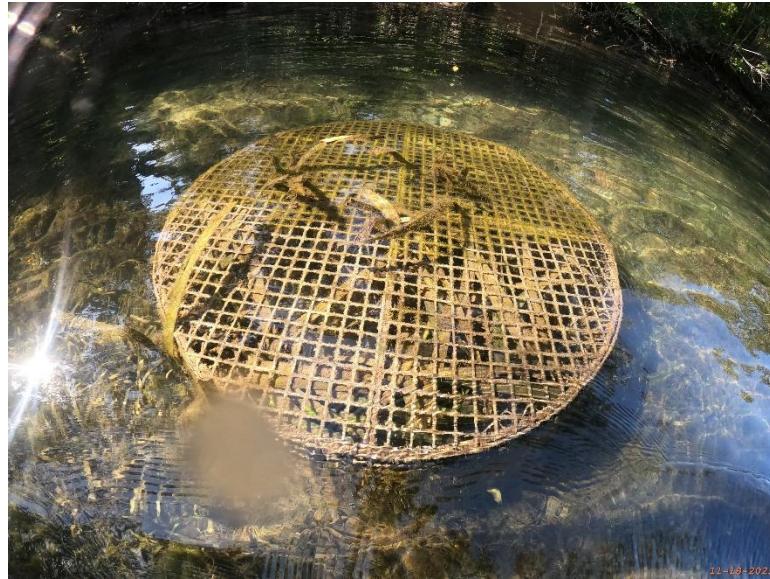
**Figure 1.** Example of biofouling prior to removal.

The sixth monthly maintenance event for the Weeki Wachee River SAV Restoration Project occurred on November 18<sup>th</sup>, 2025. The GrowSAV™ Herbivory Exclusion Devices exhibited light levels of biofouling, consisting mainly of settled sediments, filamentous algae and entrapped leaf litter. Sea & Shoreline biologists removed biofouling from the top and side mesh on mask and snorkel using stiff-bristled scrub brushes.

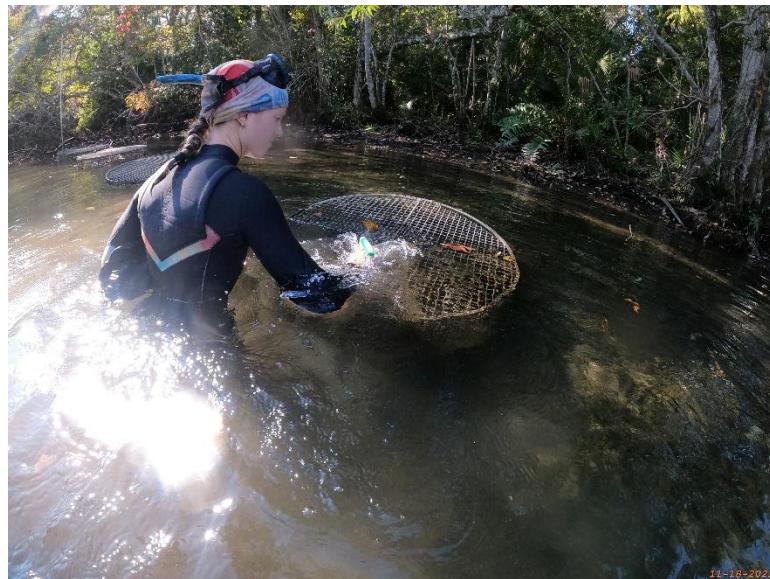
**Figure 2.** Example of Sea & Shoreline biologist removing biofouling.

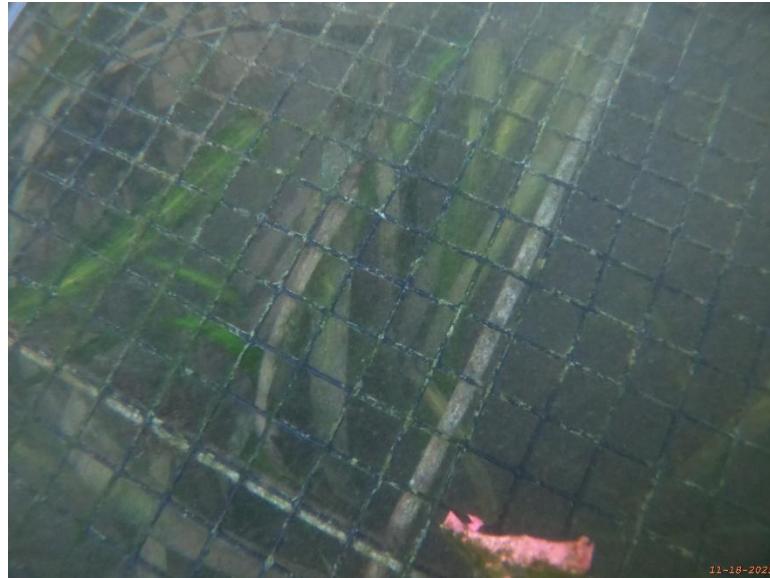
**Figure 3.** Example of GrowSAV Device after biofouling removal.

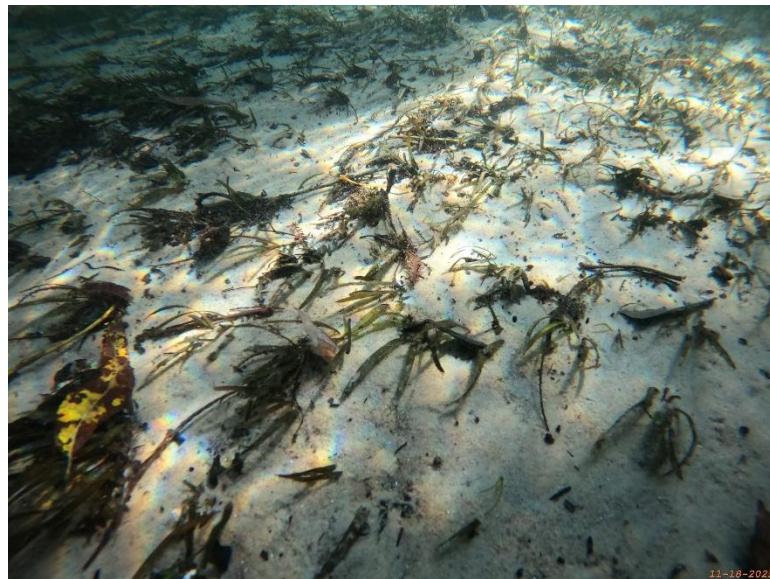
The blade height of protected units varies from 30 cm to 90 cm, with most units extending well beyond the top of their associated device. Signs of lateral expansion beyond protective devices were also observed throughout approximately 90% of devices, with some units expanding up to 5 feet from their device (**Figure 6**). Visible signs of lateral expansion were observed in unprotected planting units and new growth was observed in certain areas throughout the restoration footprint (**Figures 4 & 5**). New growth of unprotected units has taken off throughout deeper, more protected areas, however; no significant increases in canopy height have been noted. Canopy height of unprotected units ranged from 2-15 cm.

**Figure 4.** Example of unprotected units showing signs of lateral expansion.

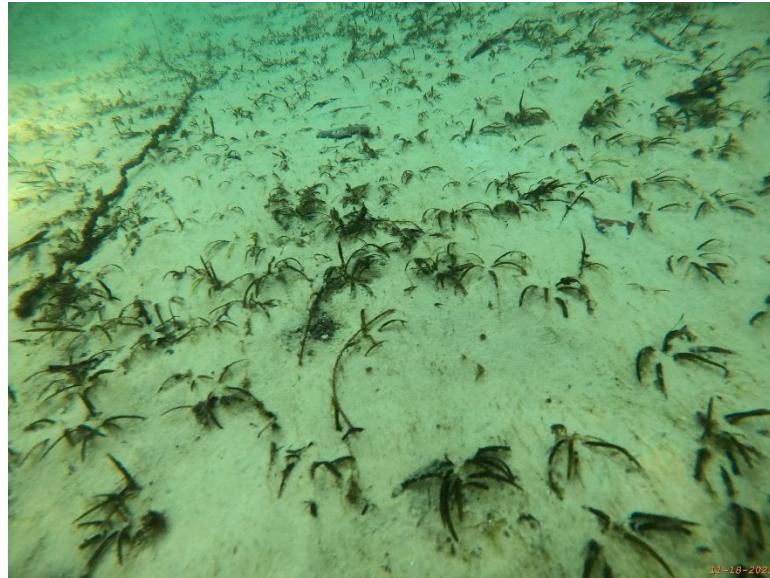
**Figure 5.** Example of unprotected planting units.

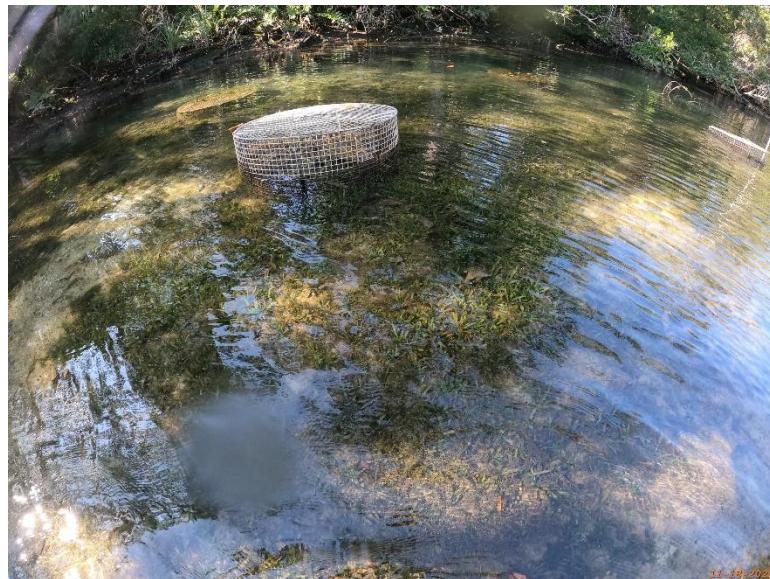
**Figure 6.** Example of protected units expanding beyond their associated device.

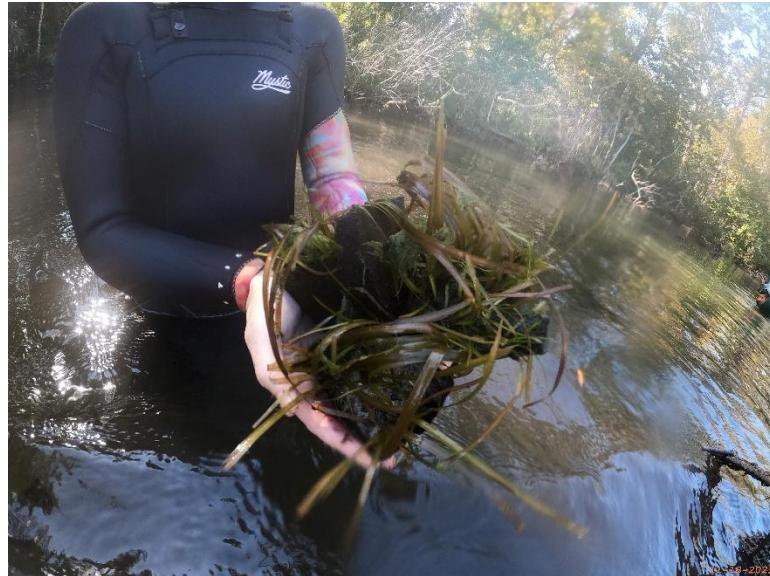
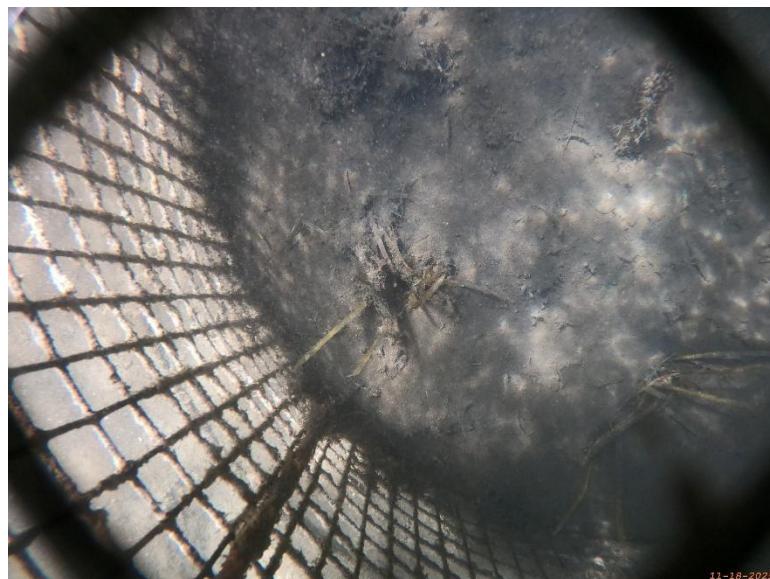
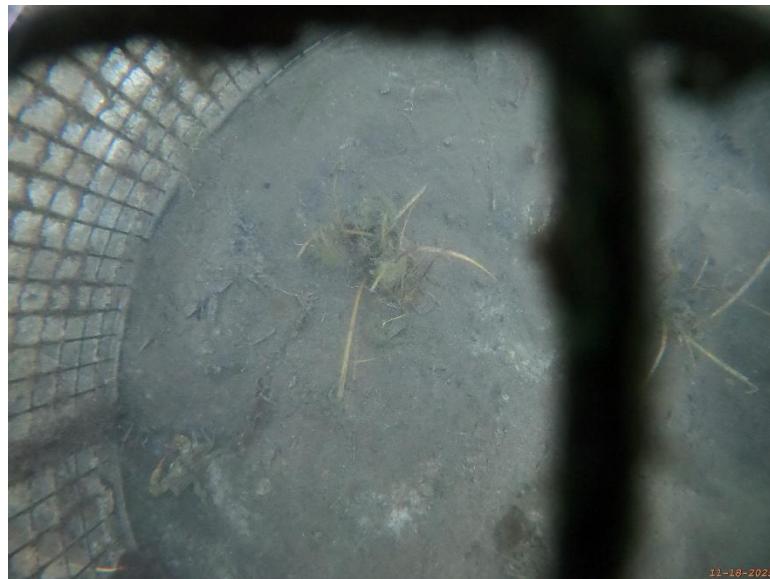
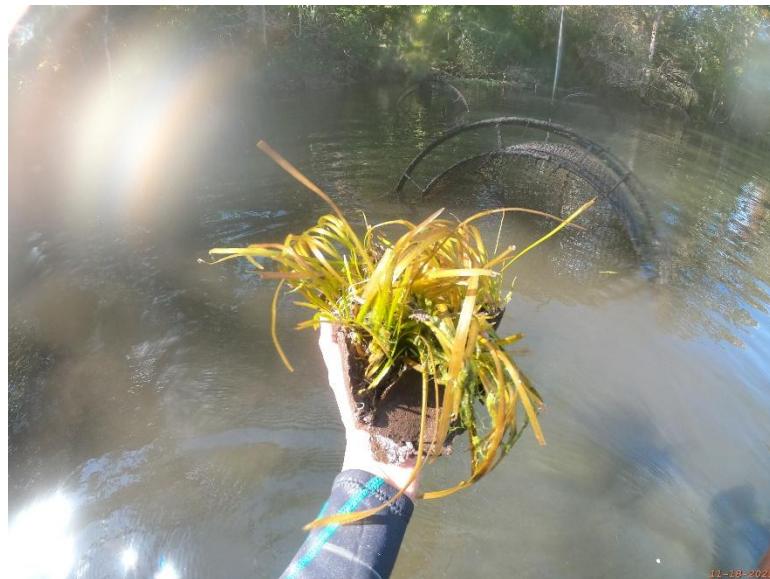
**Figure 7.** Example of supplemental planting units.

**Figure 8.** Example of supplemental planting units.

**Figure 9.** Example of supplemental planting units.

**Figure 10.** Example of supplemental planting units.

Supplemental planting took place at Site 5 during the sixth maintenance event to jumpstart the recovery of planting units in this area. Planting units were comprised of a more salt tolerant variety of *Vallisneria* which will be able to withstand the salinity fluctuations that this area experiences. A total of 75 *V. neotropicalis* peat pot planting units were installed under GrowSAV™ Devices at Site 5 (**Figures 7-10**).
