Construction Change Order

Change Order No. 2
Contract No. 25000635

CENTRIFUGE MACHINE REPAIR

Repair Inspection Report and Quote

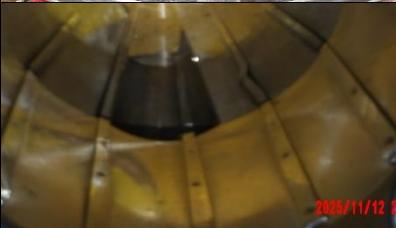
4.	Bowl Conical Inner Surface No damage Normal wear Minor wear Severe wear Solids build up	No action necessary <input type="checkbox"/> Coarse media blast <input checked="" type="checkbox"/> <input type="checkbox"/> Repair <input type="checkbox"/> <input checked="" type="checkbox"/> Replace ceramic tiles <input type="checkbox"/> <input type="checkbox"/> Clean <input type="checkbox"/>	Inner surface polished - Blast

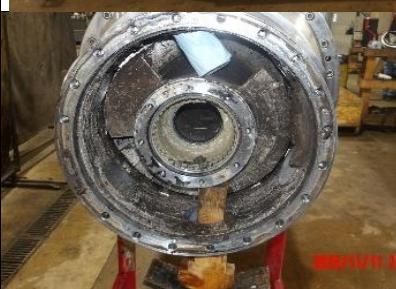
6.	Conical to SEWH Fit I.D. Ø No damage Normal wear Minor wear Severe wear Runout Undersized (Dimensional) Oversized (Dimensional)	No action necessary <input checked="" type="checkbox"/> <input type="checkbox"/> Repair <input type="checkbox"/> <input type="checkbox"/> Replace <input type="checkbox"/>

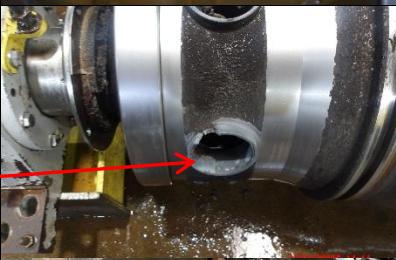
8.	Bowl Conical Discharge Nozzles No damage Normal wear Minor wear Severe wear Missing Damaged	No action necessary Repair <input type="checkbox"/> Replace	<input type="checkbox"/> <input type="checkbox"/> <input checked="" type="checkbox"/>

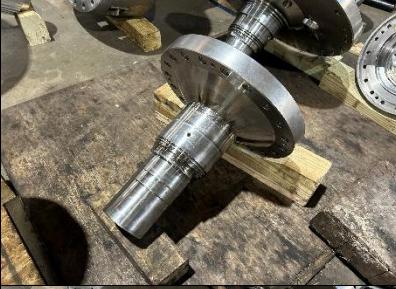
9.	Solid End Headwall External Fits No damage Normal wear Minor wear Severe wear Runout Undersized (Dimensional) Oversized (Dimensional)	No action necessary Repair <input type="checkbox"/> Replace	<input checked="" type="checkbox"/> <input type="checkbox"/> <input type="checkbox"/>

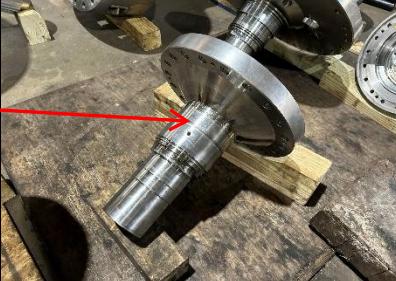
10.	Solid End Headwall Housing Seal Fits No damage Normal wear Minor wear Severe wear Runout Undersized (Dimensional) Oversized (Dimensional)	No action necessary Repair <input type="checkbox"/> Replace	<input checked="" type="checkbox"/> <input type="checkbox"/> <input type="checkbox"/>

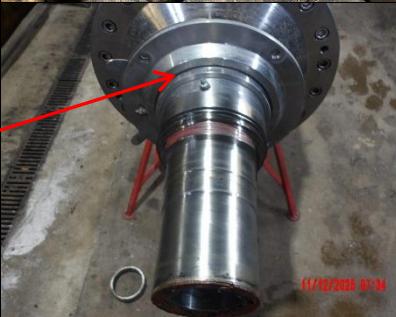
11.	Solid End Housing Seal Assembly No damage Normal wear Minor wear Severe wear Damaged Missing Undersized (Dimensional) Oversized (Dimensional)	No action necessary Repair <input type="checkbox"/> Replace	<input checked="" type="checkbox"/> <input type="checkbox"/> <input type="checkbox"/>

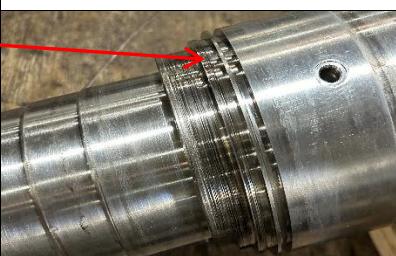
12.	Solid End Headwall Laminar Ring Groove No damage Normal wear Minor wear Severe wear	No action necessary Repair <input type="checkbox"/> Replace	<input type="checkbox"/> <input checked="" type="checkbox"/> <input type="checkbox"/>

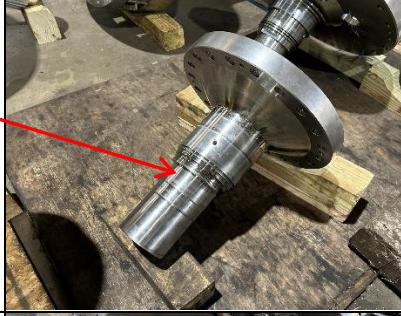
Item/Condition	Recommended Action	Notes	Picture Control & scroll to enlarge pic
13.	Solid End Headwall Main Bearing Fit No damage Normal wear Minor wear Severe wear Runout Undersized (Dimensional) Oversized (Dimensional) Corrosion found	No action necessary Repair <input type="checkbox"/> Replace	<input checked="" type="checkbox"/>

A photograph of a large metal shaft assembly. A red arrow points to the main bearing fit area at the end of the shaft.

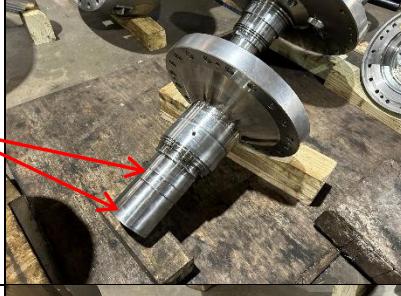
14.	Solid End Headwall Pulley Fits (external) No damage Normal wear Minor wear Severe wear Runout Undersized (Dimensional) Oversized (Dimensional)	No action necessary Repair <input type="checkbox"/> Replace	<input checked="" type="checkbox"/>

A photograph of a large metal shaft assembly. Two red arrows point to the pulley fits on the side of the shaft.

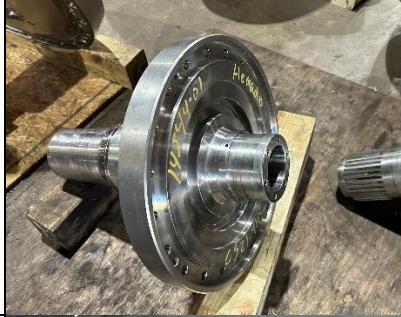
15.	Solid End Headwall- Inner Race, Retainer and Seal Ledge Fits (internal) No damage Normal wear Minor wear Severe wear Runout Undersized (Dimensional) Oversized (Dimensional)	No action necessary Repair Replace	<input checked="" type="checkbox"/>

A photograph of a large metal flange. A red arrow points to the inner race, retainer, and seal ledge fits area.

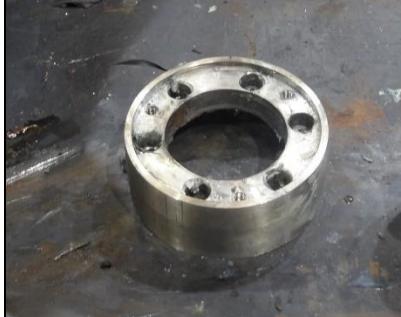
16.	Solid End Headwall- Needle Bearing Inner Race Retainer No damage Normal wear Minor wear Severe wear Runout Undersized (Dimensional) Oversized (Dimensional)	No action necessary Repair <input checked="" type="checkbox"/> Replace	<input type="checkbox"/>

A photograph of a large metal flange. A red arrow points to the needle bearing inner race retainer area.

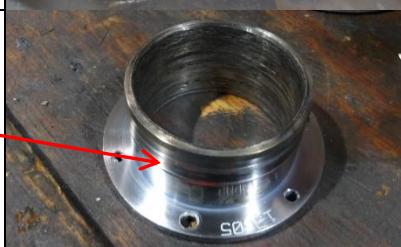
17.	Solid End Headwall Seal Ledge No damage Normal wear Minor wear Severe wear Damaged	No action necessary Repair <input checked="" type="checkbox"/> Replace	<input type="checkbox"/>

A photograph of a metal flange. A red arrow points to the seal ledge area.

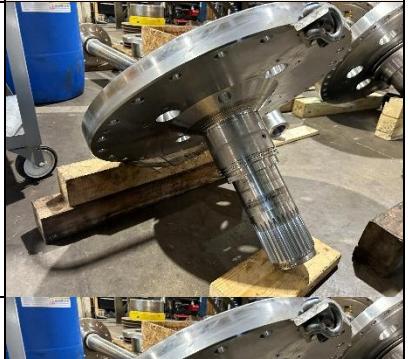
Item/Condition	Recommended Action	Notes	Picture
18.	Liquid End Headwall Fits (External) No damage Normal wear Minor wear Severe wear Runout Undersized (Dimensional) Oversized (Dimensional)	No action necessary <input checked="" type="checkbox"/> Repair <input type="checkbox"/> Replace

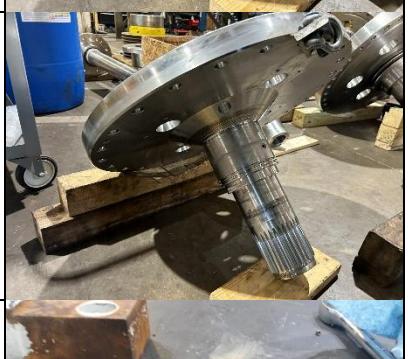
19.	Liquid End Headwall Housing Seal Fits No damage Normal wear Minor wear Severe wear Runout Undersized (Dimensional) Oversized (Dimensional)	No action necessary <input checked="" type="checkbox"/> Repair <input type="checkbox"/> Replace

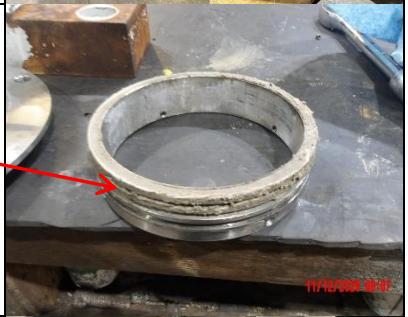
20.	Liquid End Housing Seal Assembly No damage Normal wear Minor wear Severe wear Damaged Missing Undersized (Dimensional) Oversized (Dimensional)	No action necessary <input checked="" type="checkbox"/> Repair <input type="checkbox"/> Replace

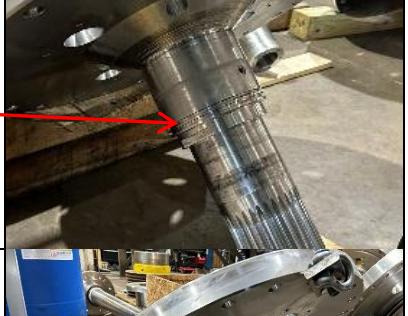
21.	Liquid End Headwall Laminar Ring Grooves No damage Normal wear Minor wear Severe wear	No action necessary <input checked="" type="checkbox"/> Repair <input type="checkbox"/> Replace

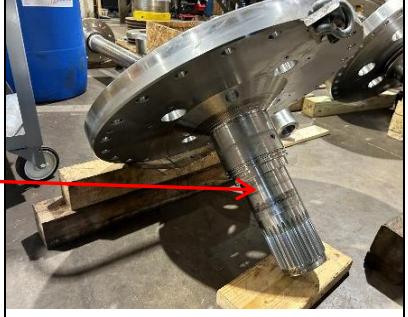
22.	Liquid End Headwall Main Bearing Fit (External) No damage Normal wear Minor wear Severe wear Runout Undersized (Dimensional) Oversized (Dimensional) Corrosion found	No action necessary <input checked="" type="checkbox"/> Repair <input type="checkbox"/> Replace

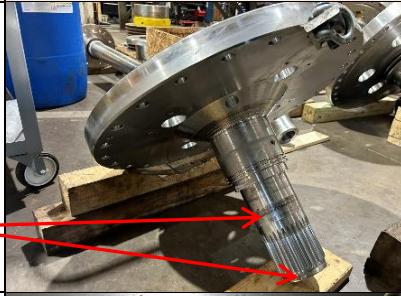
Item/Condition	Recommended Action	Notes	Picture
23.	Liquid End Headwall Carrier Fits (External) No damage Normal wear Minor wear Severe wear Runout Undersized (Dimensional) Oversized (Dimensional)	No action necessary Repair <input type="checkbox"/> Replace	<input checked="" type="checkbox"/>

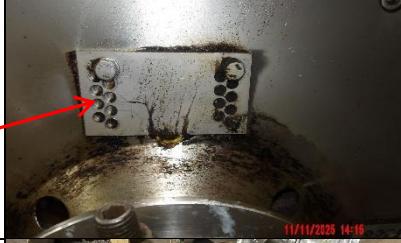
24.	Liquid End Headwall Weir Plate Assy's No damage Normal wear Minor wear Severe wear Damaged Missing	No action necessary Repair <input type="checkbox"/> Replace	<input checked="" type="checkbox"/>

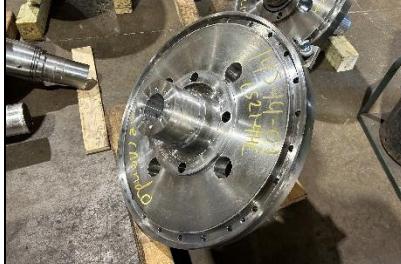
25.	Liquid End Headwall Fits (Internal) No damage Normal wear Minor wear Severe wear Runout Undersized (Dimensional) Oversized (Dimensional)	No action necessary Repair <input type="checkbox"/> Replace	<input checked="" type="checkbox"/>

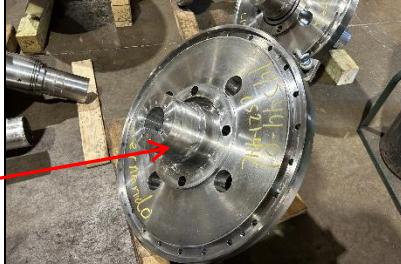
26.	Liquid End Headwall Thrust Bearing Fit (Internal) No damage Normal wear Minor wear Severe wear Runout Undersized (Dimensional) Oversized (Dimensional)	No action necessary Repair <input type="checkbox"/> Replace	<input checked="" type="checkbox"/>

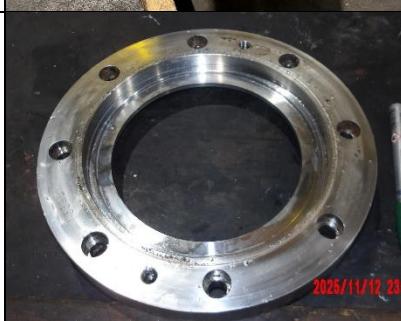
27.	Liquid End Headwall Scroll Thrust Bearing Retainer Normal wear Minor wear Severe wear Damaged Missing Undersized (Dimensional) Oversized (Dimensional)	No action necessary Repair <input type="checkbox"/> Replace	<input checked="" type="checkbox"/>

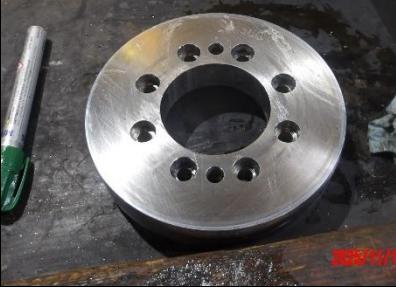
Item/Condition	Recommended Action	Notes	Picture
28.	Liquid End Thrust Bearing Retainer No damage Normal wear Minor wear Severe wear Damaged Missing Undersized (Dimensional) Oversized (Dimensional)	No action necessary Repair <input type="checkbox"/> Replace	<input type="checkbox"/> <input type="checkbox"/> <input checked="" type="checkbox"/>

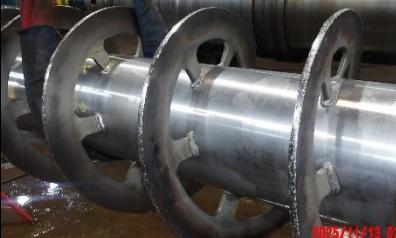
31.	Scroll Tungsten Carbide Hard Facing No damage Normal wear Minor wear Severe wear Damaged Missing	No action necessary Repair TC Hard facing	<input checked="" type="checkbox"/> <input type="checkbox"/>

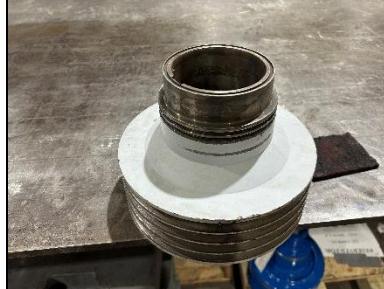
41.	Pulley No damage Normal wear Minor wear Severe wear Damaged Runout Undersized (Dimensional) Oversized (Dimensional) Corrosion found	No action necessary <input type="checkbox"/> Repair <input type="checkbox"/> Replace <input checked="" type="checkbox"/> Paint <input type="checkbox"/> Minor wear <input type="checkbox"/> Severe wear <input type="checkbox"/> Damaged <input type="checkbox"/> Runout <input type="checkbox"/> Undersized (Dimensional) <input type="checkbox"/> Oversized (Dimensional) <input type="checkbox"/> Corrosion found

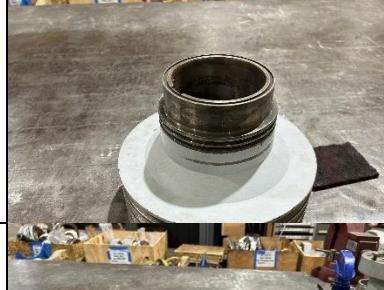
42.	Pulley Laminar Ring Grooves No damage Normal wear Minor wear Severe wear	No action necessary <input checked="" type="checkbox"/> Install Laminar Ring Groove <input type="checkbox"/> Repair Ring #18517 <input type="checkbox"/> Replace Laminar Ring Groove <input checked="" type="checkbox"/> Repair Ring #18517 <input type="checkbox"/> Minor wear

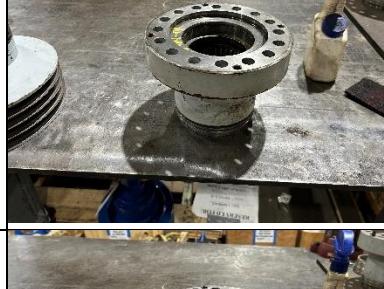
43.	Carrier 16 Holes No damage Normal wear Minor wear Severe wear Damaged Runout Undersized (Dimensional) Oversized (Dimensional) Corrosion found	No action necessary <input type="checkbox"/> Repair <input type="checkbox"/> Replace <input checked="" type="checkbox"/> Paint <input type="checkbox"/> Minor wear

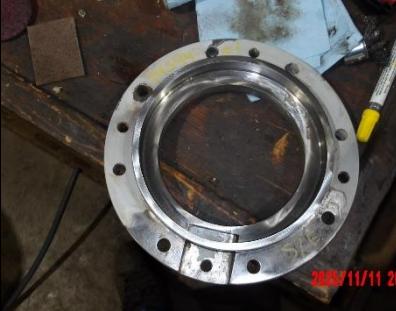
Item/Condition	Recommended Action	Notes	Picture
46.	Main Bearing Cover Plate Outer (SE) No damage Normal wear Minor wear Severe wear Damaged Missing Undersized (Dimensional) Oversized (Dimensional)	No action necessary Repair <input type="checkbox"/> Replace <input type="checkbox"/> Paint	<input type="checkbox"/> <input type="checkbox"/> <input type="checkbox"/> <input checked="" type="checkbox"/>

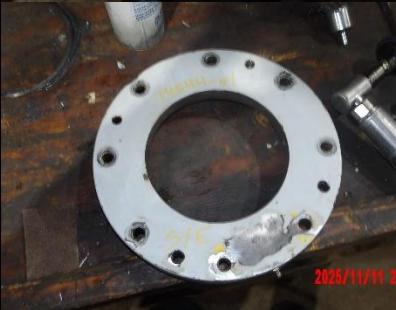
47.	Main Bearing Cover Plate Inner (SE) No damage Normal wear Minor wear Severe wear Damaged Missing Undersized (Dimensional) Oversized (Dimensional)	No action necessary Repair <input type="checkbox"/> Replace <input type="checkbox"/> Paint	<input type="checkbox"/> <input type="checkbox"/> <input checked="" type="checkbox"/>

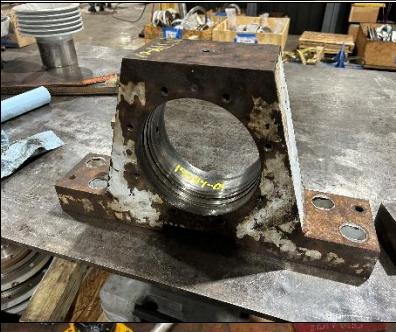
48.	Liquid End Pillow Block No damage Normal wear Minor wear Severe wear Damaged Runout Undersized (Dimensional) Oversized (Dimensional) Corrosion found	No action necessary Repair <input type="checkbox"/> Replace <input checked="" type="checkbox"/> Paint	<input type="checkbox"/> <input type="checkbox"/> <input checked="" type="checkbox"/>

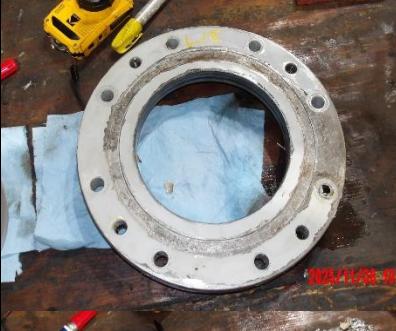
49.	Main Bearing Cover Plate Outer (LE) No damage Normal wear Minor wear Severe wear Damaged Missing Undersized (Dimensional) Oversized (Dimensional)	No action necessary Repair <input type="checkbox"/> Replace <input type="checkbox"/> Paint	<input type="checkbox"/> <input type="checkbox"/> <input checked="" type="checkbox"/>

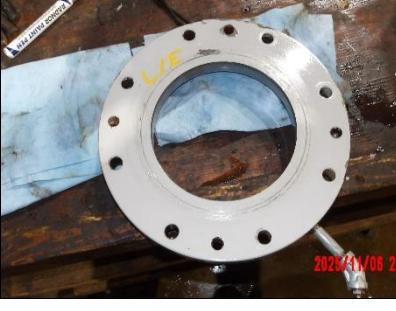
50.	Main Bearing Cover Plate Inner (LE) No damage Normal wear Minor wear Severe wear Damaged Missing Undersized (Dimensional) Oversized (Dimensional)	No action necessary Repair <input type="checkbox"/> Replace <input type="checkbox"/> Paint	<input type="checkbox"/> <input type="checkbox"/> <input checked="" type="checkbox"/>

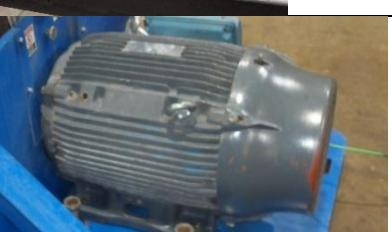
69.	Main Drive Motor No damage Normal wear Minor wear Severe wear Missing	No action necessary <input type="checkbox"/> Repair <input type="checkbox"/> Replace <input type="checkbox"/> Replace bearings <input checked="" type="checkbox"/> Paint <input type="checkbox"/>
