Weeki Wachee River SAV Restoration Project

Month 9 Maintenance Report

FDEP PERMIT NUMBER: 27-0192455-004-EI

Prepared On:
February 10th, 2026

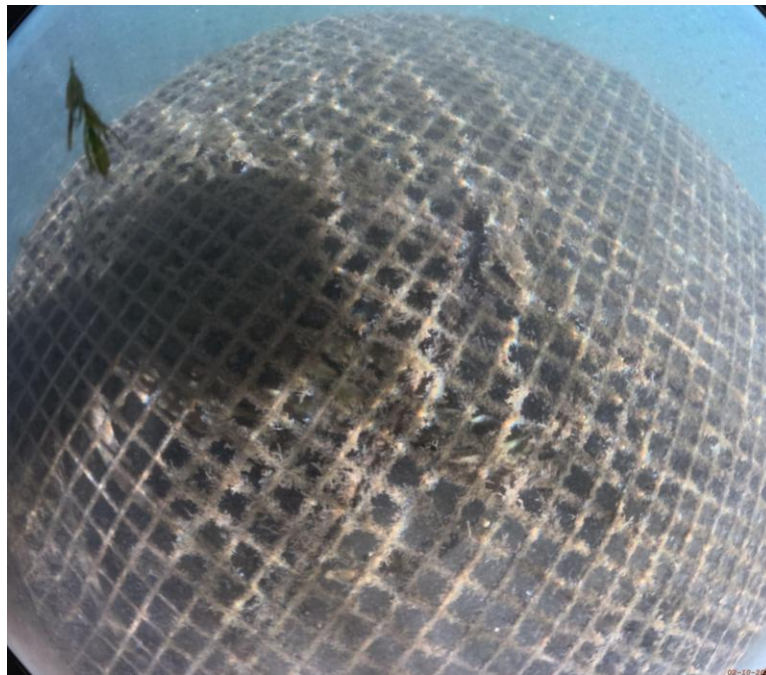
The ninth monthly maintenance event for the Weeki Wachee River SAV Restoration Project occurred on February 10th, 2026. The GrowSAV™ Herbivory Exclusion Devices exhibited light levels of biofouling, consisting mainly of settled sediments, filamentous algae and entrapped leaf litter. Sea & Shoreline biologists removed biofouling from the top and side mesh of the devices using stiff-bristled brushes (**Figures 1 & 2**).

Figure 1. Example of biofouling on GrowSAV™ device

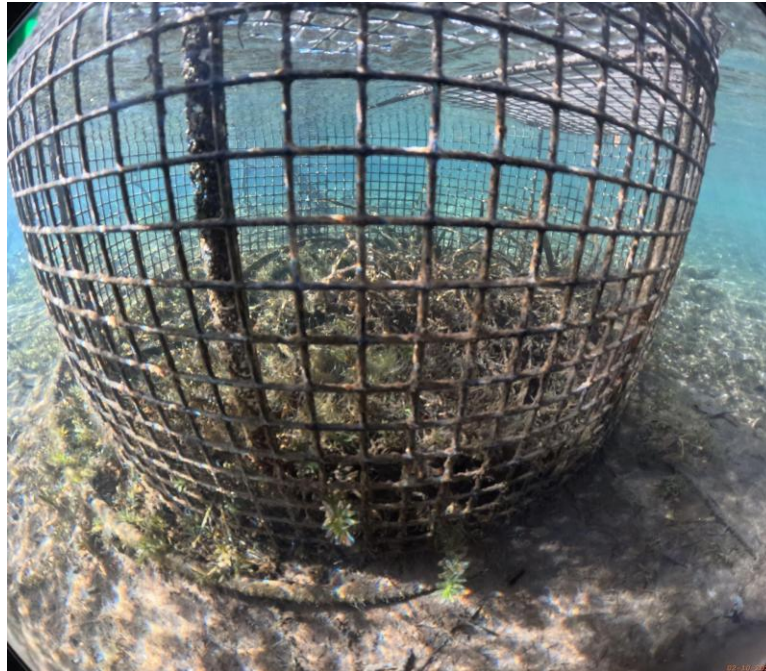
The estimated success rate of *V. neotropicalis* within GrowSAV™ Herbivory Exclusion Devices remained similar to that of past maintenance events, with roughly 80% of the devices exhibiting successful growth. *V. neotropicalis* coverages ranged from 0.5 to 4 on the Braun-Blanquet coverage scale (<5% - 75%). The blade height of protected units varied from 10 cm to upwards of 55 cm. Canopy heights were noted to be slightly lower than previous months, likely due to increased grazing pressure (**Figure 3**). As manatees and turtles migrate out of the river during the coming warmer months, grazing pressure should decrease, promoting greater vertical growth of *V. neotropicalis*.

Figure 3. Example of protected units.

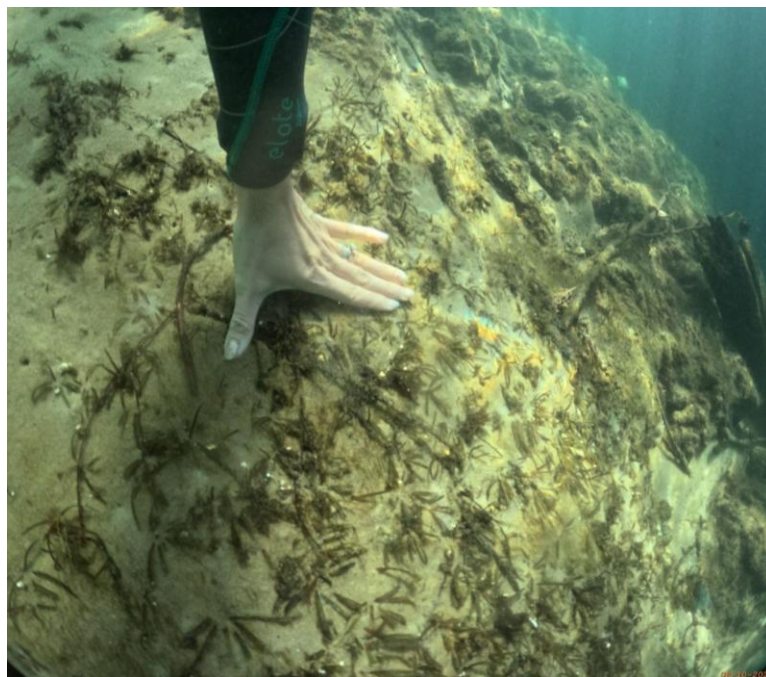
Unprotected planting units remain short but are continuing to laterally expand throughout the deeper portions of the river (**Figures 4 & 5**). The canopy height of unprotected units remains relatively unchanged, ranging from 2-15 cm. Unprotected units were observed at coverages of 0.5 to 3 on the Braun-Blanquet coverage scale (<5% - 50%).

Figure 4. Example of unprotected units showing signs of lateral expansion.

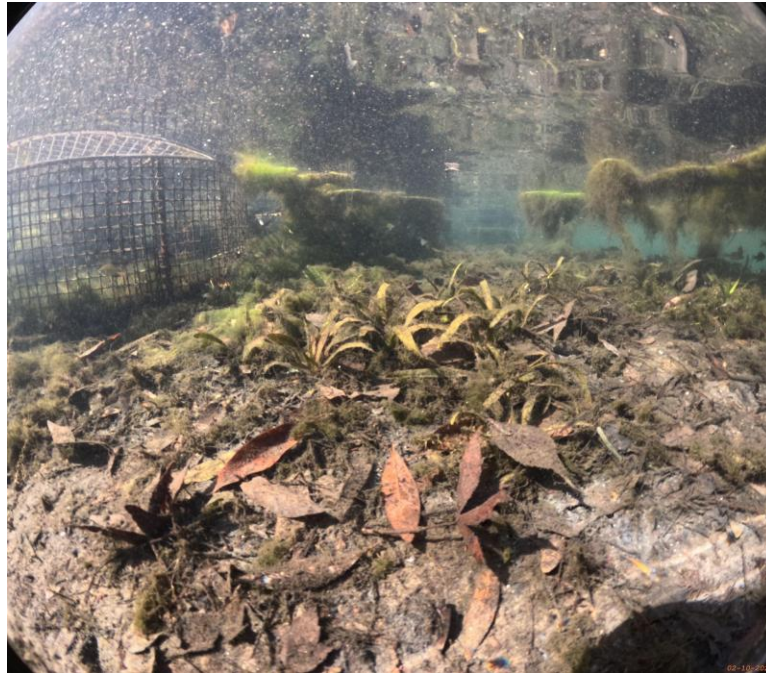
Figure 5. Example of unprotected planting units.

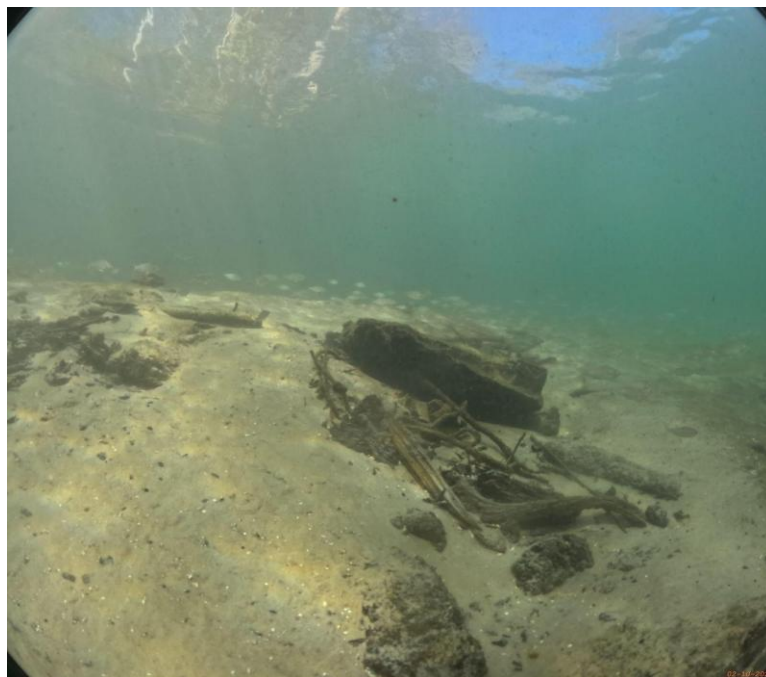
Figure 6. Example of an area experiencing increased sediment relocation due to current.

There remains evidence of steady erosion around parts of the planting area, with more rapid erosion noticed on the outside bends of the river (**Figure 6**). If erosion continues to worsen, supplemental planting in areas that experience less water flow may be recommended. The supplemental planting units at site 5 will continue to be monitored and sediment inside devices will continue to be removed as necessary. Salinity data will be recorded at site 5 during the next maintenance event to determine if it is still a rate limiting factor to plant growth. Maintenance will continue for the next three months, with the next event taking place in March of 2026.
