## **Weeki Wachee River SAV Restoration Project**

### **Month 10 Maintenance Report**

FDEP PERMIT NUMBER: 27-0192455-004-EI

USACE PERMIT NUMBER: SAJ-2019-01203

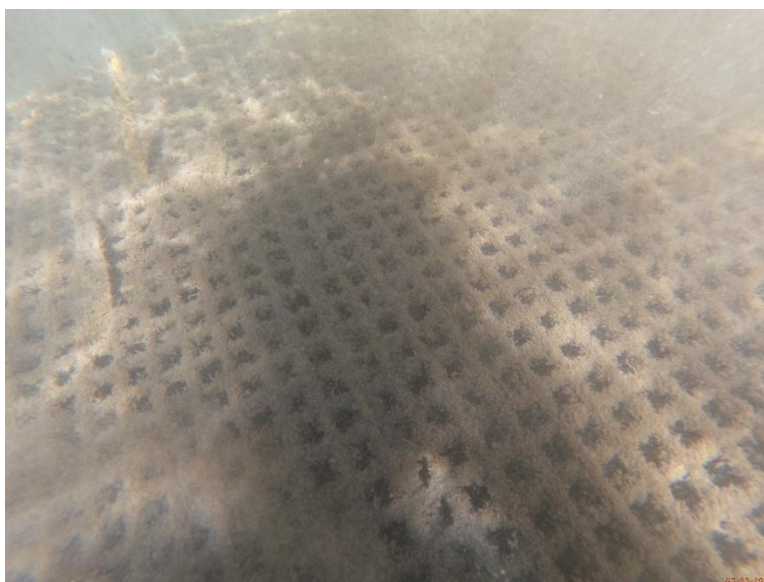
**Figure 1.** Example of biofouling on GrowSAV™ device

The tenth monthly maintenance event for the Weeki Wachee River SAV Restoration Project occurred on March 23<sup>rd</sup>, 2026. The GrowSAV™ Herbivory Exclusion Devices exhibited light levels of biofouling, consisting mainly of settled sediments, filamentous algae and entrapped leaf litter. Sea & Shoreline biologists removed biofouling from the top and side mesh of the devices using stiff-bristled brushes (**Figures 1 & 2**).

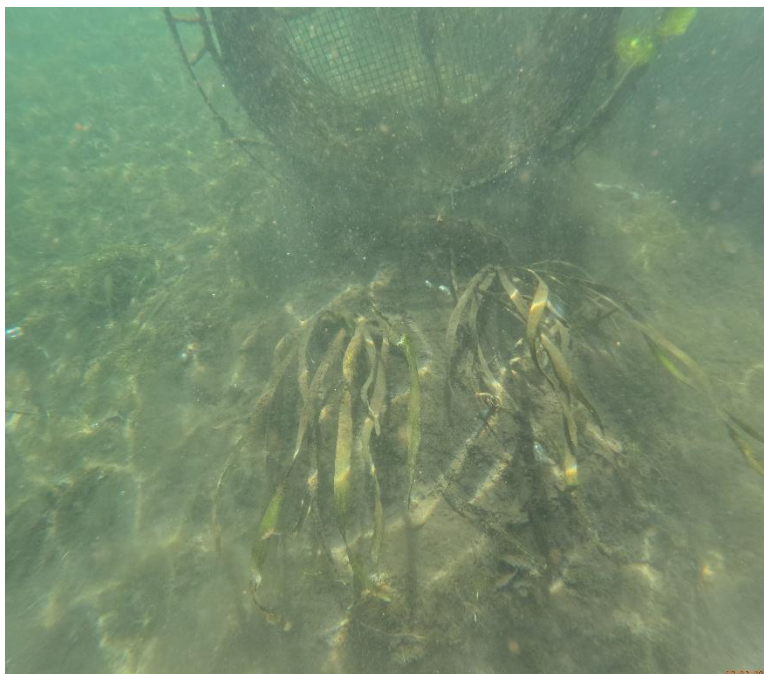
**Figure 3.** Example of protected units.

The estimated success rate of *V. neotropicalis* within GrowSAV™ Herbivory Exclusion Devices has decreased slightly since month 9, with approximately 65% of the devices exhibiting successful growth. *V. neotropicalis* coverage ranged from 0.5 to 4 on the Braun-Blanquet coverage scale (<5% - 75%). The blade height of protected units varied from 10 cm to upwards of 60 cm. Canopy heights of unprotected units were noted to be slightly lower than previous months, likely due to increased grazing pressure during the winter months (**Figure 3**). Unprotected units remain short but continue to display signs of lateral expansion throughout the river. Unprotected units were observed at coverages of 0.5 to 3 on the Braun-Blanquet coverage scale (<5% - 50%).

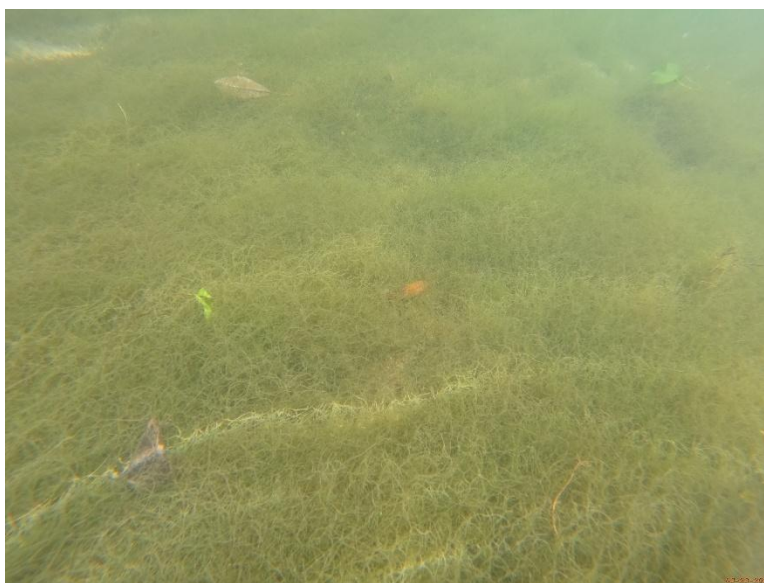
**Figure 6.** Example of *Chaetomorpha* at the most downstream site.

Supplemental planting units installed at site 5 were observed in approximately 20% of the GrowSAV™ Devices. A dense *Chaetomorpha* bloom was observed at site 5 during this event, covering almost 90% of the total area where GrowSAV Devices are installed (**Figure 6**). *Chaetomorpha* usually blooms when there are excess nutrients in the system and prefers higher salinity levels. The bloom that appeared shortly after supplemental units were installed could be smothering the new units and blocking light availability.

The *Chaetomorpha* bloom at site 5 will continue to be monitored, any algae that builds up within the devices will be gently swept out. An overall increase in the biomass of submerged aquatic vegetation is anticipated in coming months as we move into the growing season. Maintenance will continue for the next two months, with the next event taking place in April of 2026.
