Weeki Wachee River SAV Restoration Project

Month 7 Maintenance Report

FDEP PERMIT NUMBER: 27-0192455-004-EI

Prepared On:
January 5th, 2026

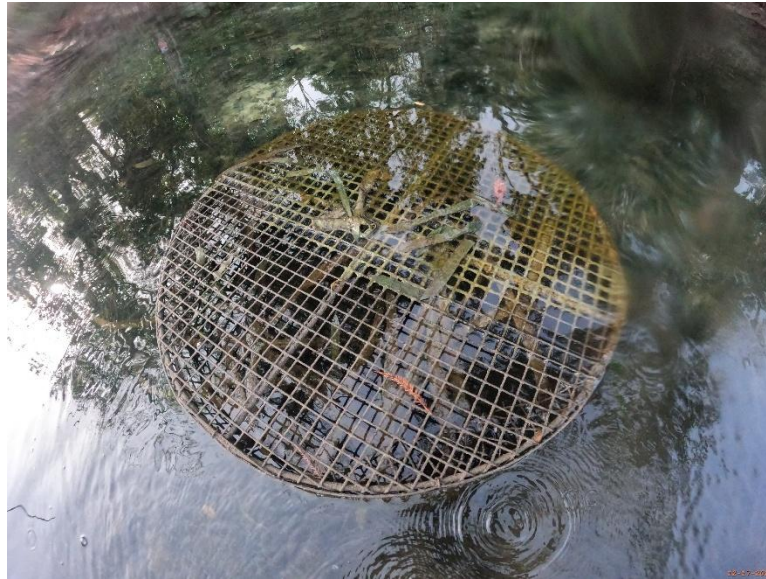
The seventh monthly maintenance event for the Weeki Wachee River SAV Restoration Project occurred on December 17th, 2025. The GrowSAV™ Herbivory Exclusion Devices exhibited light levels of biofouling, consisting mainly of settled sediments, filamentous algae and entrapped leaf litter. Sea & Shoreline biologists removed biofouling from the top and side mesh on mask and snorkel using stiff-bristled scrub brushes.

Figure 1. Example of biofouling prior to removal.

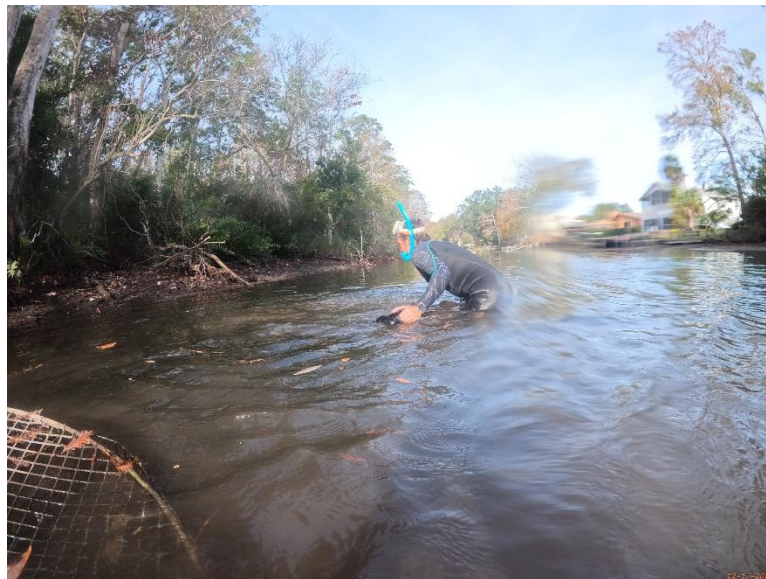
Figure 2. Example of Sea & Shoreline biologist removing biofouling.

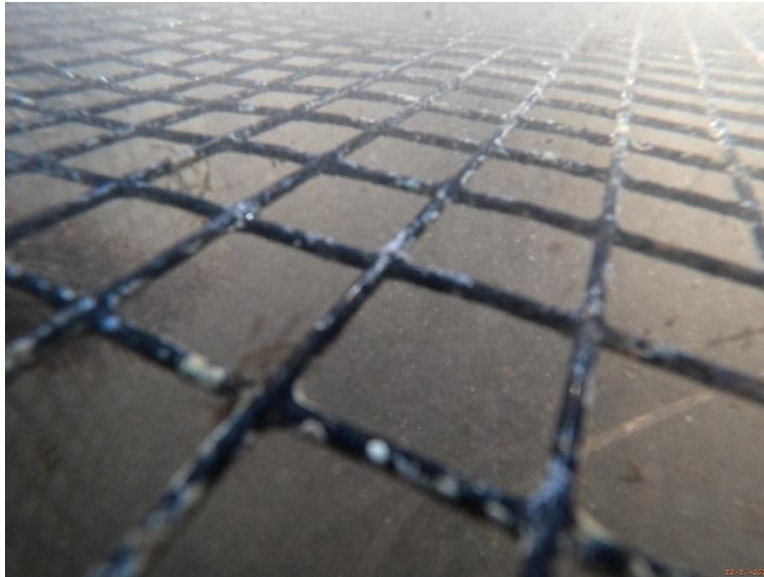
Figure 3. Example of GrowSAV Device after biofouling removal.

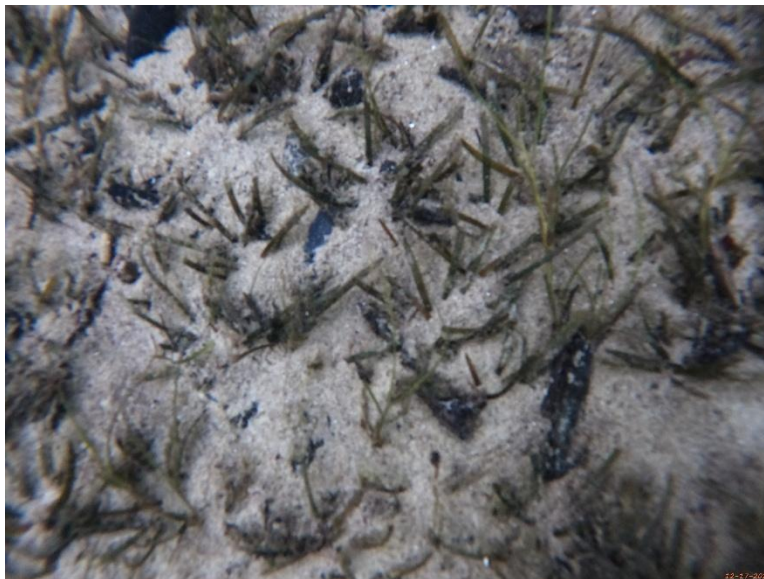
Unprotected planting units remain short but are continuing to laterally expand throughout the deeper portions of the river (**Figures 4 & 5**). The canopy height of unprotected units remains unchanged, ranging from 2-15 cm. Unprotected units were observed at coverages of 0.5 to 3 on the Braun-Blanquet coverage scale (<5% - 50%). It was also noted that unprotected units are becoming uprooted in certain areas, likely due to the strong currents and sediment transport that the Weeki Wachee River experiences. Specifically, **Figures 9 and 10** show the formation of two steep slopes observed during the seventh maintenance event, where the roots of planting units have become exposed. These figures demonstrate the loss of plant life that the steady erosion has caused.

Figure 4. Example of unprotected units showing signs of lateral expansion.

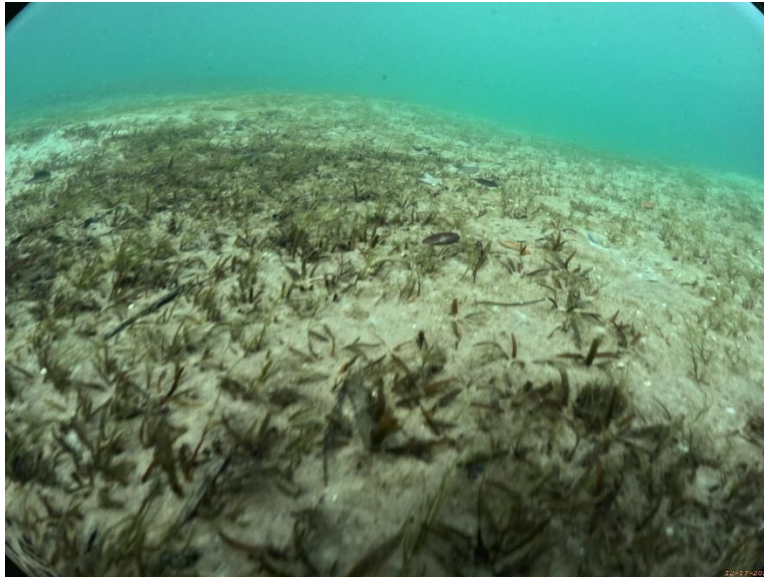
Figure 5. Example of unprotected planting units.

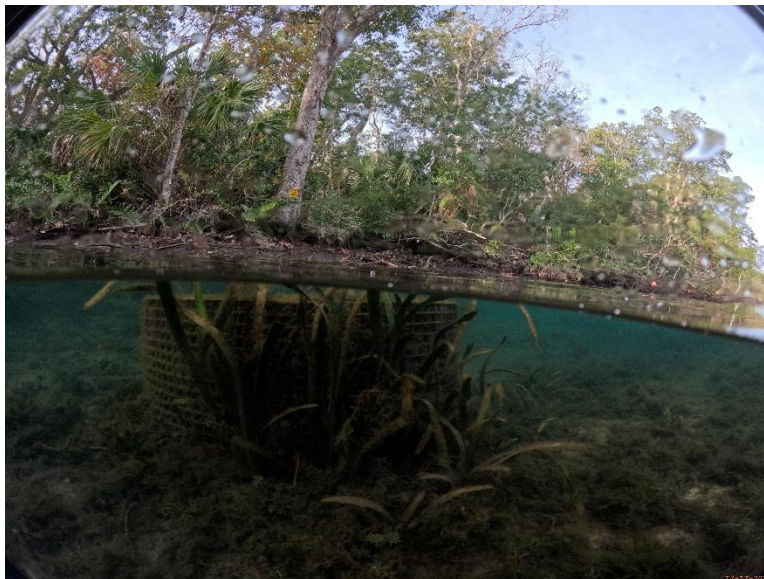
It is estimated that *V. neotropicalis* is now present in 118/132 (89%) of the GrowSAV™ Herbivory Exclusion Devices, with coverages ranging from 0.5 to 4 on the Braun-Blanquet coverage scale (<5% - 75%). The blade height of protected units varies from 10 cm to 80 cm, with most units extending well beyond the top of their associated device. Slight decreases in canopy height were noted during this event, which is expected during the winter season with lower water levels and shorter days. Signs of lateral expansion beyond protective devices were also observed throughout approximately 90% of devices, with some units expanding up to 5 feet from their device (**Figure 6**). Supplemental planting units installed the previous month at site 5 were observed in approximately 50% of the GrowSAV™ Devices. Protected units were covered by approximately 5-7 cm of settled sediment and were only revealed once this sediment was gently brushed away (**Figure 7**).

Figure 6. Example of protected units expanding beyond their associated device.

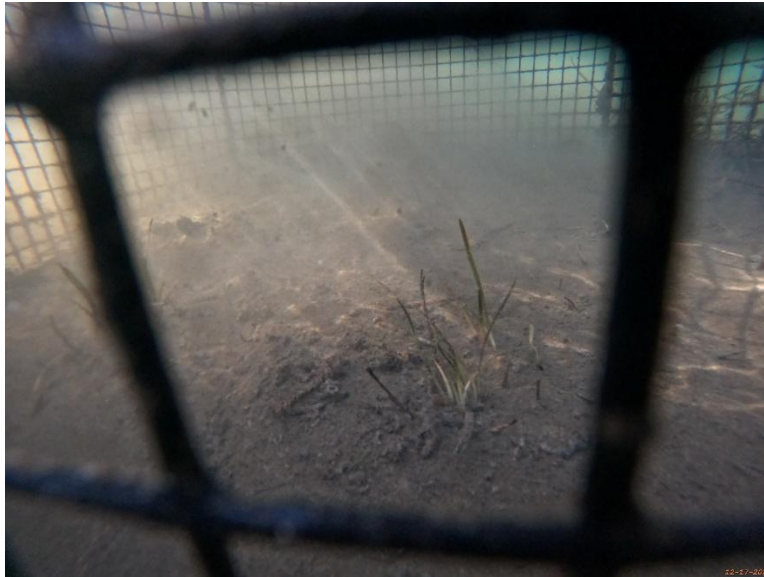
Figure 7. Example of supplemental planting units.

As of December 2025, the sediment transportation issue was only observed at a select few spots. If the erosion continues to worsen, supplemental planting in areas that experience less water flow may be recommended. The supplemental planting units at site 5 will continue to be monitored and sediment inside devices will continue to be removed as necessary. Maintenance will continue for the next five months, with the eighth event taking place in January 2026.

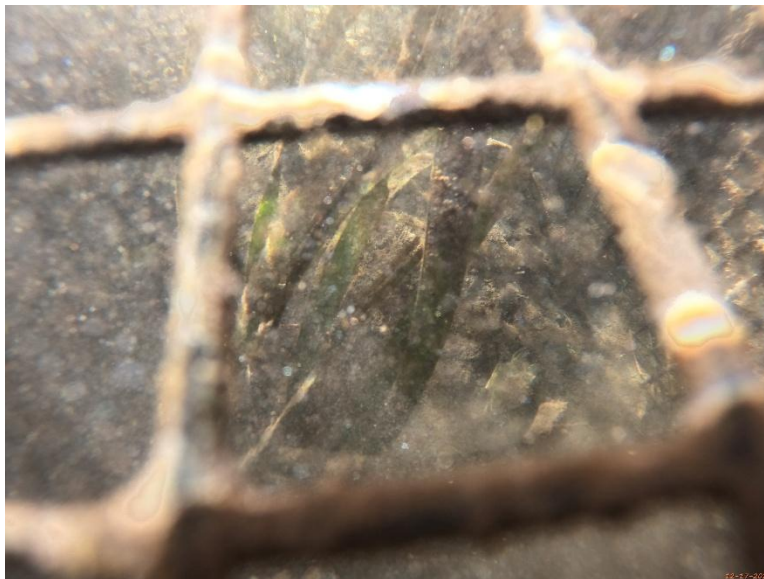
Figure 8. Example of protected planting units.

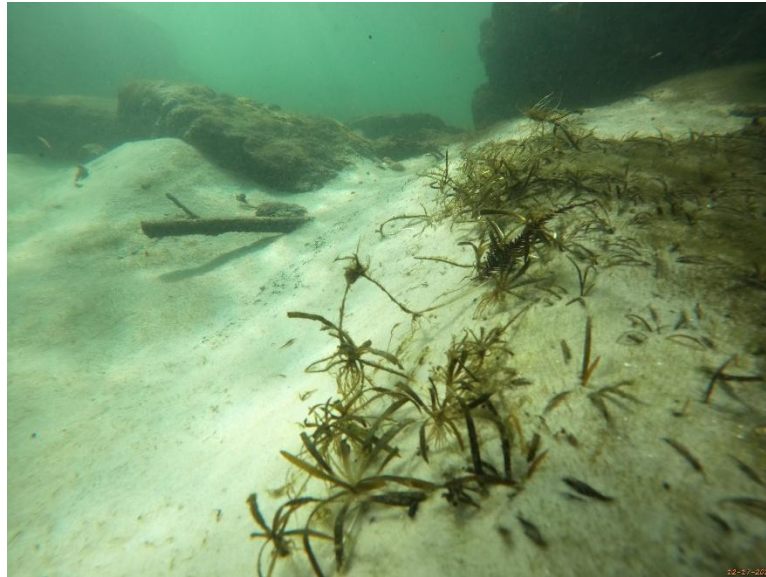
Figure 9. Example of sediment transport exposing roots and rhizomes of unprotected units.

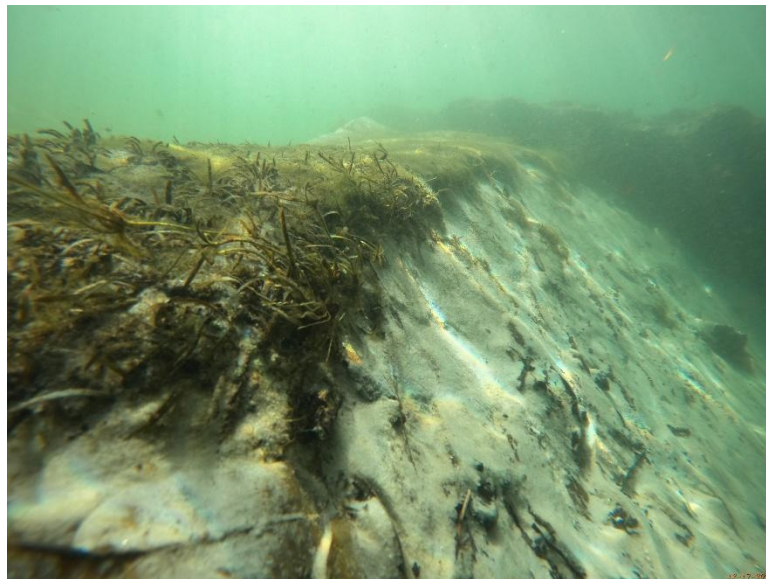
Figure 10. Example of sediment transport exposing roots and rhizomes of unprotected units.
