Weeki Wachee River SAV Restoration Project

Month 8 Maintenance Report

FDEP PERMIT NUMBER: 27-0192455-004-EI

USACE PERMIT NUMBER: SAJ-2019-01203

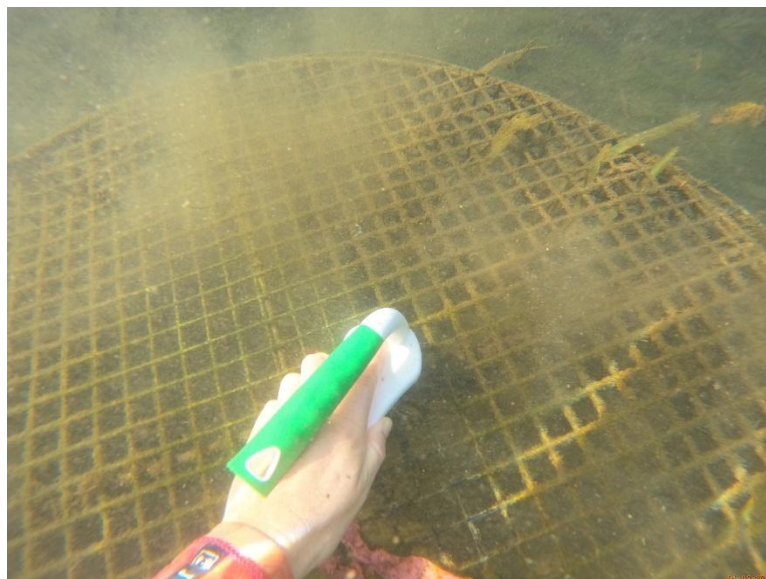
Figure 2. Example of Sea & Shoreline biologist removing biofouling.

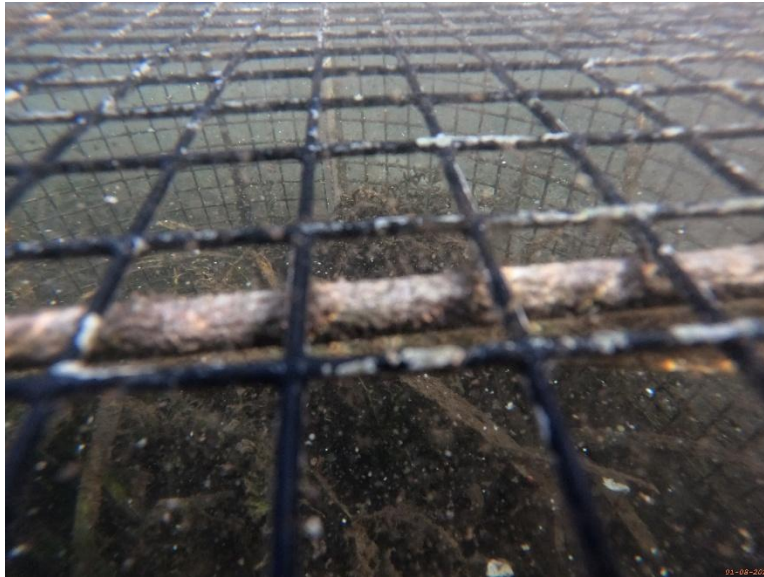
Figure 3. Example of GrowSAV Device after biofouling removal.

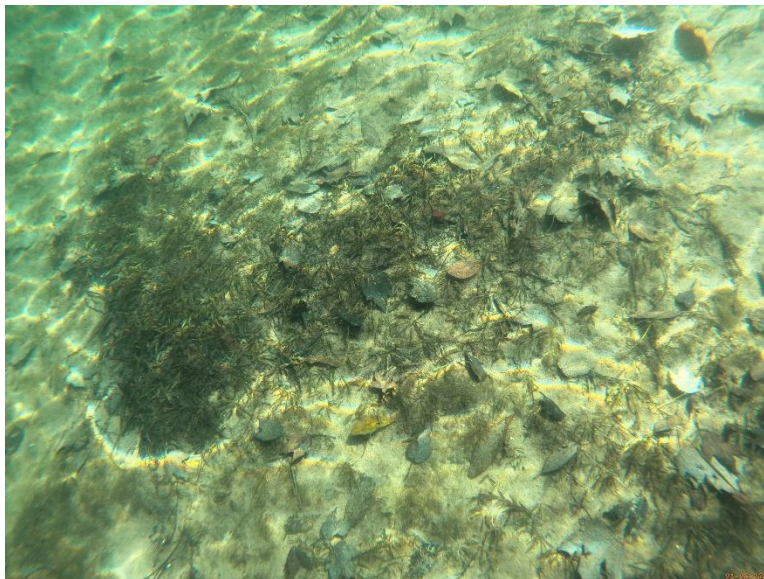
Unprotected planting units remain short but are continuing to laterally expand throughout the deeper portions of the river (**Figures 4 & 5**). The canopy height of unprotected units has decreased slightly, ranging from 2-10 cm. Unprotected units were observed at coverages of 0.5 to 3 on the Braun-Blanquet coverage scale (<5% - 50%). Sediment transport is still evident in certain areas throughout the river, but no active signs of uprooting were noted during the eighth maintenance event.

Figure 4. Example of unprotected units showing signs of lateral expansion.

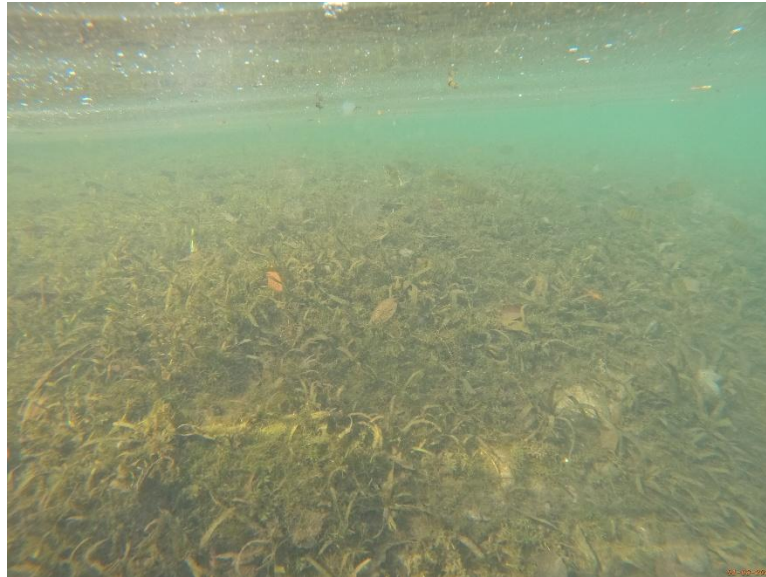
Figure 5. Example of unprotected planting units.

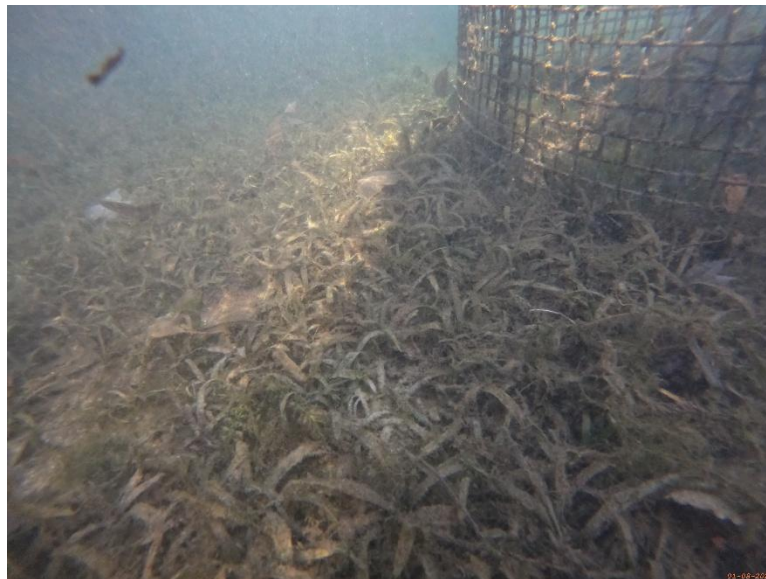
It is estimated that *V. neotropicalis* is now present in 112/132 (84%) of the GrowSAV™ Herbivory Exclusion Devices, with coverages ranging from 0.5 to 4 on the Braun-Blanquet coverage scale (<5% - 75%). The blade height of protected units varies from 10 cm to 70 cm, with most units extending beyond the top of their associated device. Signs of lateral expansion beyond protective devices were also observed throughout approximately 85% of devices, with some units expanding up to 5 feet from their device (**Figure 6**). Slight decreases in canopy height were noted during this event, which is expected during the winter season with lower water levels and shorter days. As we progress further into winter months, and herbivores move into warmer waters, planting units throughout the footprint are beginning to show signs of increased grazing pressure. At this time, this is not posing a major threat to the survival of planting units, but it will continue to be monitored.

Figure 6. Example of protected units expanding beyond their associated device.

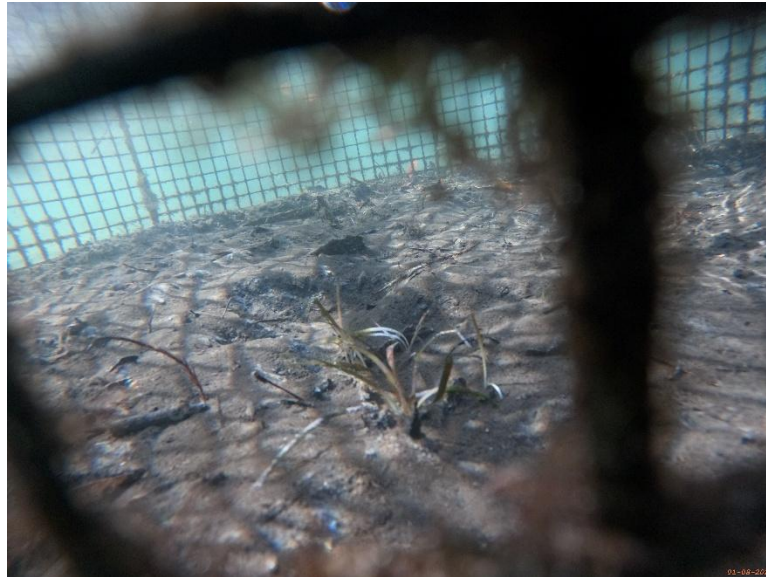
Supplemental planting units installed the previous month at site 5 were observed in approximately 40% of the GrowSAV™ Devices. Protected units continue to be covered by settled sediments and were only revealed once this sediment was gently brushed away (**Figure 7**).

Figure 7. Example of supplemental planting units at site 5.

The supplemental planting units at site 5 will continue to be monitored and sediment inside devices will continue to be removed as necessary. Maintenance will continue for the next four months, with the ninth event taking place in February 2026.

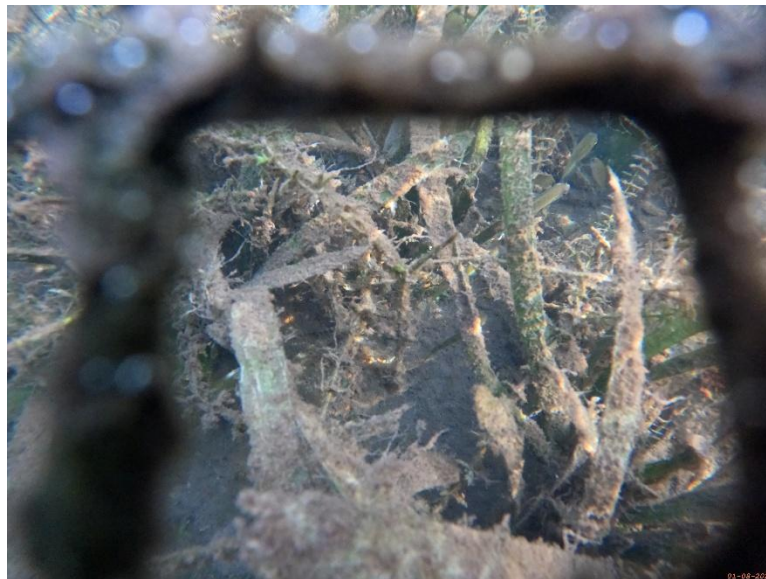
Figure 8. Example of protected planting units.
