Limited Condition Assessment Report

Linda Pederson Observation Tower

**Subject: Limited Condition Assessment
Observation Tower
Linda Pedersen Park
6340 Shoal Line Boulevard
Spring Hill, FL 34607**

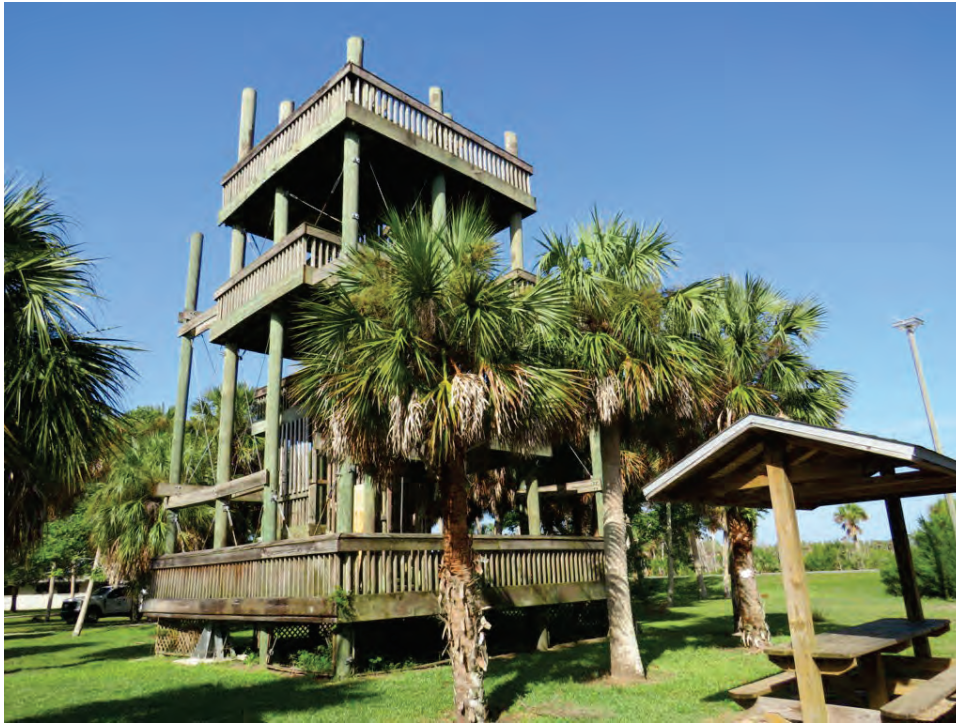
Figure A-1

Table A – Documented Observations	
Conditions Observed	Refer. Photos
Exterior Elevations	
Overall photograph of north elevation	<i>Figure A-1</i>
Overall photograph of south elevation	<i>Figure A-2</i>
Overall photograph of west elevation	<i>Figure A-3</i>
Overall photograph of east elevation	<i>Figure A-4</i>
<i>Typical Conditions</i>	
Organic growth and staining along the exterior rails, balusters, and fascia boards	<i>Figures A-5 and A-6</i>
Surface wear and minor separation along the perimeter rail balusters	<i>Figures A-7 and A-8</i>
Horizontal separations along the perimeter rail fascia boards	<i>Figure A-9</i>
Missing or protruding fasteners along the perimeter railing caps, fascia boards, and balusters	<i>Figures A-10 and A-11</i>
Separations along lumber poles surfaces	<i>Figures A-12 and A-13</i>
<i>Isolated Conditions</i>	
The two center poles along the north elevation appeared to exhibit lateral displacement (see columns marked with dashed red line)	<i>Figure A-14</i>

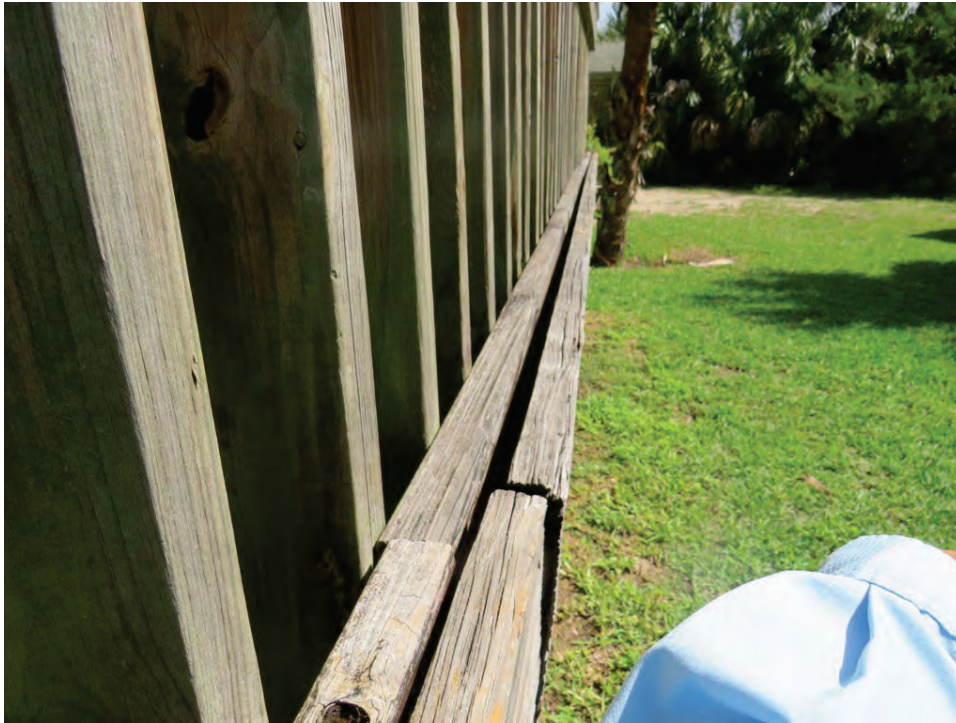
Figure A-19

Separation between the fascia boards along the east elevation of the 1 st level	<i>Figure A-19</i>
Separation with protruding fasteners along the east elevation railing cap	<i>Figure A-20</i>
Separation, deflection, missing fasteners, and holes between the lateral bracing at the 3 rd pole from the north along the east elevation	<i>Figure A-21</i>
Underside of 1st Level	
Overall photographs of the crawlspace below the 1 st level	<i>Figures A-22 through A-24</i>
Organic growth at sporadic locations along the 1 st level joists	<i>Figure A-25</i>
Section loss with deterioration along the top of the end section of a 1 st level floor joist at the southeast corner	<i>Figure A-26</i>
Splitting and section loss at the south end of floor joist at southwest corner of 1 st level	<i>Figure A-27</i>
Staining and organic growth along the floor joists at the gaps between the deck boards	<i>Figure A-28</i>
Overdriven bolts at sporadic column to joist connections	<i>Figure A-29</i>

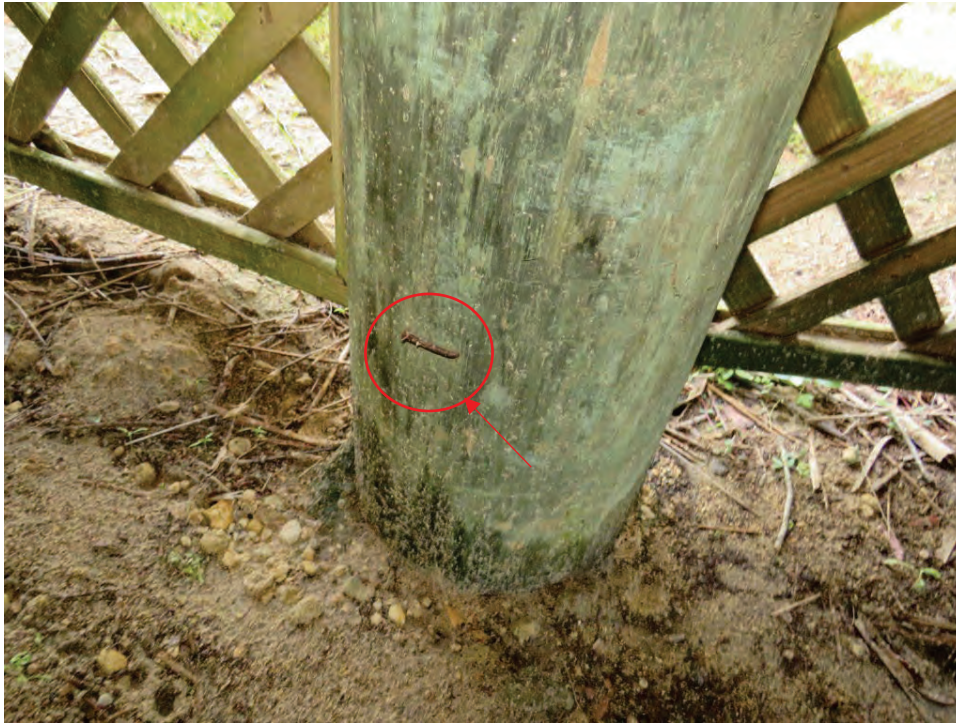
Figure A-39

Surficial deterioration at the top of the west pole at the top of the entrance ramp	<i>Figure A-38</i>
Left-in-place nail along the 2 nd pole from the south along the east elevation (circled in red)	<i>Figure A-39</i>
Separation along the base of the 2 nd column from the west along the north elevation	<i>Figure A-40</i>
Separation along the base of the 3 rd pole from the south along the east elevation	<i>Figure A-41</i>
Discoloration at sporadic locations along the base of poles	<i>Figures A-39 through A-42</i>

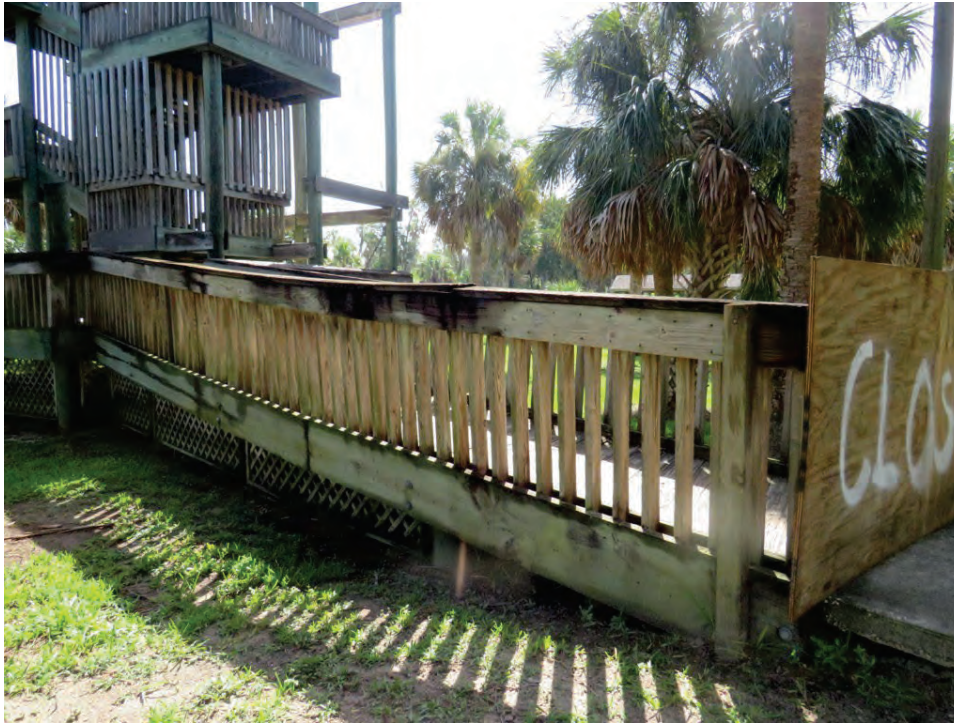
Figure A-43

1st Level Entrance Ramp	
Overall photograph of 1 st level entrance ramp	<i>Figure A-43</i>
The east side railing exhibited lateral displacement	<i>Figures A-44 and A-45</i>
Loose fasteners and separation of the lumber boards along the west railing cap	<i>Figure A-46</i>
Sporadic areas of separation/splits, section loss, and deterioration along railing balusters	<i>Figures A-47 and A-48</i>
Organic growth with loose fasteners at sporadic locations along the exterior rails	<i>Figure A-49</i>
Separation/splits at sporadic locations along the railing cover boards	<i>Figure A-50</i>
Section loss at an isolated location along the ramp deck	<i>Figure A-51</i>
Space between rail balusters was measured to be greater than 4-inches at sporadic locations	<i>Figure A-52</i>
Deteriorated deck boards with loose fasteners along entrance ramp	<i>Figures A-53 and A-54</i>
Metal angle brace with deteriorated fasteners at an isolated location along the entrance ramp	<i>Figure A-55</i>
