# Limited Condition Assessment Report

## Linda Pederson Observation Tower

**September 2, 2025**

**Subject: Limited Condition Assessment  
Observation Tower  
Linda Pedersen Park  
6340 Shoal Line Boulevard  
Spring Hill, FL 34607**

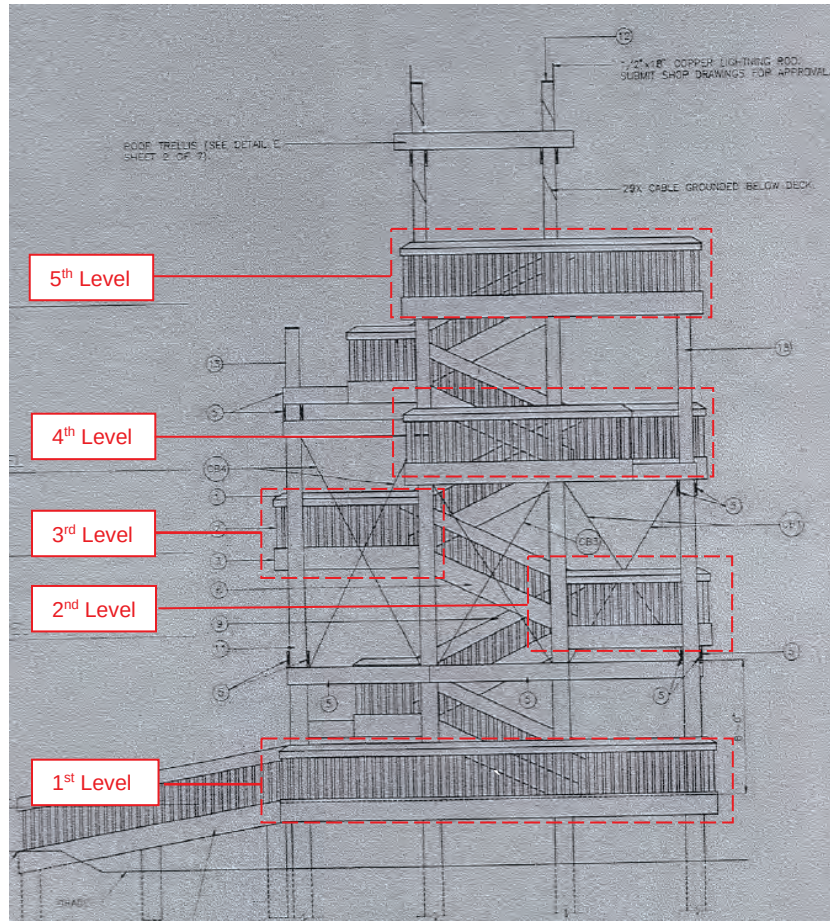
Exhibit 1 – East Elevation of Observation Tower, 1994 Office of the County Engineer

Based on our review of the provided documentation, BillerReinhart understands that the subject observation tower structure was originally constructed in 1994 and subsequently repaired and reinforced in 2005/2006. The tower structure consists of five (5) levels of observation decks and two (2) intermediate landings, one between the 1<sup>st</sup> and 2<sup>nd</sup> levels and the other between the 4<sup>th</sup> and 5<sup>th</sup> levels (Refer to *Exhibit 1* below).

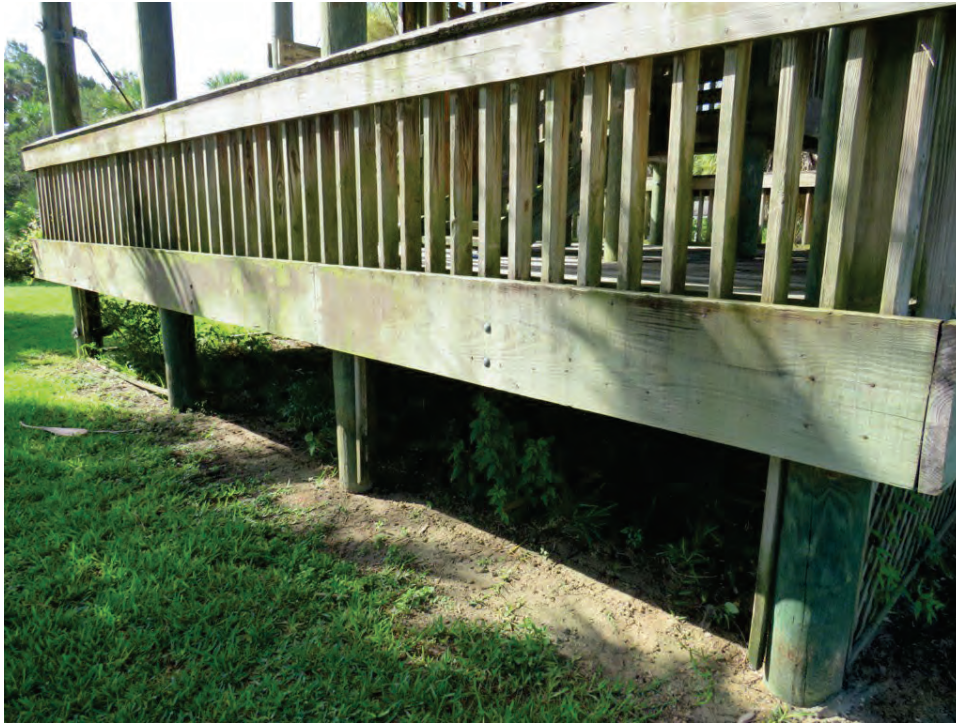
Figure A-5

| <b>Table A – Documented Observations</b> | |
|---|---|
| Organic growth and staining along the exterior rails, balusters, and fascia boards | <i>Figures A-5 and A-6</i> |

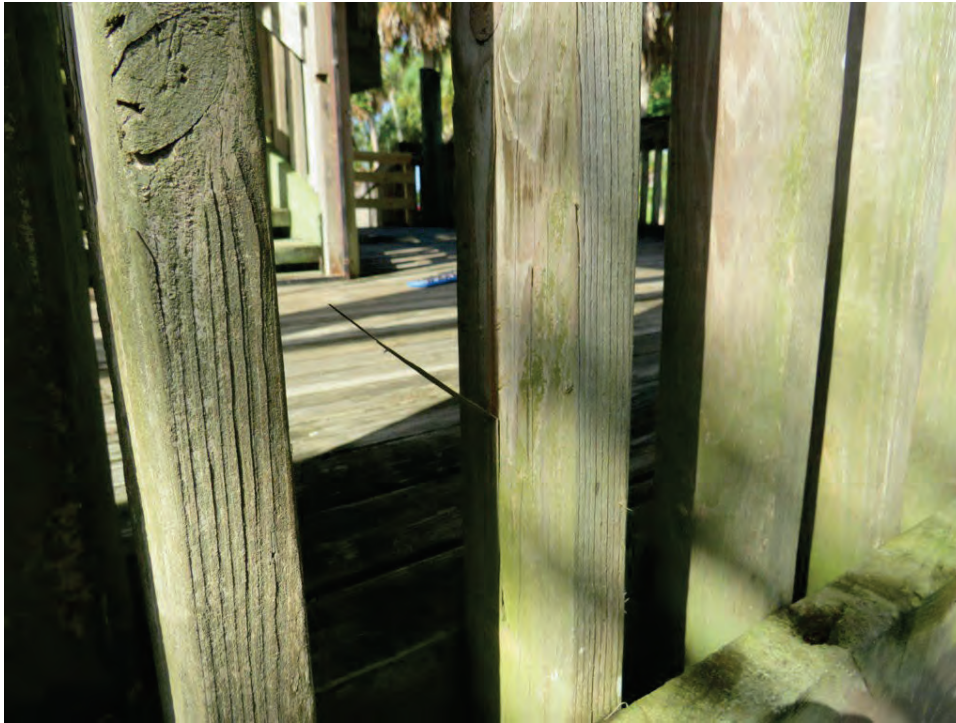
Figure A-7

| <b>Table A – Documented Observations</b> | |
|---|---|
| Surface wear and minor separation along the perimeter rail balusters | <i>Figures A-7 and A-8</i> |

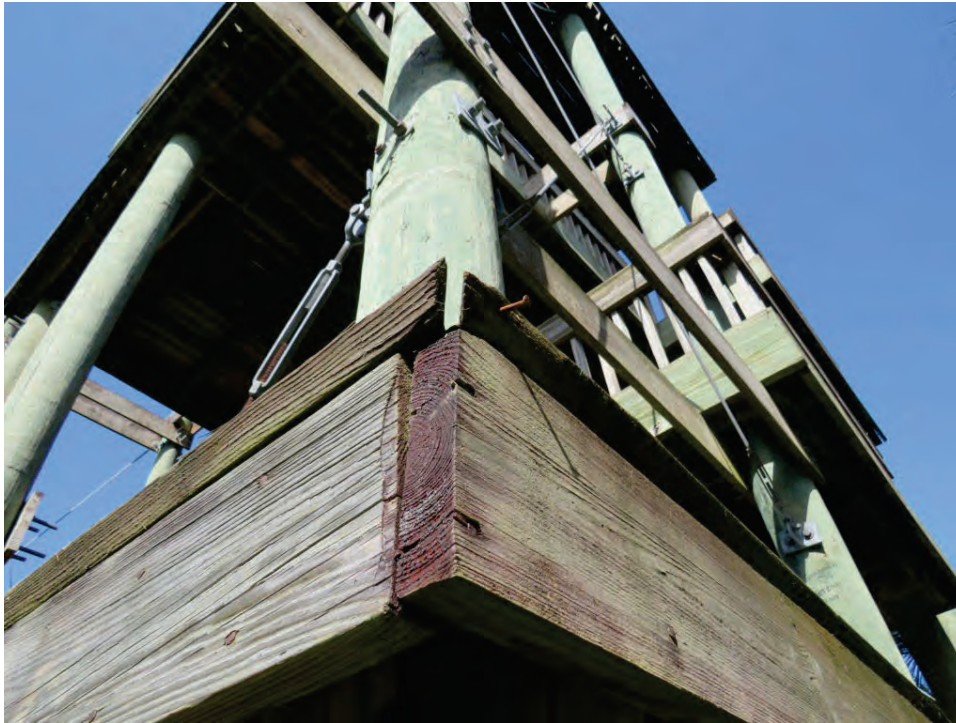
Figure A-11

| <b>Table A – Documented Observations</b> | |
|---|---|
| Missing or protruding fasteners along the perimeter railing caps, fascia boards, and balusters | <i>Figures A-10 and A-11</i> |

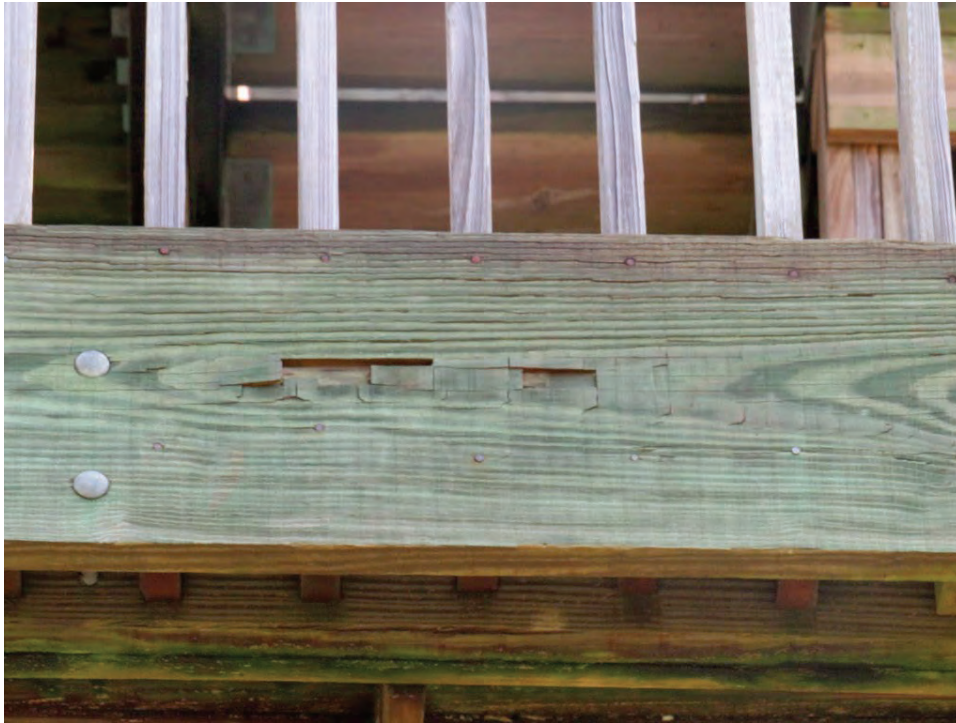
Figure A-17

| <b>Table A – Documented Observations</b> | |
|---|---|
| Surficial decay along the lower fascia board along the south elevation of the 3 <sup>rd</sup> level railing | <i>Figure A-17</i> |

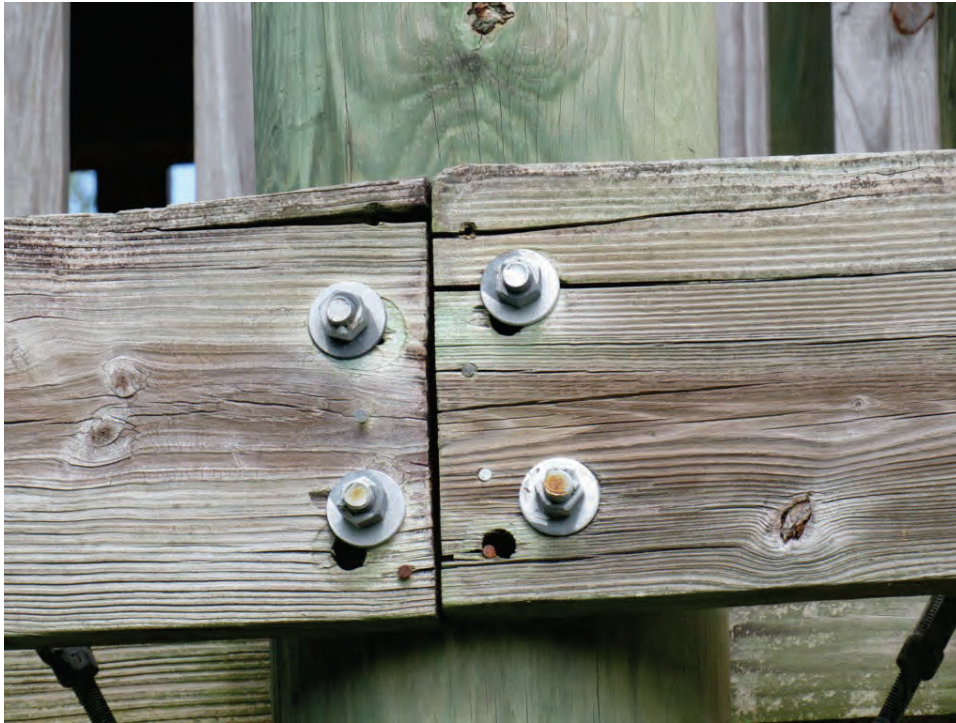
Figure A-21

| Separation, deflection, missing fasteners, and holes between the lateral bracing at the 3 <sup>rd</sup> pole from the north along the east elevation | <i>Figure A-21</i> |

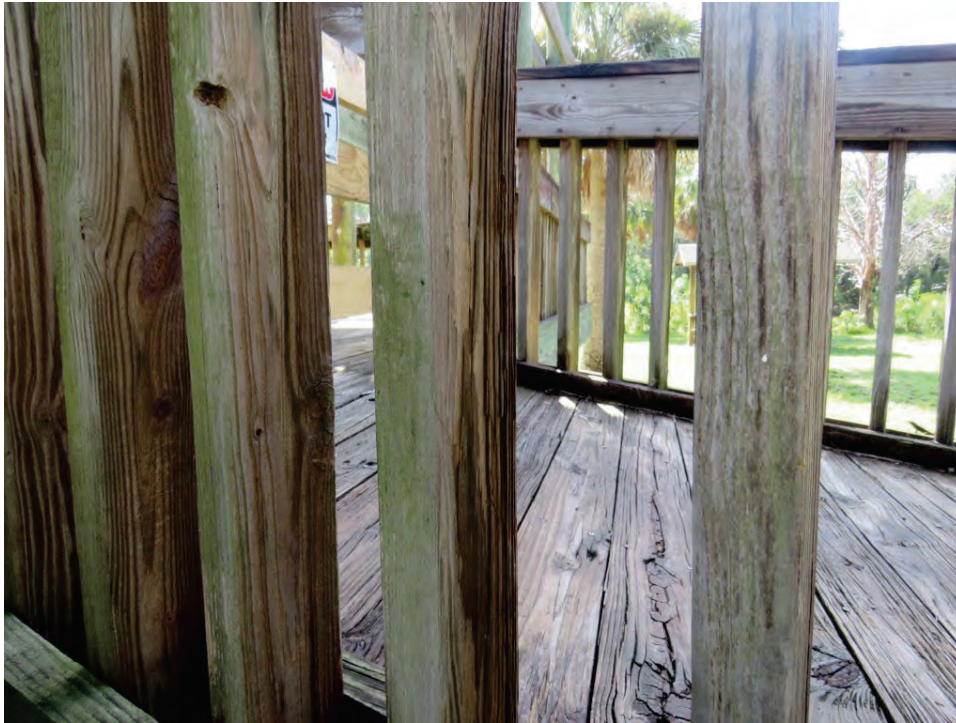
Figure A-47

| Sporadic areas of separation/splits, section loss, and deterioration along railing balusters | <i>Figures A-47 and A-48</i> |

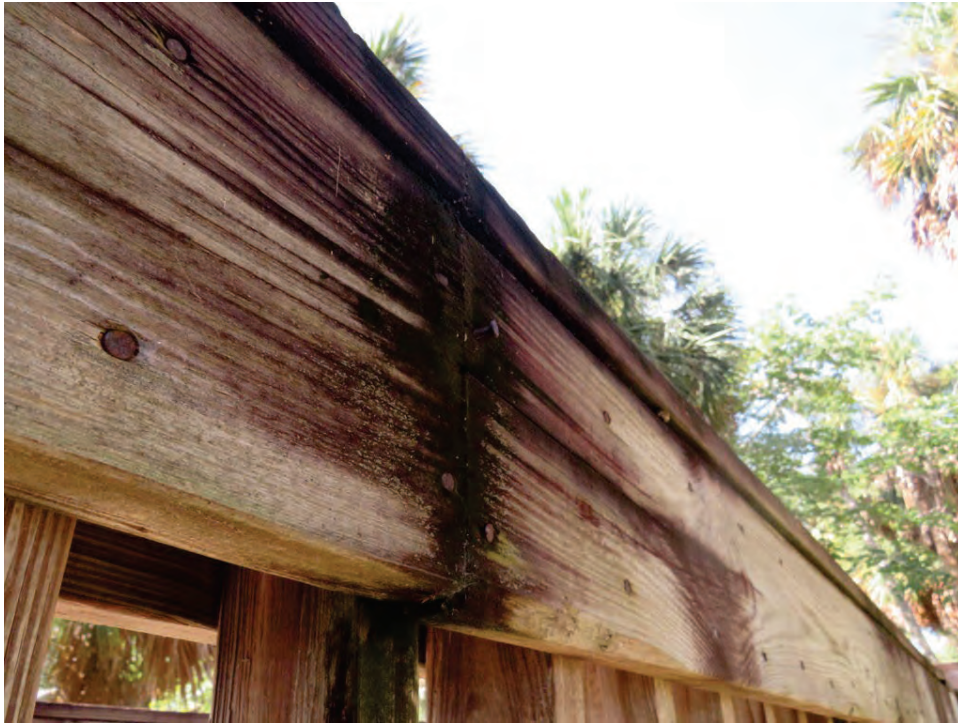
Figure A-49

| Organic growth with loose fasteners at sporadic locations along the exterior rails | <i>Figure A-49</i> |

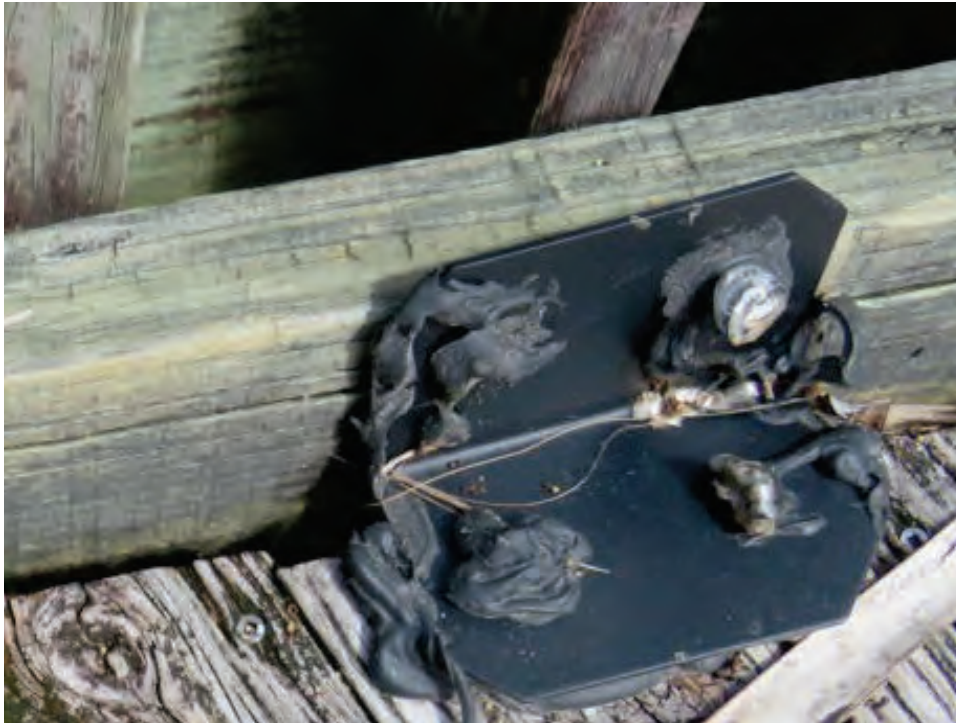
Figure A-55

| Metal angle brace with deteriorated fasteners at an isolated location along the entrance ramp | <i>Figure A-55</i> |
