Road Safety Audit Report

Spring Hill Drive from US 19 to east of Kenlake Avenue.

Hernando County, Florida

April 2025

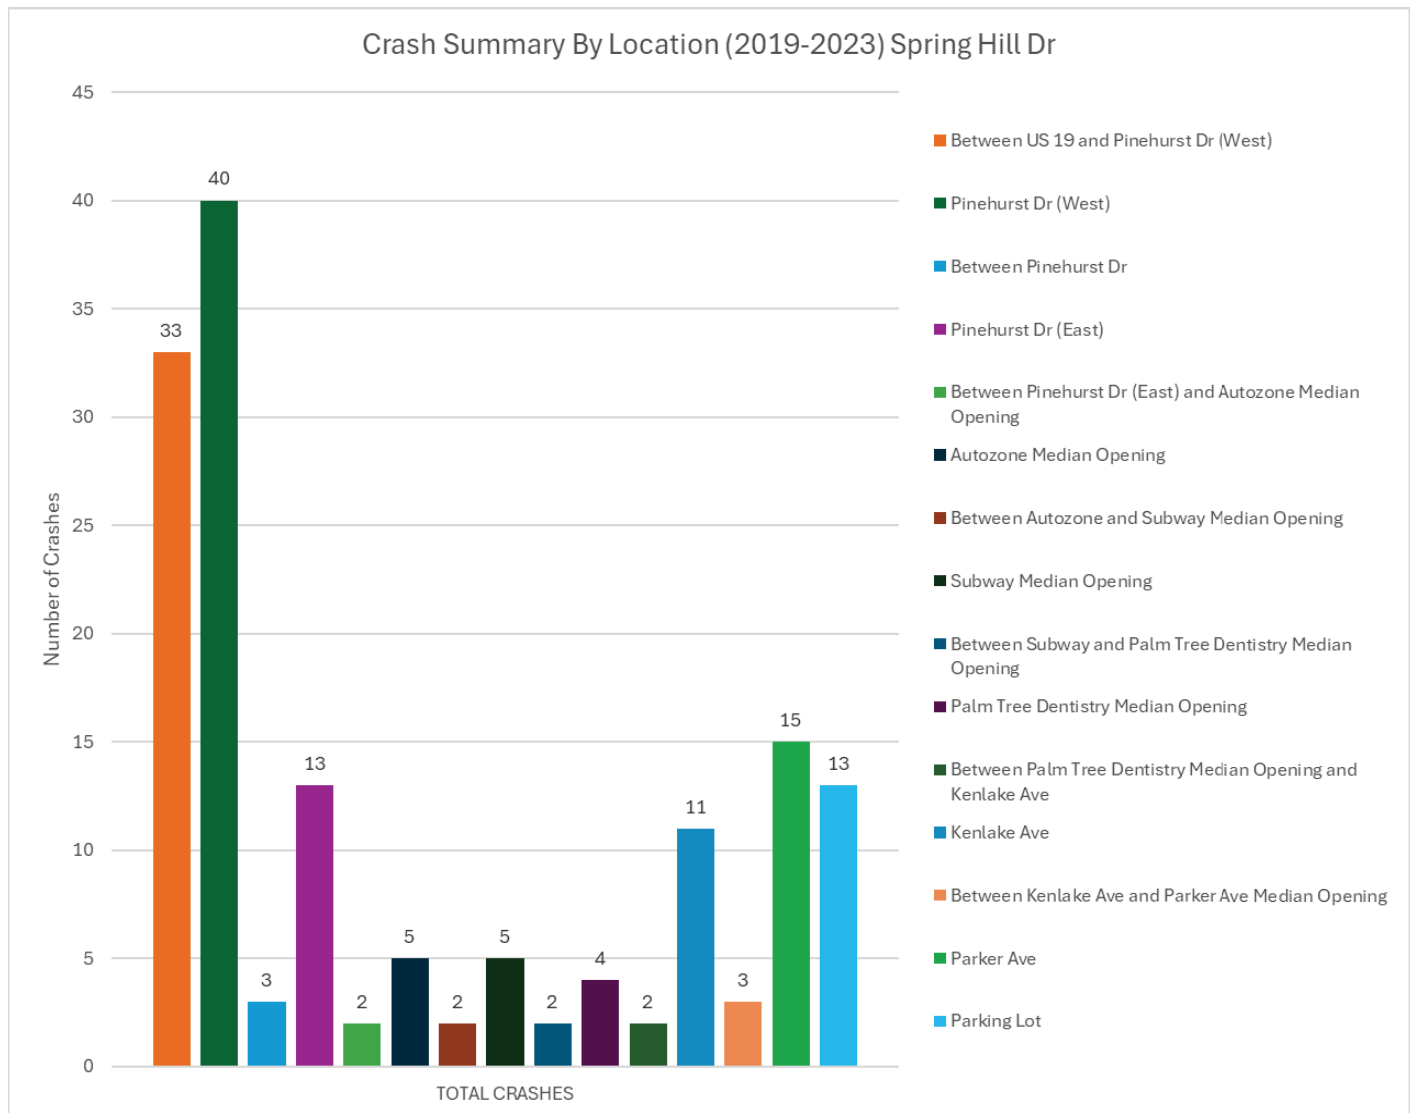
Figure 3-1. Crashes by Intersection

The crash frequencies by location, as shown in **Figure 3-1**, indicate that most of the crashes occurred Between US 19 and Pinehurst Dr (West Location), Pinehurst Dr (West Location), Parker Ave, Pinehurst Dr (East Location) and Kenlake Ave.

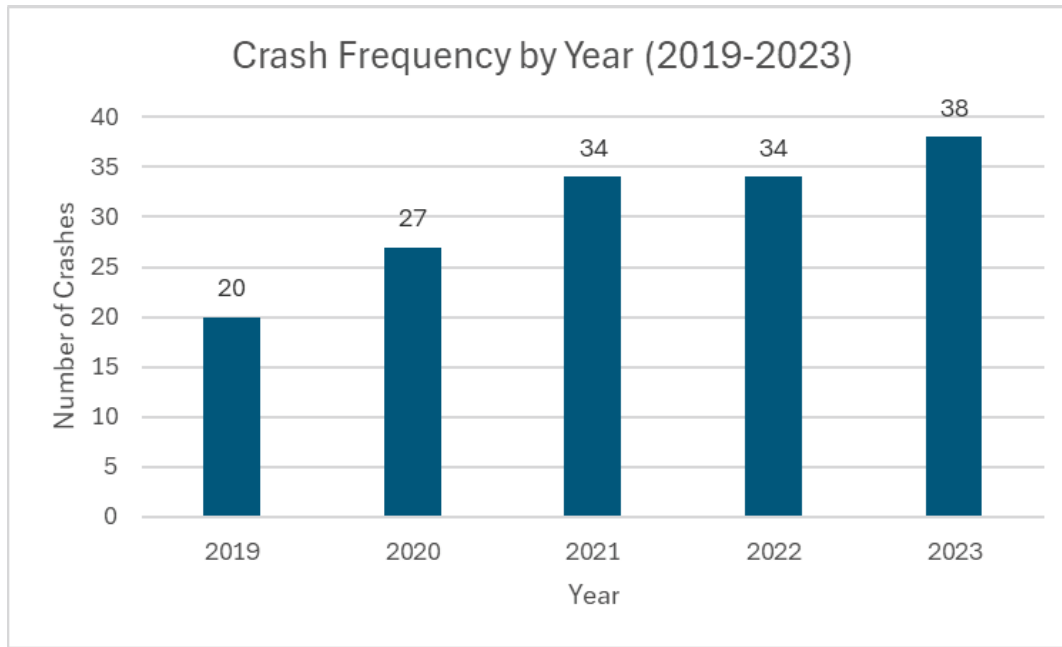
Figure 3-2. Crashes by Year

The crash frequency and severity by year are shown in **Figure 3-2** and **Figure 3-3**. The number of crashes has been on the rise over the study period:
