RESOLUTION NO. 2025-103

Road Safety Audit Report

Spring Hill Drive from US 19 to east of Kenlake Avenue.

Hernando County, Florida

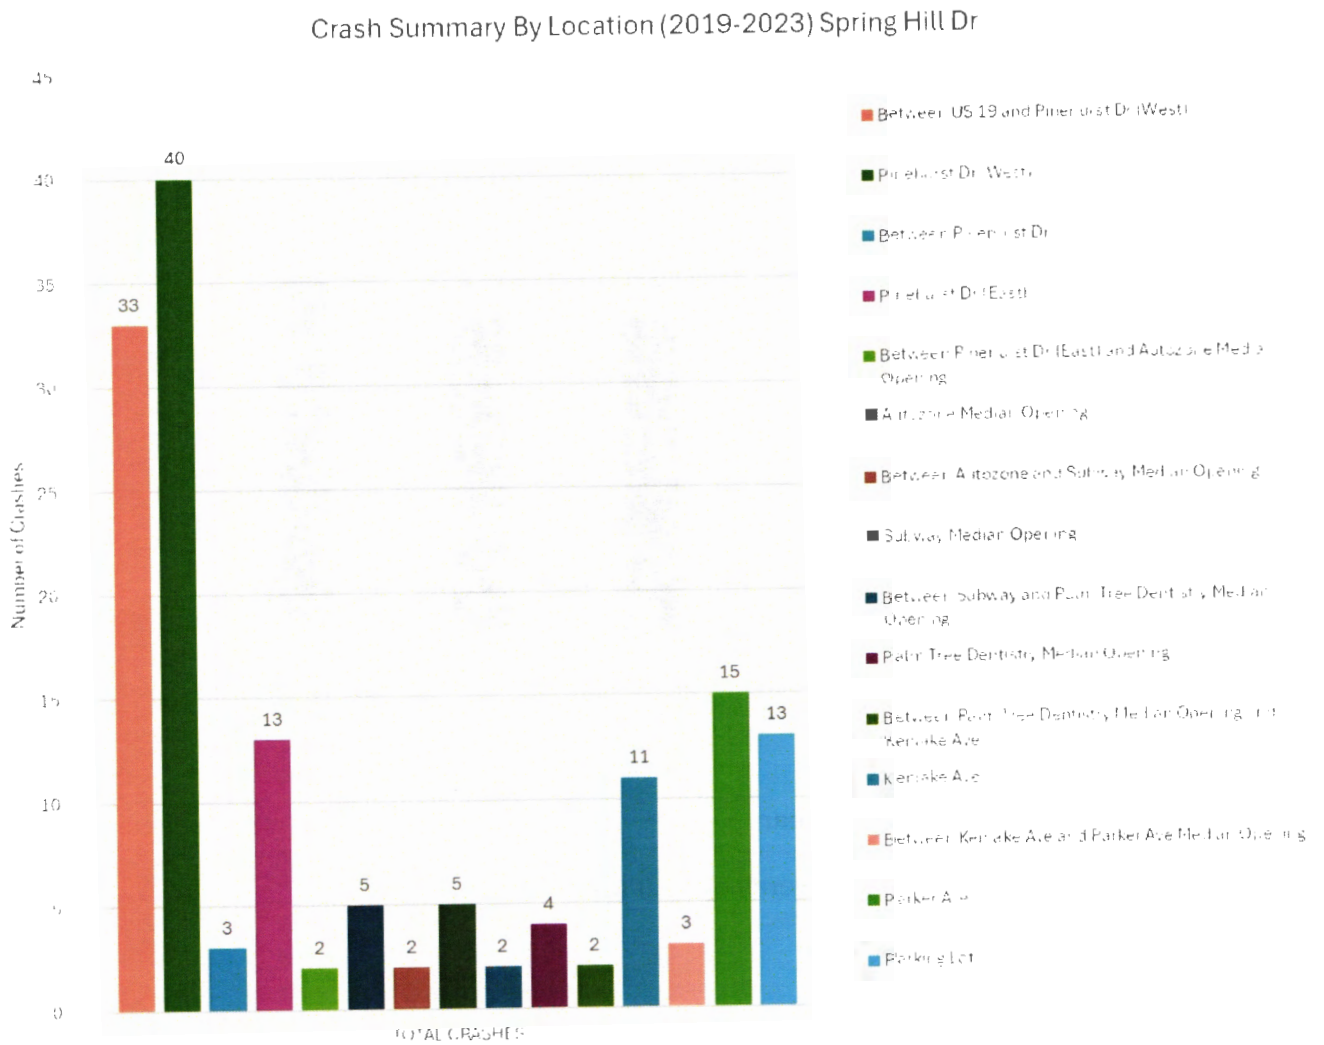
Figure 3-1. Crashes by Intersection

The crash frequencies by location, as shown in **Figure 3-1**, indicate that most of the crashes occurred Between US 19 and Pinehurst Dr (West Location), Pinehurst Dr (West Location), Parker Ave, Pinehurst Dr (East Location) and Kenlake Ave.

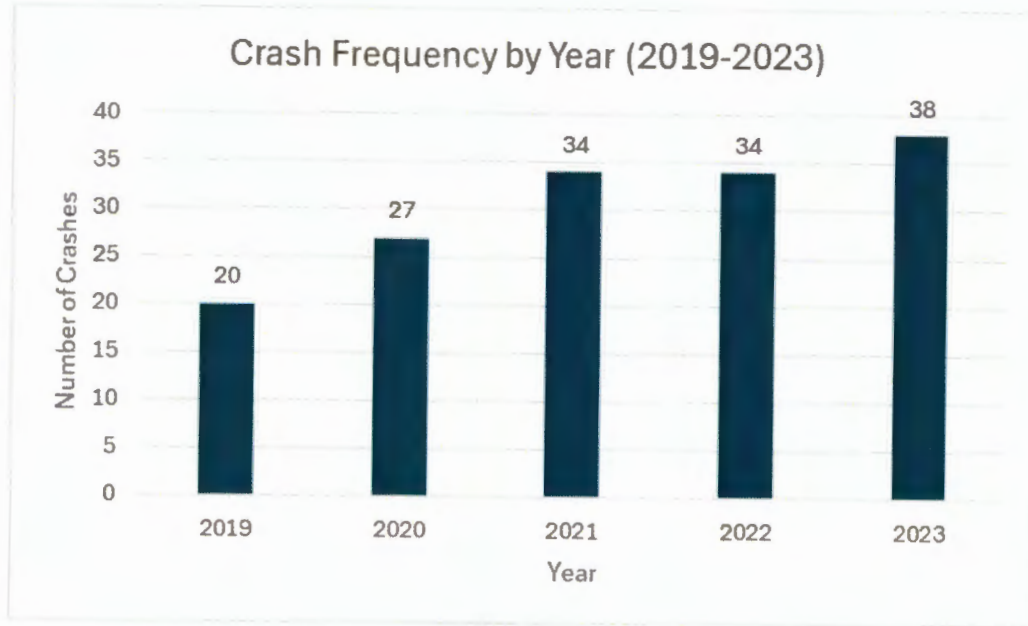
Figure 3-2. Crashes by Year

The crash frequency and severity by year are shown in **Figure 3-2** and **Figure 3-3**. The number of crashes has been on the rise over the study period:
