ADA Site Review and Comments

Project: **Chinsegut Hill Retreat**
22495 Chinsegut Hill Rd, Brooksville, FL 34601

Survey Date/Time: **May 25, 2021 @ 9:15 am**

Summary: **Accessible path slopes/surfaces, accessible parking space, ramps slope, emergency egress accessibility**

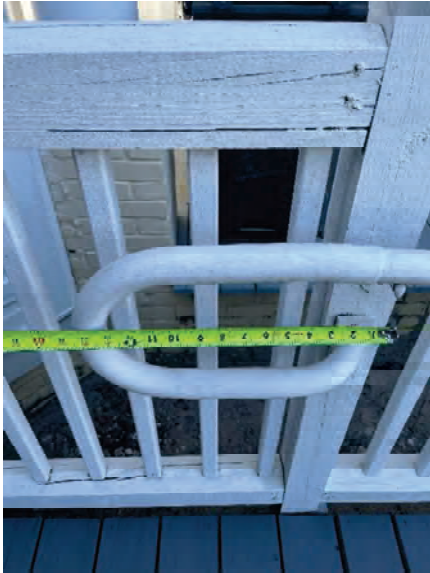
Figure 16, Handrail Return

Handrail Height: 34.75" (34"-38" allowed FAC 505.4)
 Handrail Dia: 1.5" (1.5" required FAC 505.6)
 Handrail Extension: 14" (12" min. Required FAC 505.10)
 Handrail Clear: 1.5" (1.5" min. clearance required FAC 505.5)

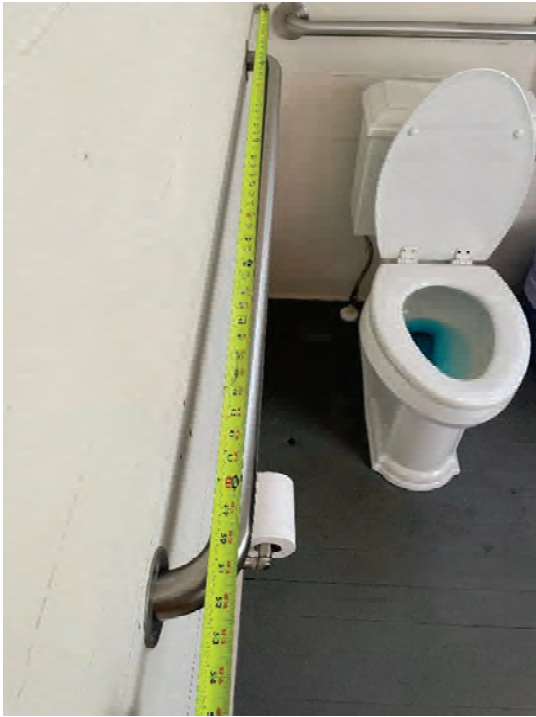
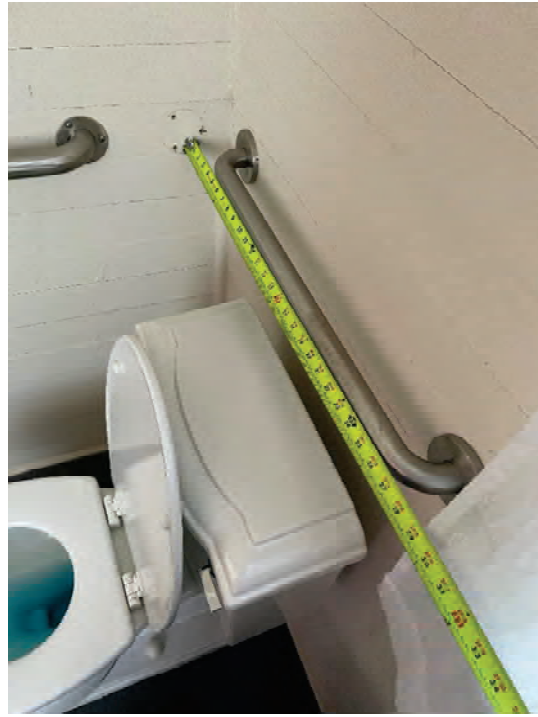
Figures 29 & 30: Grab Bars

- ✘** Water Closet Height: 17.5" (19" Required) (Figure 27)
- +** Side Clearance: 18" (18" required) (Figure 28)
Flush Lever on Room Site: Yes
Lavatory Depth: 21" (19" required) (Figure 31)
Controls: Levers are Historic (Exempt)
Height: 33" (32" – 34" Required) (Figure 33)
- ✘** Lavatory Side Clearance: 4" (6" required) (Figure 32)
Scald Protection: Missing (Figure 34)
- +** Door Clearance: Push 23" (12" Required) Pull 18.5" (18" Required 24" Preferred)
Door Signage: Sign at 54" AFF w./ Brail (Figures 35-36)
- ✘** Grab Bars: 24" Rear 48" Side (36" Rear and 48" Side) (Figures 29, 30)
35" High (34" – 36" Allowed) (Figure 26)
(Historic Exception Allowed for Window)

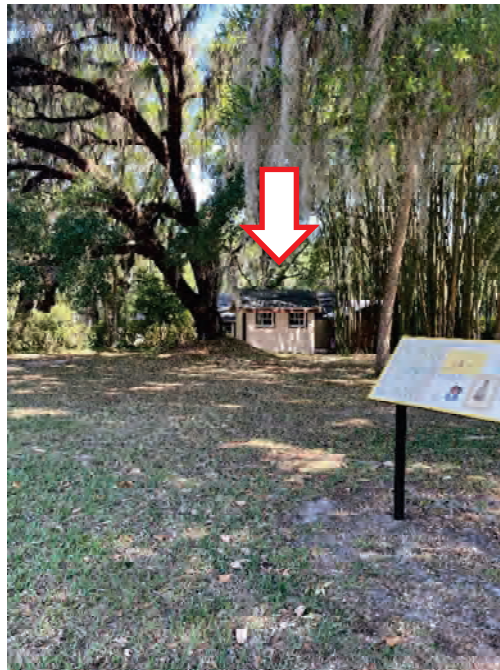
Figure 48: Bathhouse

An exterior bathhouse is located to the east of the classroom and South of Cabin 1. This bathhouse is not accessible under the ADA and cannot be modified to meet ADA requirements. Since there are ADA bathing facilities in the Accessible Cabin meeting the county and requirements for such facilities and an accessible restroom within 500' of this location this structure is excluded from this report.

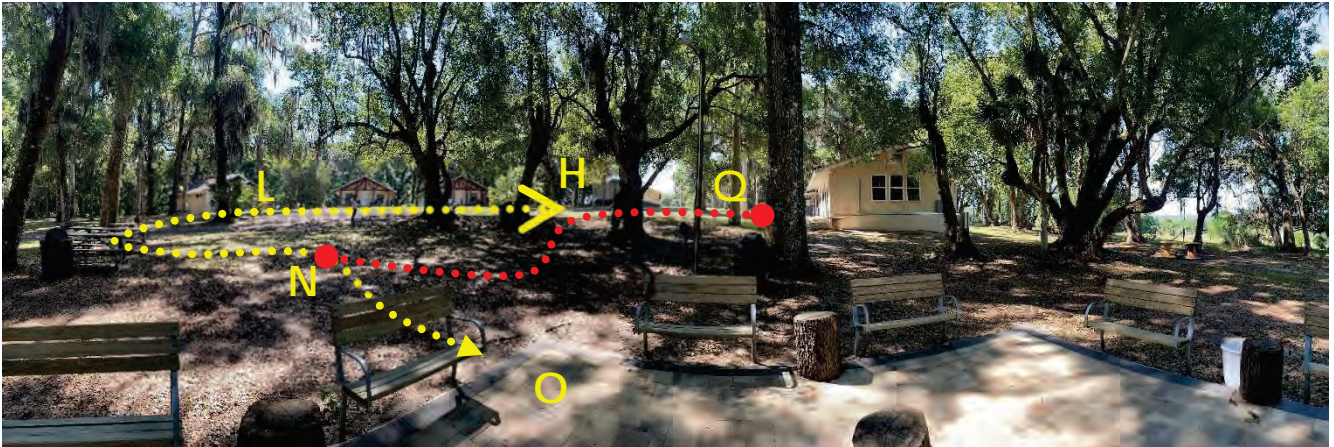
Figure 57: Accessible Path H-O (yellow) and O-Q (red)

H-Q Accessible Path: No Accessible Path exists connecting public spaces on the site to include the Manor House (B), Parking Area (A&E), Classroom Cottage 2 (K), Fire Pit (O) and Dining Hall (Q). Excluded from this requirement are cottages 4-7 which are not required to be on an accessible route as these are not accessible lodging. (Figure 63)

Possible Solution: Install a 5'-0" wide concrete sidewalk (min. 4" thick @ 2500 psi with control joints in 5'-0" increments) from the Manor House to Dining Hall (connecting points A, D, E, G, H, K, O and Q). Potential path indicated in (Figures 56-57). Path shall be no greater than 5% in slope in the direction of travel with a maximum 2% cross slope which is possible in

the general path shown in Figure 6. The sidewalk can be curved to fit with the dynamics of the land, reduce slope to less than 5%. prevent abrupt changes in direction requiring landings and avoid trees and tree roots. (Figures 57-61, 63)
