**BOARD OF COUNTY COMMISSIONERS
LAKE COUNTY, FLORIDA
OFFICE OF THE COUNTY MANAGER
AGENDA ITEM COVER SHEET**

SUBJECT: Agreement between Lake County and Seminole County for Medical Examiner

BUILDING DESCRIPTION

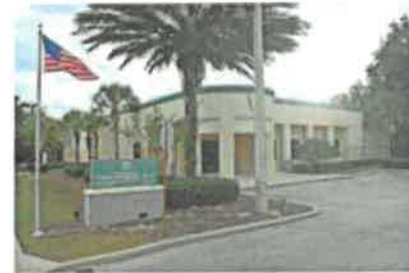
Constructed in year 2000, the building currently houses the District 5 Medical Examiner. The facility consists of a single-story building with an auxiliary generator and HVAC equipment located at the south and east ends of the building. The building is approximately 8,770 sf of enclosed floor area and a garage of approximately 1,265 sf. The space includes offices (including Doctor's), cooler, morgue, storage and supply rooms. It is assumed that the building walls rest upon spread footings and the interior structural columns rest upon isolated concrete column bases. There are no signs of damage or settlement. Exterior walls consist of a combination of pre-cast panels and concrete masonry units and are generally in very good condition. The exterior doors and windows are glazed in metal frames. The corrugated metal roof deck is supported by steel bar joists and structural members. The roof is a low slope, membrane on insulation system which was reported to have been recently replaced. The building is fully sprinkled.
