**BOARD OF COUNTY COMMISSIONERS
HERNANDO COUNTY, FLORIDA
WORK AUTHORIZATION AGREEMENT**

PRE-QUALIFICATION FOR DEMOLITION CONTRACTORS - RFQ NO. 23-RFQ00435/TPR QUOTE NO. 2

RE-QUOTE FOR DEMOLITION OF PORT AUTHORITY & OBSERVATION TOWER

GLE Associates, Inc. (GLE) performed a pre-demolition survey for asbestos-containing materials (ACM) and lead-containing paint (LCP) on November 20, 2024, at the Hernando Beach Recreation Center, located at the address referenced above in Spring Hill, Florida. The survey was performed by Mr. Eric Penvose with GLE. This report outlines the sampling and testing procedures, and presents the results along with our conclusions and recommendations.

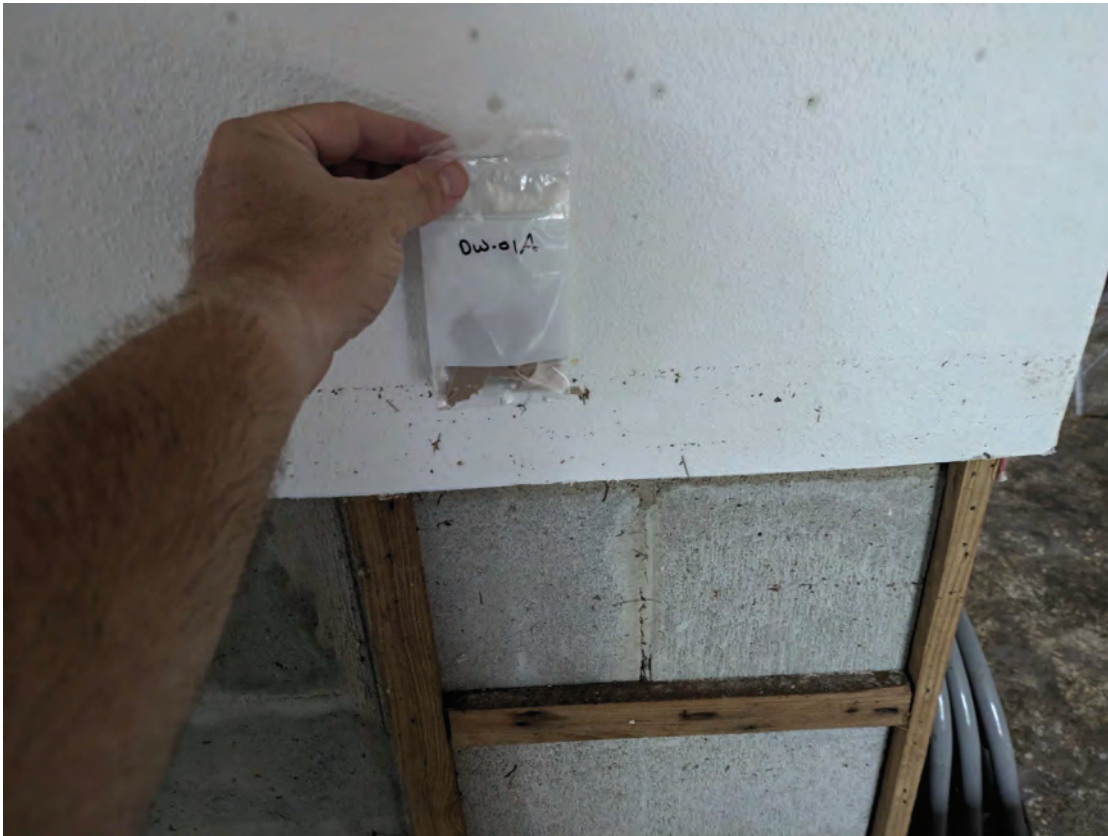
Figure
1

Upper Photo: DW-01

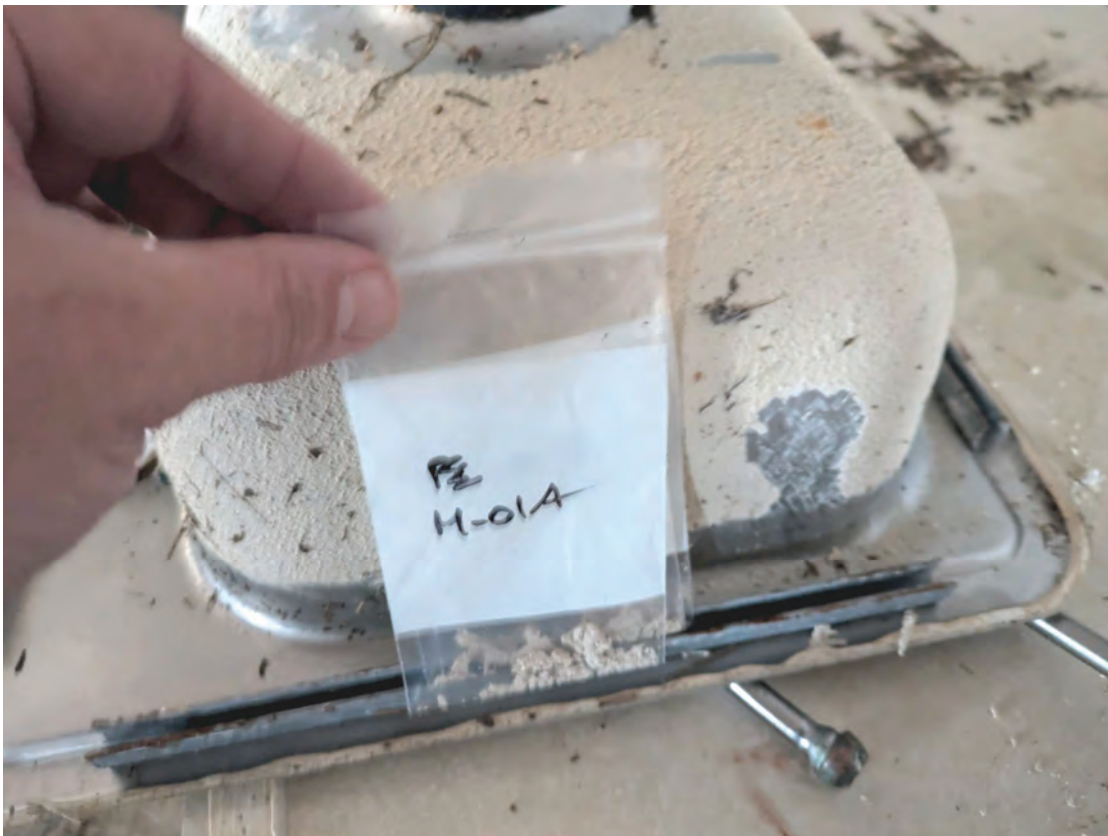
Lower Photo: M-01

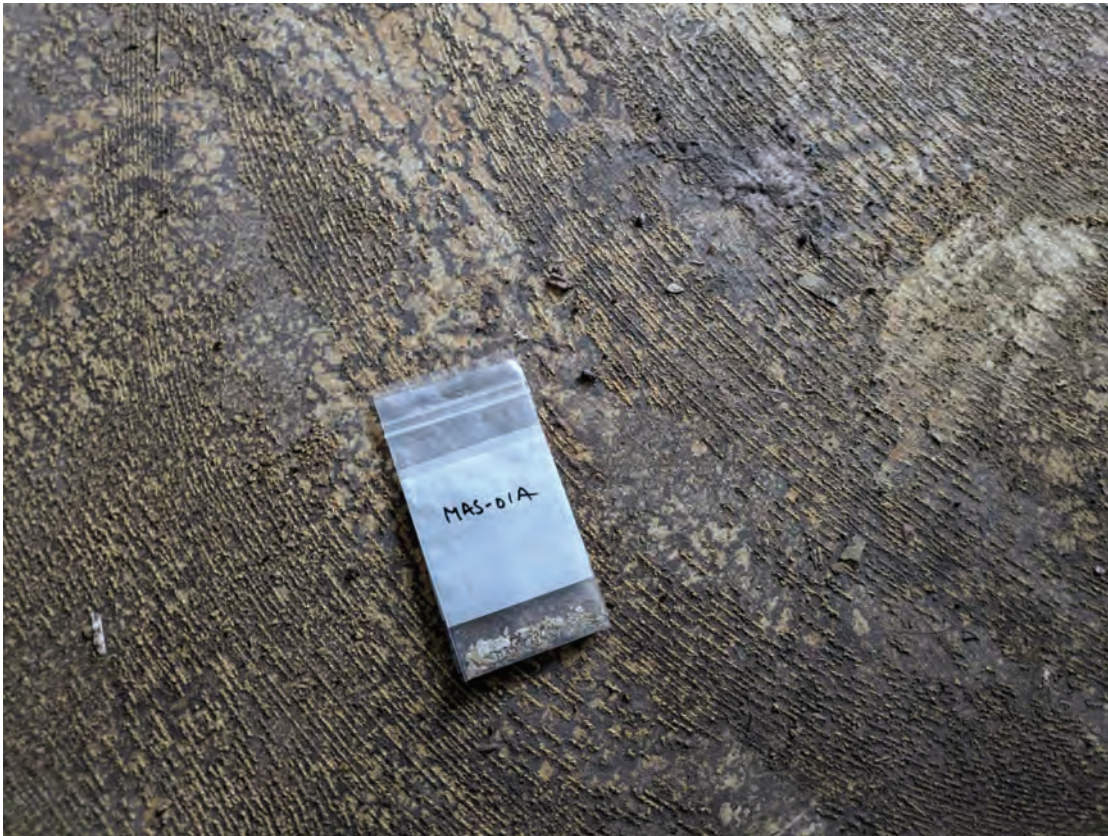
Figure
2

Upper Photo: MAS-01

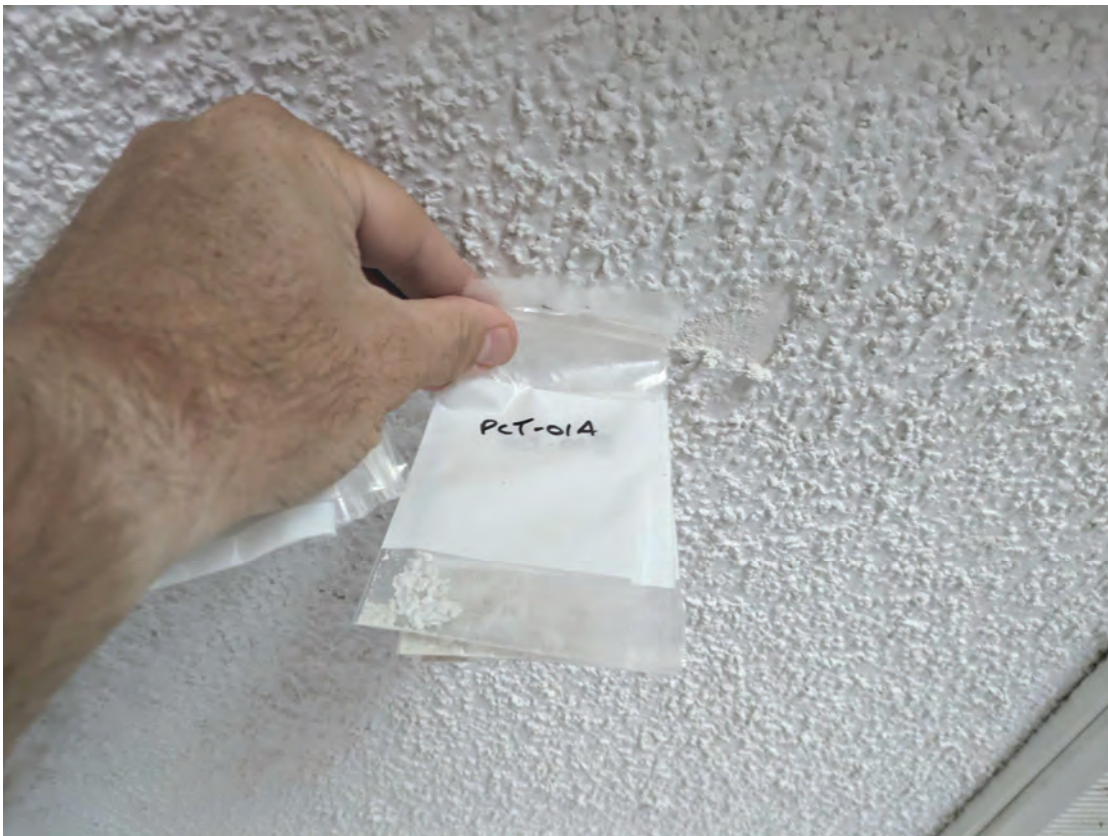
Lower Photo: PCT-01

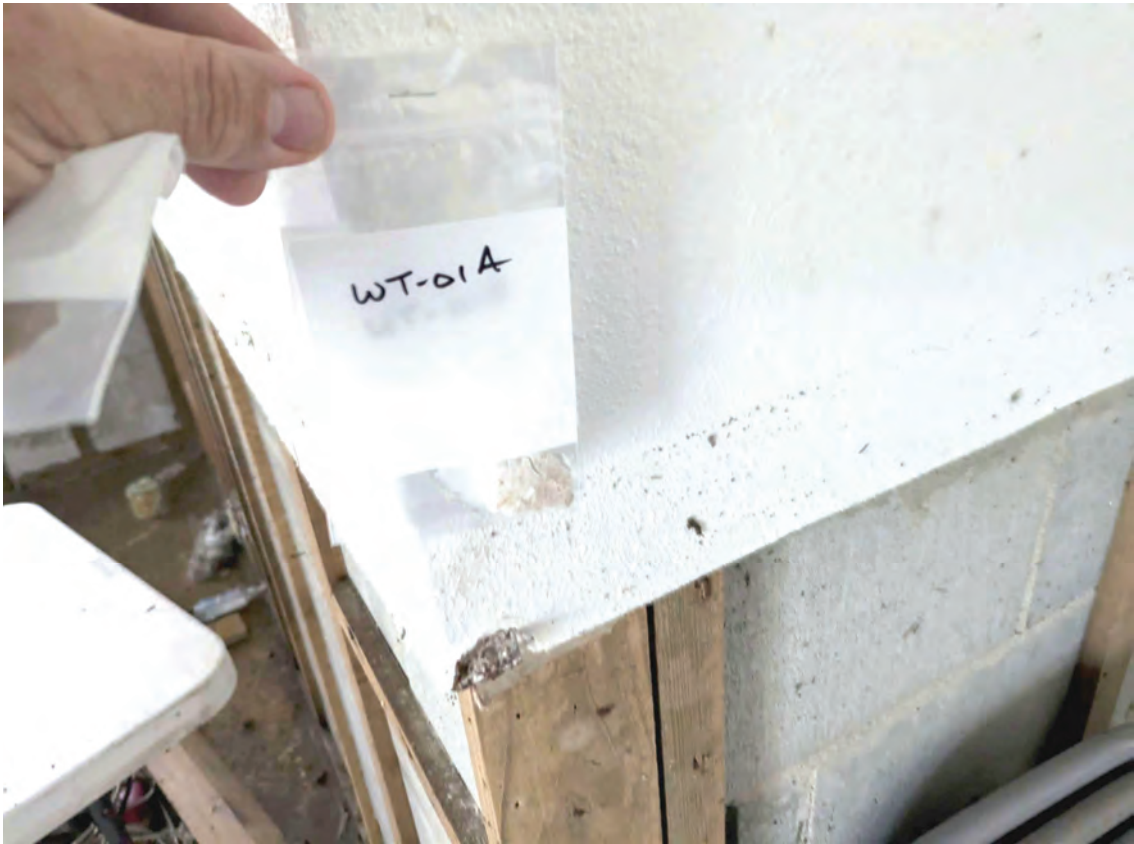
3

Upper Photo: WT-01

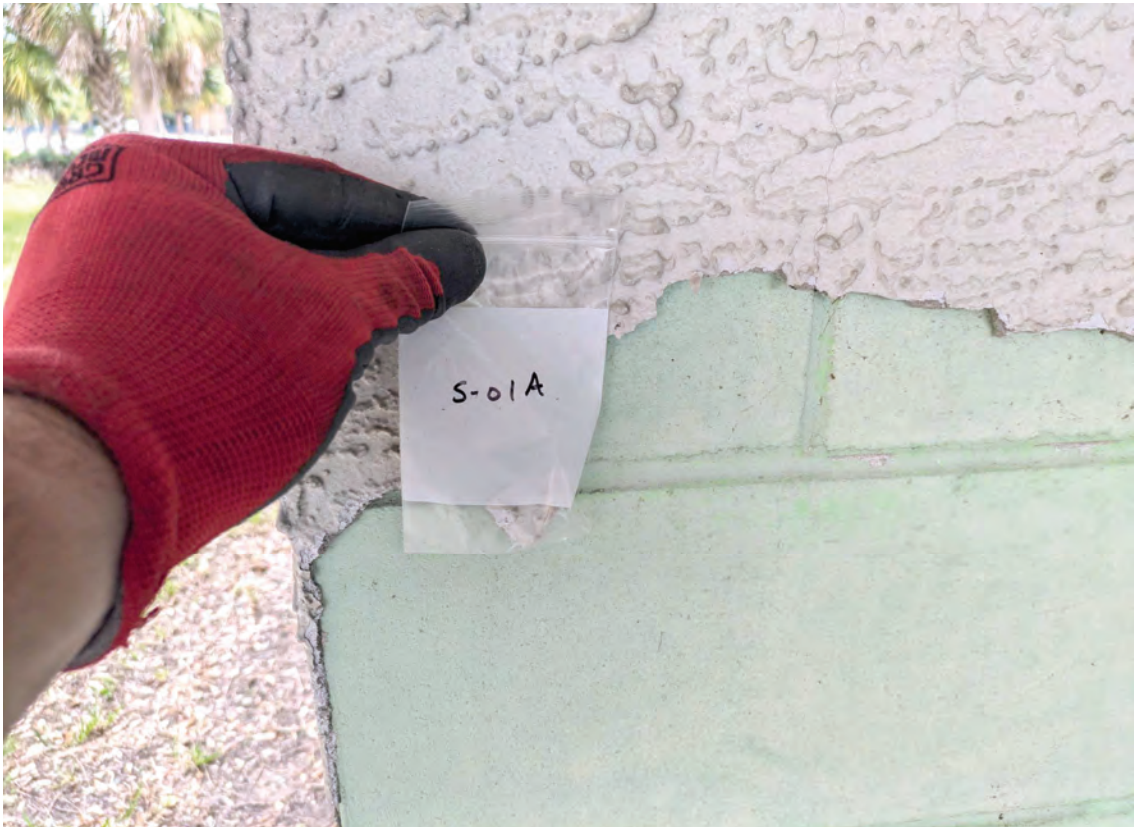
Lower Photo: S-01

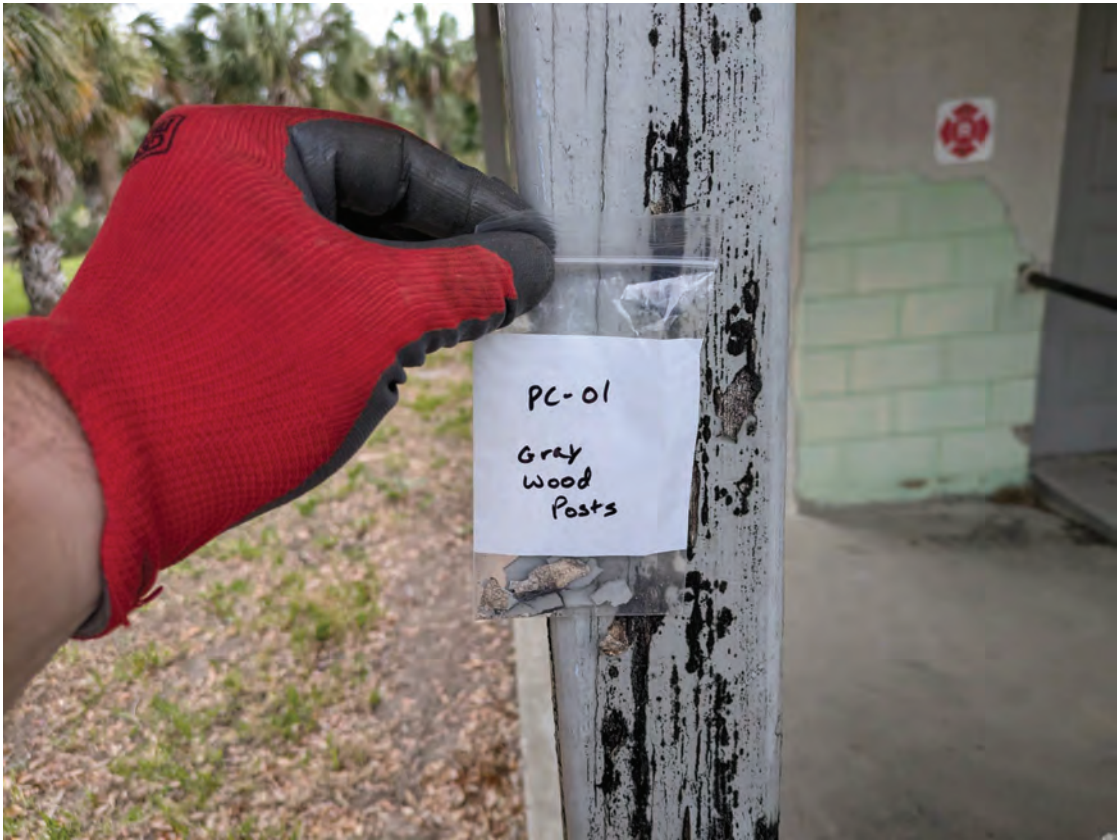
4

Upper Photo: PC-01

For all identified lead painted materials where abrasive blasting, welding, cutting and/or torch burning are planned, removal of lead paint is to be completed by a properly trained lead removal contractor.

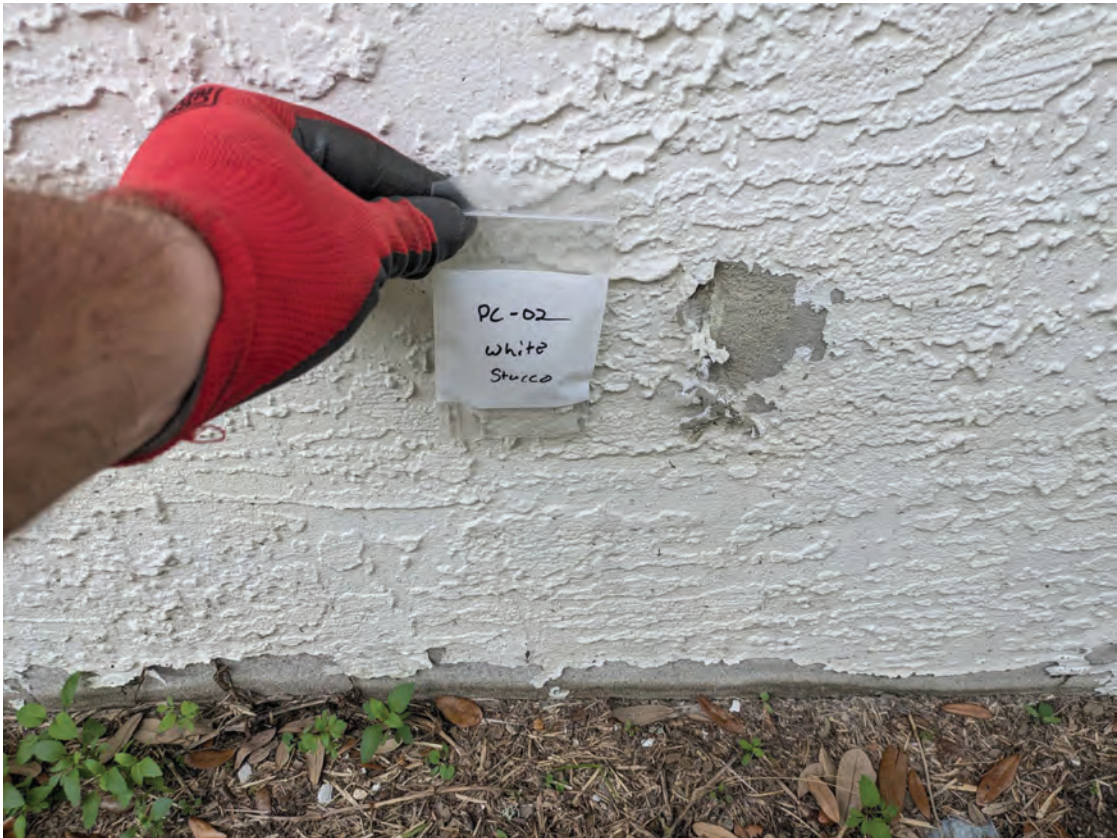
Lower Photo: PC-02

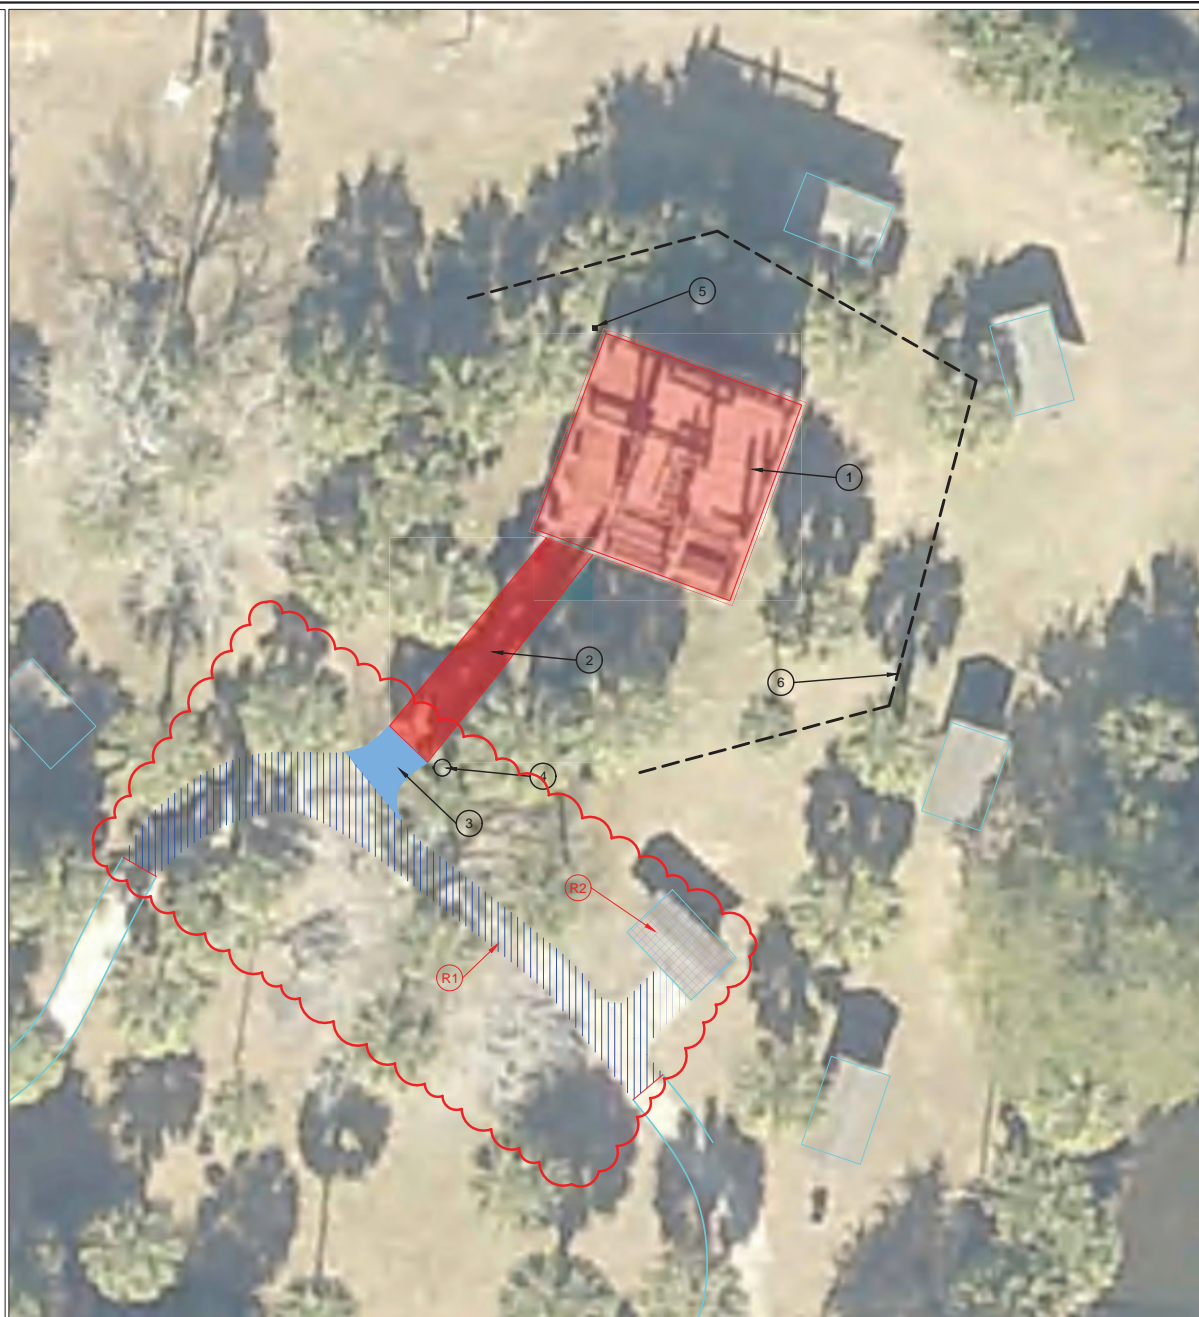
C-3.1

- ① REMOVE ALL OF THE STRUCTURE INCLUDING FOUNDATION SYSTEM
- ② REMOVE WOOD RAMP IN IT'S ENTIRETY
- ③ REMOVE CONCRETE SIDEWALK IN SOLID HATCHED AREA
- ④ GARBAGE RECEPTACLE TO BE REMOVED BY OWNER
- ⑤ HOSE BIB AND VALVE BOX TO BE REMOVED AND CAPPED BY OWNER
- ⑥ PROVIDE SILT FENCE FOR EROSION AND DEBRIS CONTROL
- (R1) REMOVE AND DISPOSE OF APPROXIMATELY 78' OF SIDEWALK
- (R2) REMOVE AND DISPOSE OF PAVILION

- . NO TRACKING OF DEBRIS ON RIGHT-OF-WAY TO INCLUDE PARKING LOT
- . DUST CREATED BY DEMOLITION SHALL BE MITIGATED BY USING WATER OR OTHER MEANS
- . ALL AREAS EFFECTED BY DEMOLITION SHALL BE FREE OF ANY DEBRIS
- . WHERE FOUNDATION AND SIDEWALKS WERE REMOVED BACK FILL WITH CLEAN FILL DIRT, WHEEL PACK AND GRADE TO MATCH EXISTING PROPERTY ELEVATIONS
- . SOD DEMOLITION AREA WITH PENSACOLA BIHAI
- . CONTRACTOR IS RESPONSIBLE TO REPLACE ANY CONCRETE SIDEWALK DAMAGE FROM DEMOLITION
- . CONTRACTOR SHALL PROVIDE PEDESTRIAN AND ADJACENT PROPERTY PROTECTION IF APPLICABLE
- . HERNANDO COUNTY RELINQUISHES ALL SALVAGE RIGHT
- . CONTRACTOR TO TRIM OAK AND MULBERRY TREE TO GAIN ACCESS TO OBSERVATION TOWER
- . CONTRACTOR TO SUPPLY PADLOCK TO SECURE BRIDGE GATE UNTIL COMPLETION OF PROJECT
- . CONTRACTOR TO BLOCK OF PARKING LOT AS NEEDED TO SAFE OFF WORK AREAS

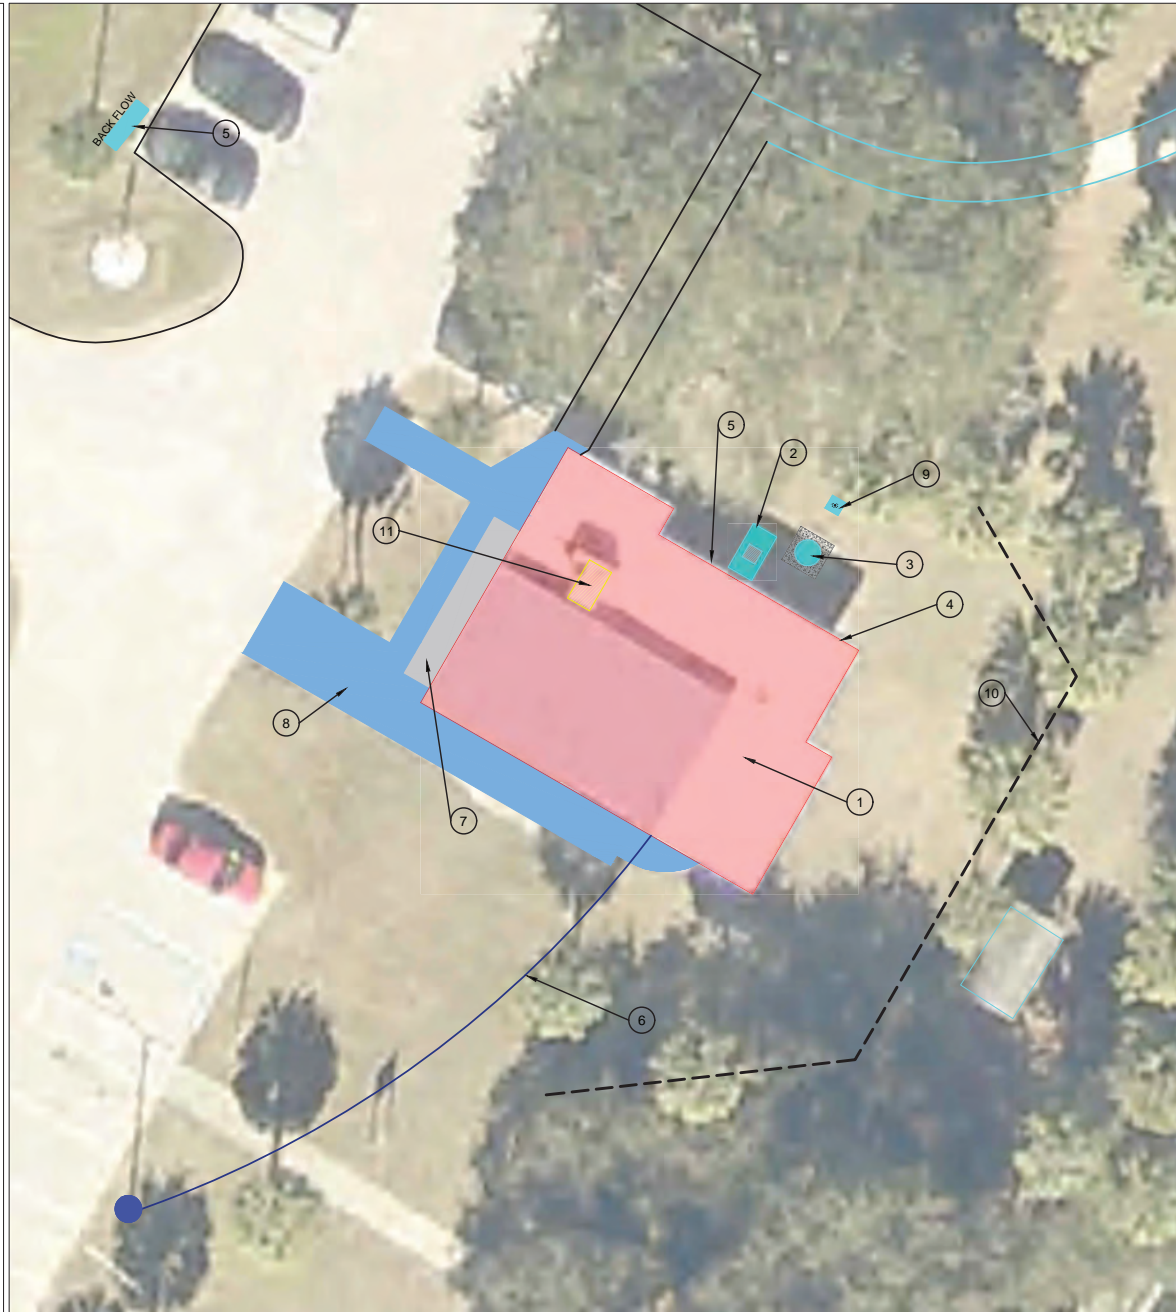
- ① REMOVE ALL OF THE STRUCTURE INCLUDING FOUNDATION SYSTEM
- ② PUMP SEPTIC TANK, CRUSH TANK AND BACK FILL WITH CLEAN FILL DIRT CAP SANITARY BEFORE ENTERING LIFT STATION
- ③ LIFT STATION TO STAY IN PLACE
- ④ LIFT STATION ALARM AND ELECTRIC ON BUILDING WALL WILL BE REMOVED BY OWNER
- ⑤ BACKFLOW TO REMAIN. DISCONNECT WATER AT BUILDING AND CAP. MARK OR RECORD ON PLANS WHERE WATER LINE WAS CAPPED
- ⑥ ELECTRIC DROP TO BE DISCONNECT FROM BUILDING BY WREC, OWNER TO FACILITATE
- ⑦ REMOVE VEGETATION IN FRONT OF BUILDING WITHIN SOLID HATCHED AREA
- ⑧ REMOVE CONCRETE WITHIN SOLID HATCHED AREA
- ⑨ CLEANOUT TO REMAIN
- ⑩ PROVIDE SILT FENCE FOR EROSION AND DEBRIS CONTROL
- ⑪ ROOF TOP UNIT TO BE DISCONNECTED BY OWNER. CONTRACTOR TO LIFT OF ROOF AND PLACE ON OWNERS TRUCK AND OR TRAILER. OWNER TO SUPPLY RIGGING FOR LIFTING RTU OFF ROOF

- . NO TRACKING OF DEBRIS ON RIGHT-OF-WAY TO INCLUDE PARKING LOT
- . DUST CREATED BY DEMOLITION SHALL BE MITIGATED BY USING WATER OR OTHER MEANS
- . ALL AREAS EFFECTED BY DEMOLITION SHALL BE FREE OF ANY DEBRIS
- . WHERE FOUNDATION AND SIDEWALKS WERE REMOVED BACK FILL WITH CLEAN FILL DIRT, WHEEL PACK AND GRADE TO MATCH EXISTING PROPERTY ELEVATIONS
- . SOD DEMOLITION AREA WITH PENSACOLA BIHAI
- . CONTRACTOR IS RESPONSIBLE TO REPLACE ANY CONCRETE SIDEWALK DAMAGE FROM DEMOLITION
- . PRE-DEMOLITION ASBESTOS AND LEAD-CONTAINING PAINT SURVEY REPORT AVAILABLE UPON REQUEST
- . CONTRACTOR SHALL PROVIDE PEDESTRIAN AND ADJACENT PROPERTY PROTECTION IF APPLICABLE
- . HERNANDO COUNTY RELINQUISHES ALL SALVAGE RIGHT (EXCLUDING ROOF TOP A/C UNIT)

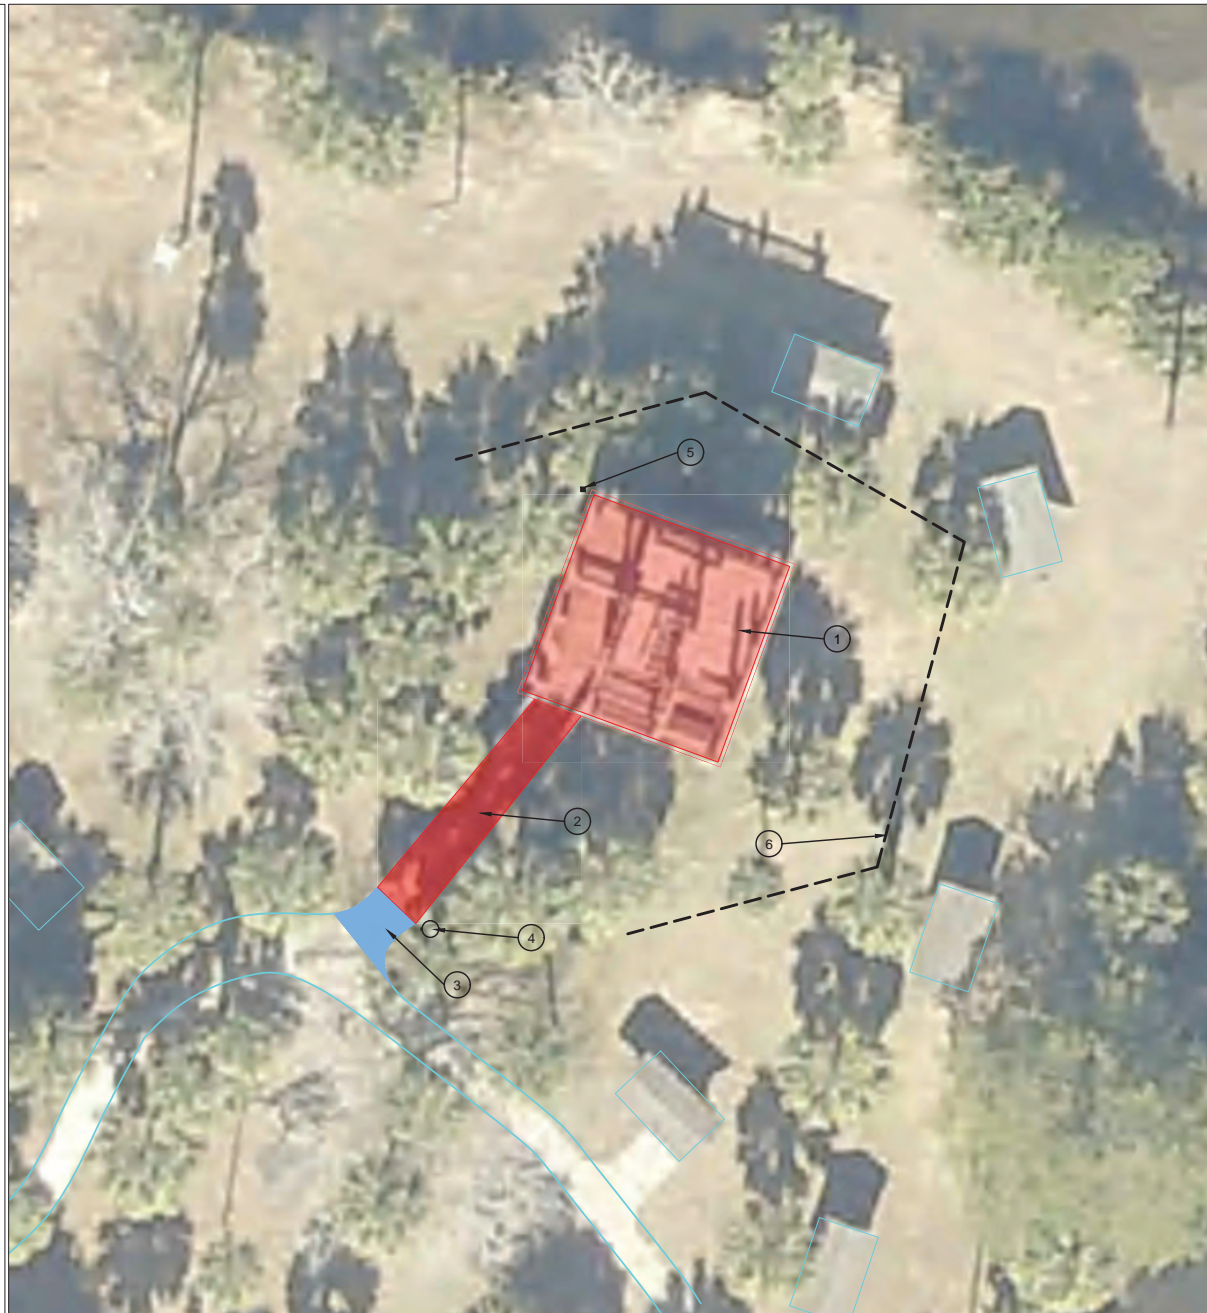
- ① REMOVE ALL OF THE STRUCTURE INCLUDING FOUNDATION SYSTEM
- ② REMOVE WOOD RAMP IN ITS ENTIRETY
- ③ REMOVE CONCRETE SIDEWALK IN SOLID HATCHED AREA
- ④ GARBAGE RECEPTACLE TO BE REMOVED BY OWNER
- ⑤ HOSE BIB AND VALVE BOX TO BE REMOVED AND CAPPED BY OWNER
- ⑥ PROVIDE SILT FENCE FOR EROSION AND DEBRIS CONTROL

- . NO TRACKING OF DEBRIS ON RIGHT-OF-WAY TO INCLUDE PARKING LOT
- . DUST CREATED BY DEMOLITION SHALL BE MITIGATED BY USING WATER OR OTHER MEANS
- . ALL AREAS EFFECTED BY DEMOLITION SHALL BE FREE OF ANY DEBRIS
- . WHERE FOUNDATION AND SIDEWALKS WERE REMOVED BACK FILL WITH CLEAN FILL DIRT, WHEEL PACK AND GRADE TO MATCH EXISTING PROPERTY ELEVATIONS
- . SOD DEMOLITION AREA WITH PENSACOLA BIHAI
- . CONTRACTOR IS RESPONSIBLE TO REPLACE ANY CONCRETE SIDEWALK DAMAGE FROM DEMOLITION
- . CONTRACTOR SHALL PROVIDE PEDESTRIAN AND ADJACENT PROPERTY PROTECTION IF APPLICABLE
- . HERNANDO COUNTY RELINQUISHES ALL SALVAGE RIGHT

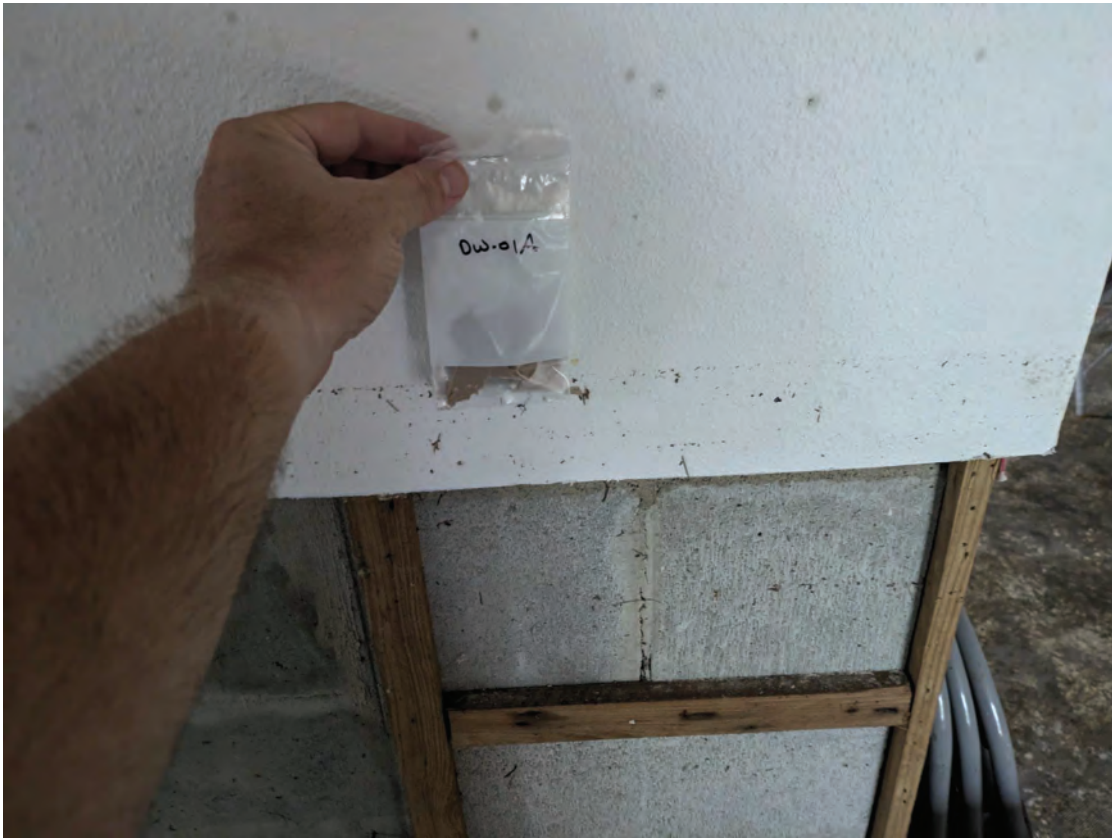
Figure
1

Upper Photo: DW-01

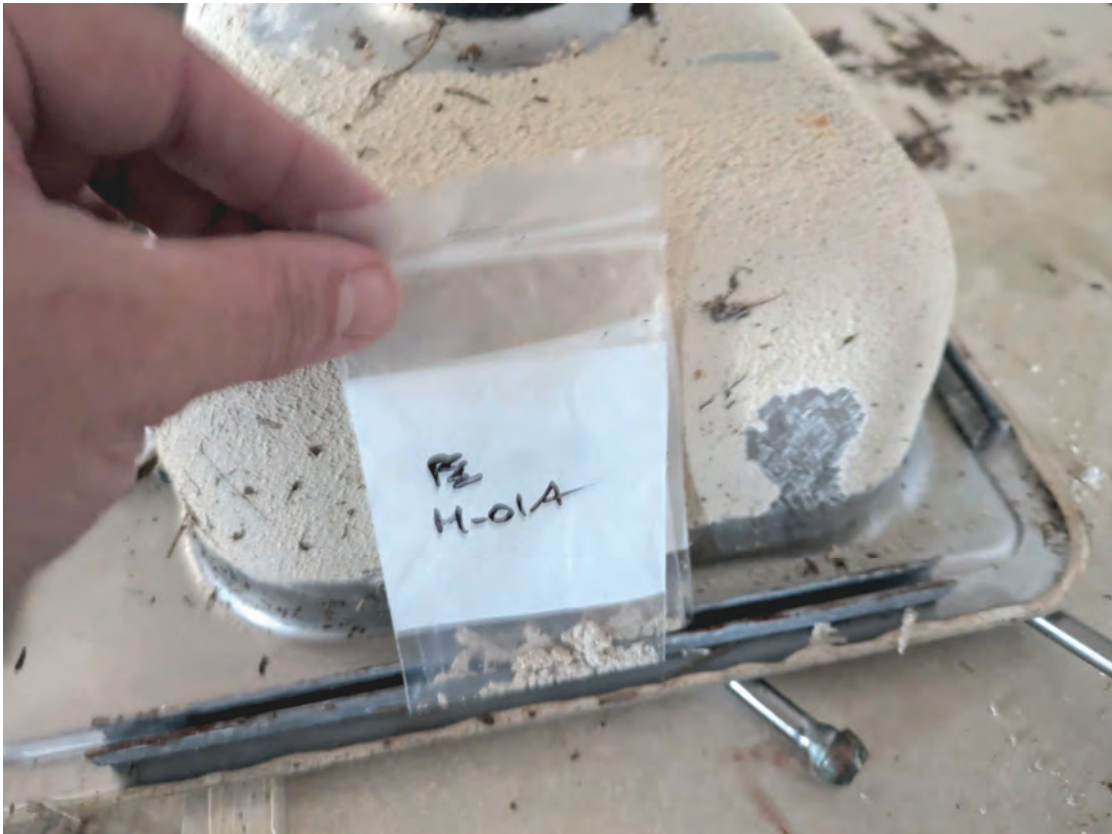
Lower Photo: M-01

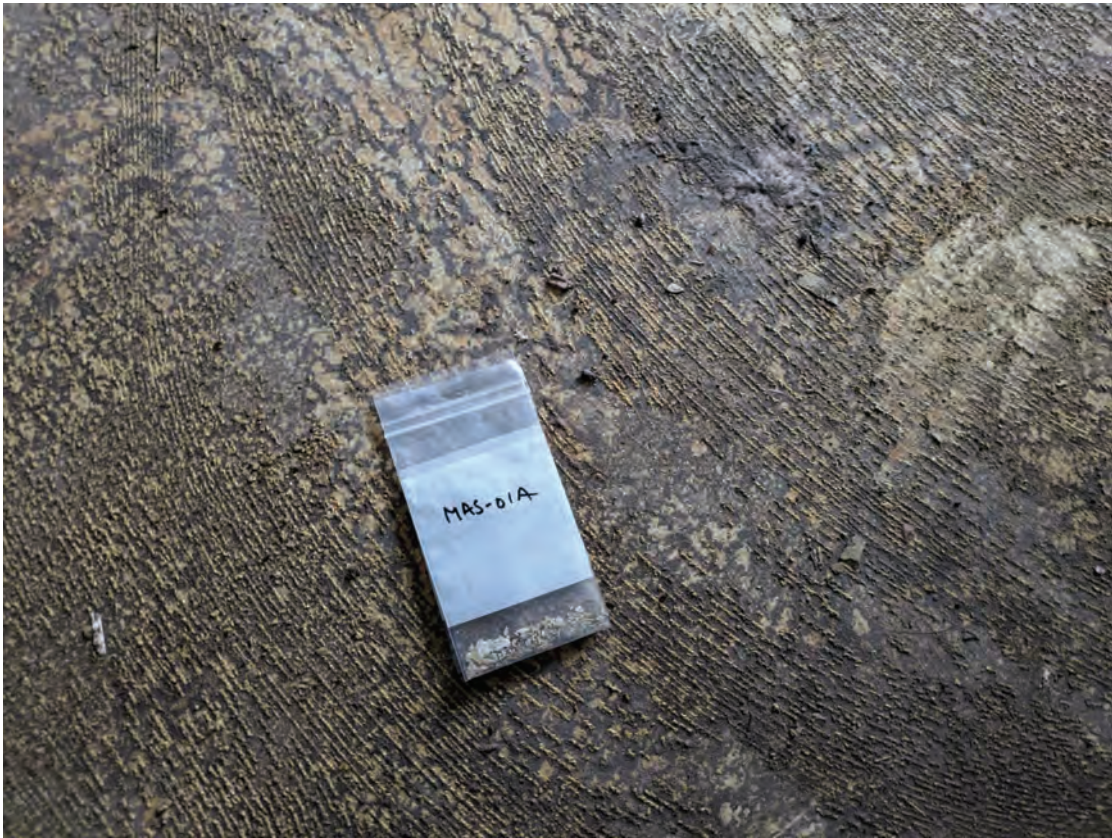
Figure
2

Upper Photo: MAS-01

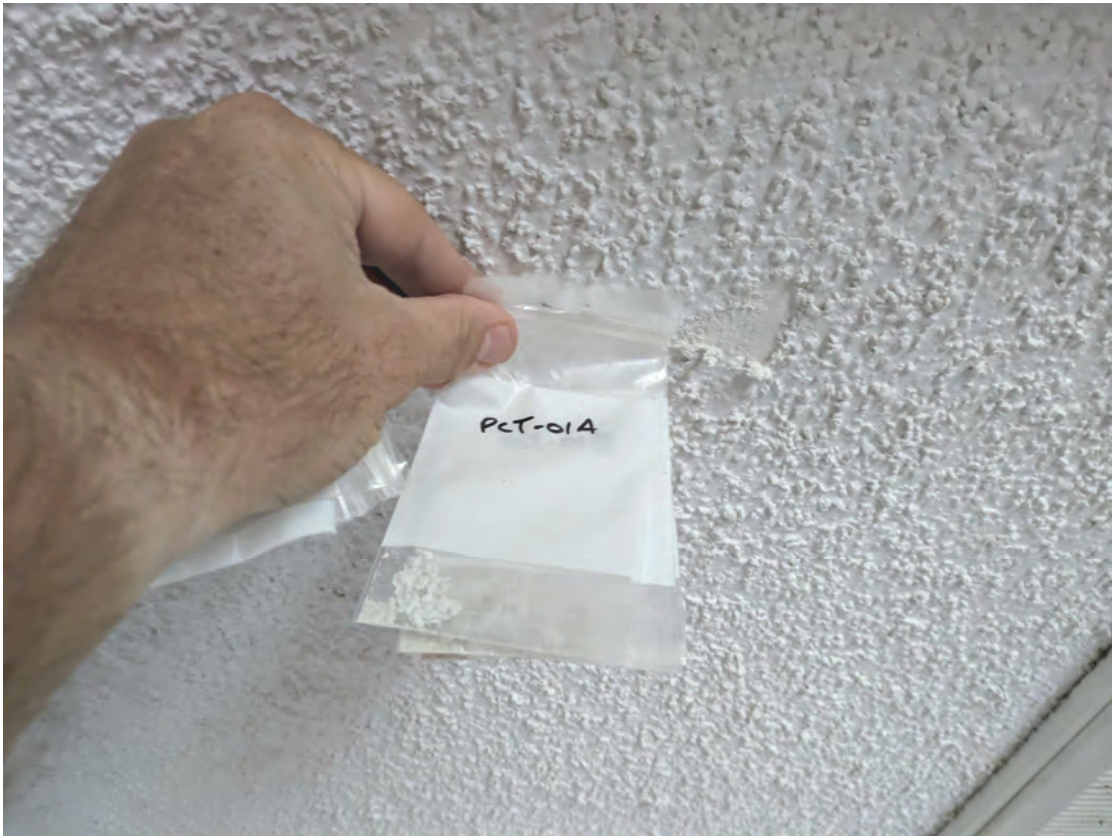
Lower Photo: PCT-01

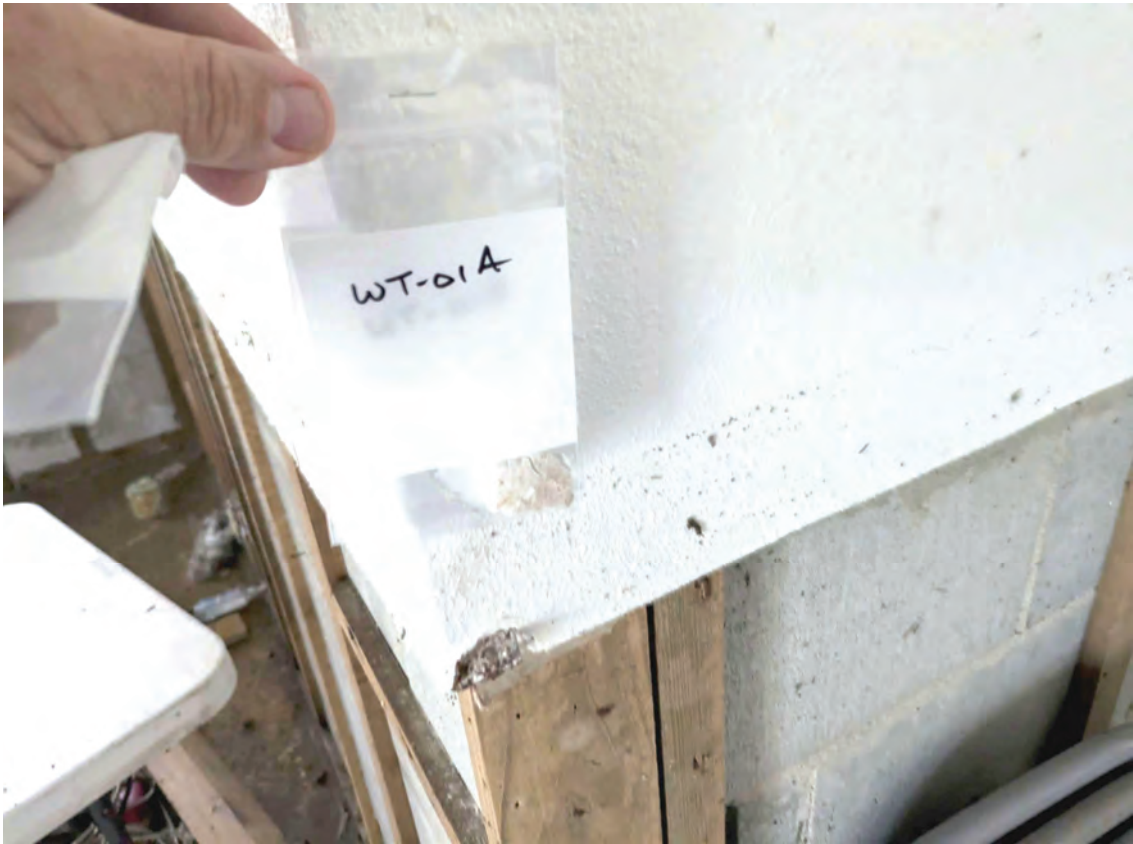
3

Upper Photo: WT-01

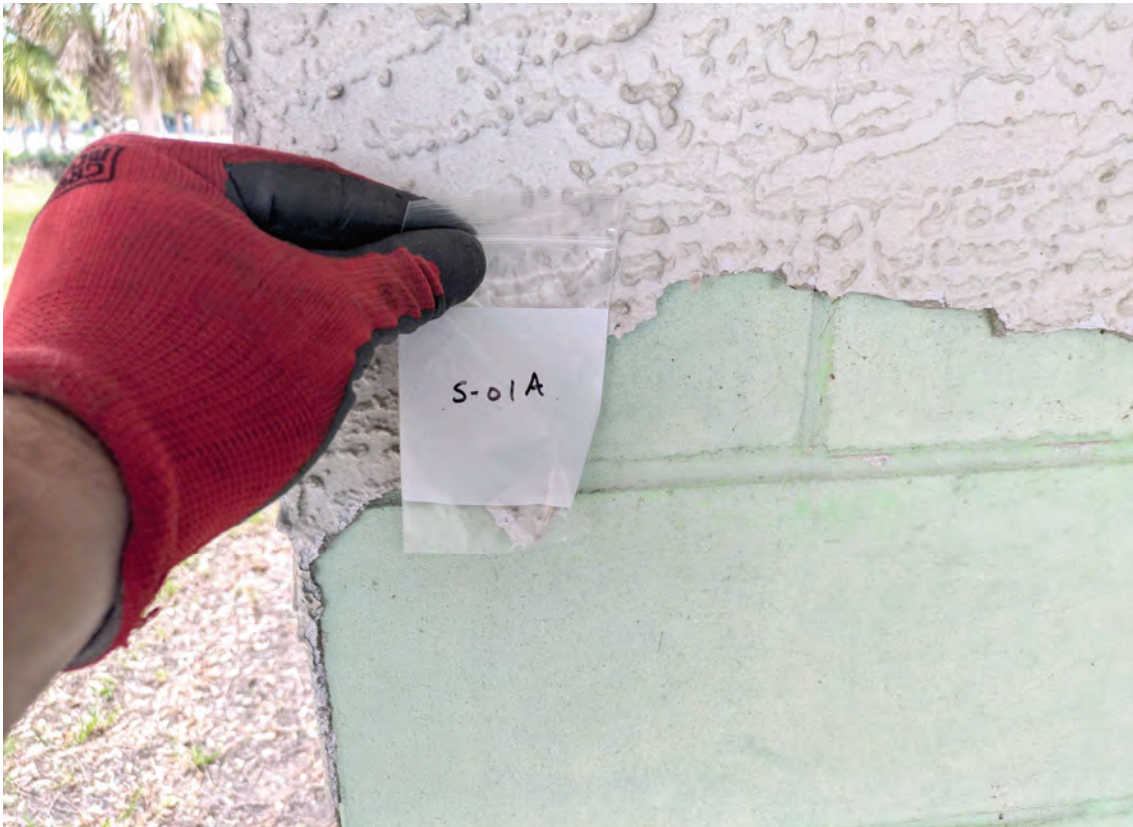
Lower Photo: S-01

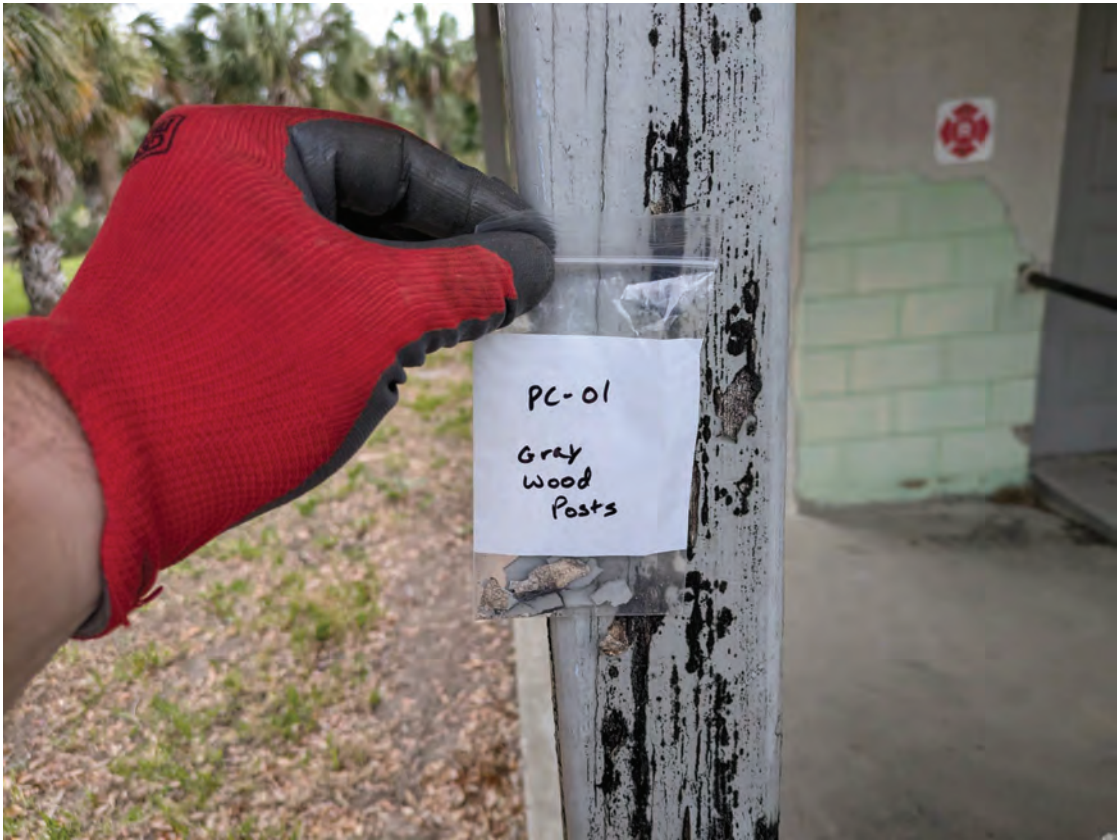
4

Upper Photo: PC-01

For all identified lead painted materials where abrasive blasting, welding, cutting and/or torch burning are planned, removal of lead paint is to be completed by a properly trained lead removal contractor.

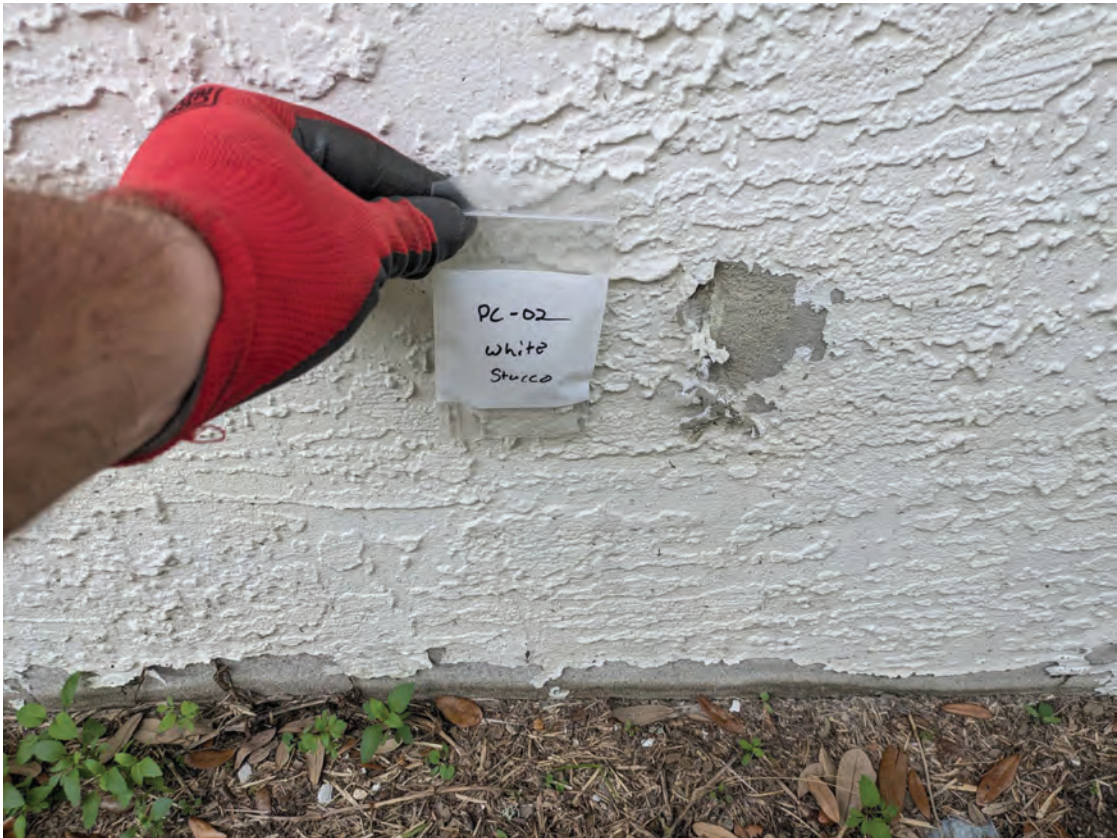
Lower Photo: PC-02
